GLOUCESTER CATHEDRAL CLOISTER
LAVATORIUM BUTTRESSES
2001-3

An archaeological report, incorporating archaeological assessment
by
Carolyn Heighway
and
Survey
by
Pascal Mychalysin

GCAR 99/G
Architect reference number 1900-5034
copyright: authors and Chapter of Gloucester Cathedral
3 March, 1999 updated 7 June, 2001; further edited July 2007.

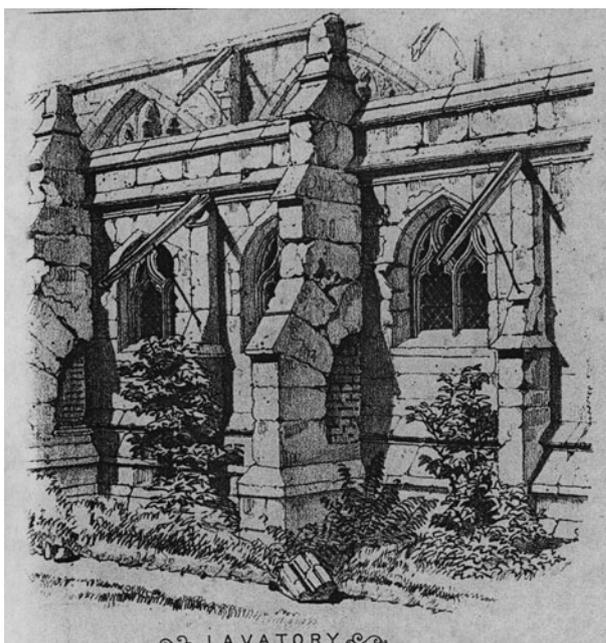
1 Gloucester cathedral: the lavatorium, drawn by Waller (1856)

The documentary evidence for previous repairs is summarised below (Appendix A). The architect F S Waller drew the buttresses in 1856 (FIG 1); the pinnacles were mere stumps and the buttress arches were filled with brick. In 1877 one buttress was replaced (Appendix A) to act as a guide for the replacement of others, which were not expected to last for long. The lavatorium windows and buttresses were further repaired in 1885. A photograph published in 1898 (FIG 2) shows the buttresses carrying new pinnacles, showing clearly in lighter-coloured stone than the buttress stonework beneath. Morley's internal elevation (FIG 3) of 1910 also shows a complete pinnacle on the first southern buttress. More repairs were done in the 1950s and 1960s.

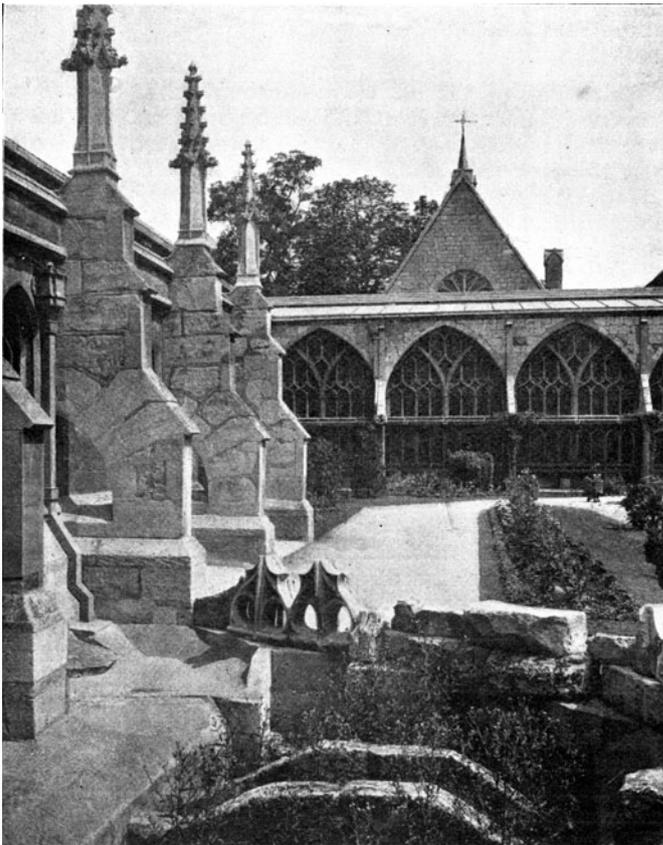
2 The lavatorium buttresses in 1898 (Masse 1898, opposite page 106). In the foreground is the medieval flushing tank, with cover ribs exposed, which had been uncovered a few years before this photograph was taken.

The 1898 photograph (FIG 2) shows that some of the piecing assigned to the 1950s work had already been done in 1898; a portion of the work assigned to the 1950s may thus be replacement of repairs of the 1880s.

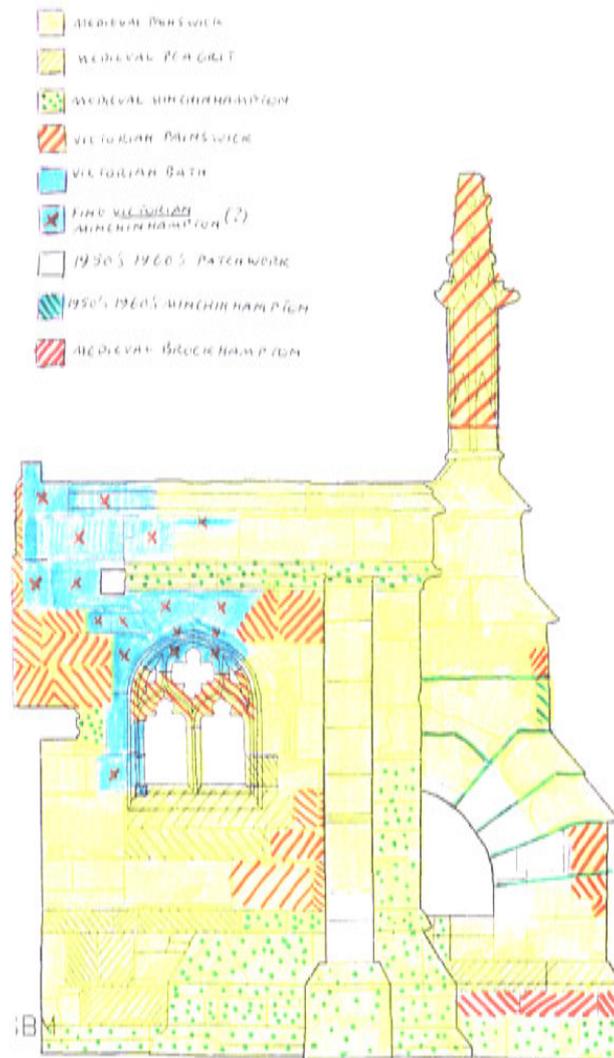
Buttress 2 The 1960s repairs on the underside are poorly cut and do not form a curve. The medieval coursing can be reconstructed.

4 Gloucester Cathedral: cloister lavatorium: elevation of west face including Buttresses 1 and 2. Petrological survey by Pascal Mychalysin.

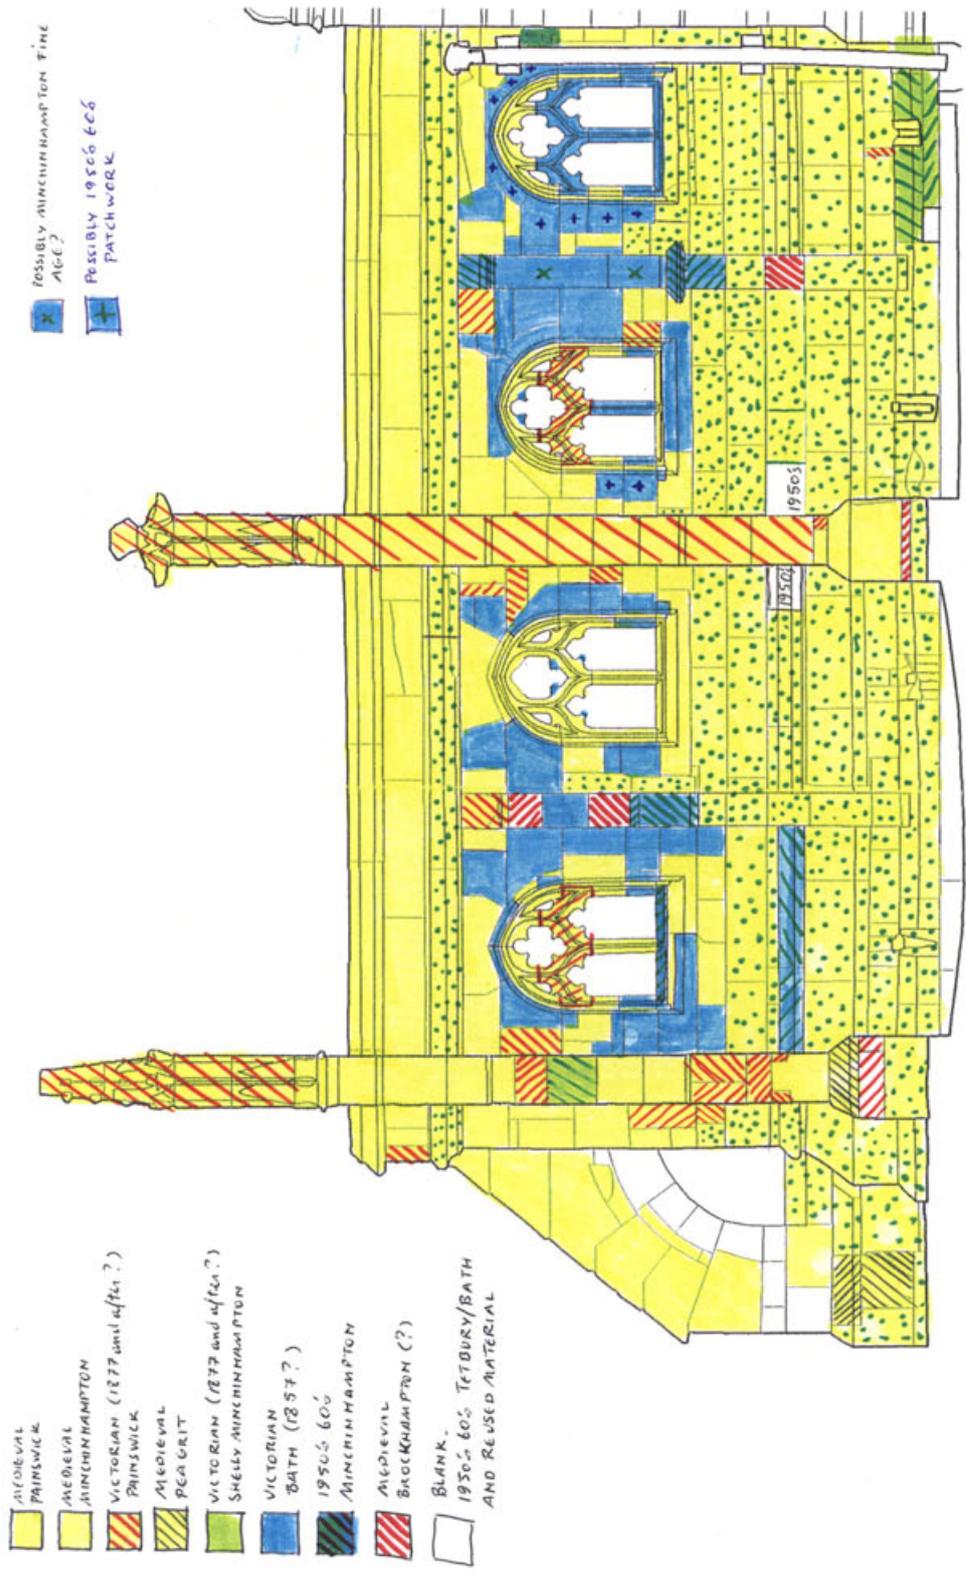
Buttress 3. This is the one replaced as a model in 1877, apart from the plinth. It therefore ought to be the buttress that best preserves the medieval design; the large size of the elements suggests this is the case.

5 Gloucester Cathedral: cloister lavatorium: elevation of south face (west part) including buttresses 1, 2 and 3. Petrological survey by Pascal Mychalysin.

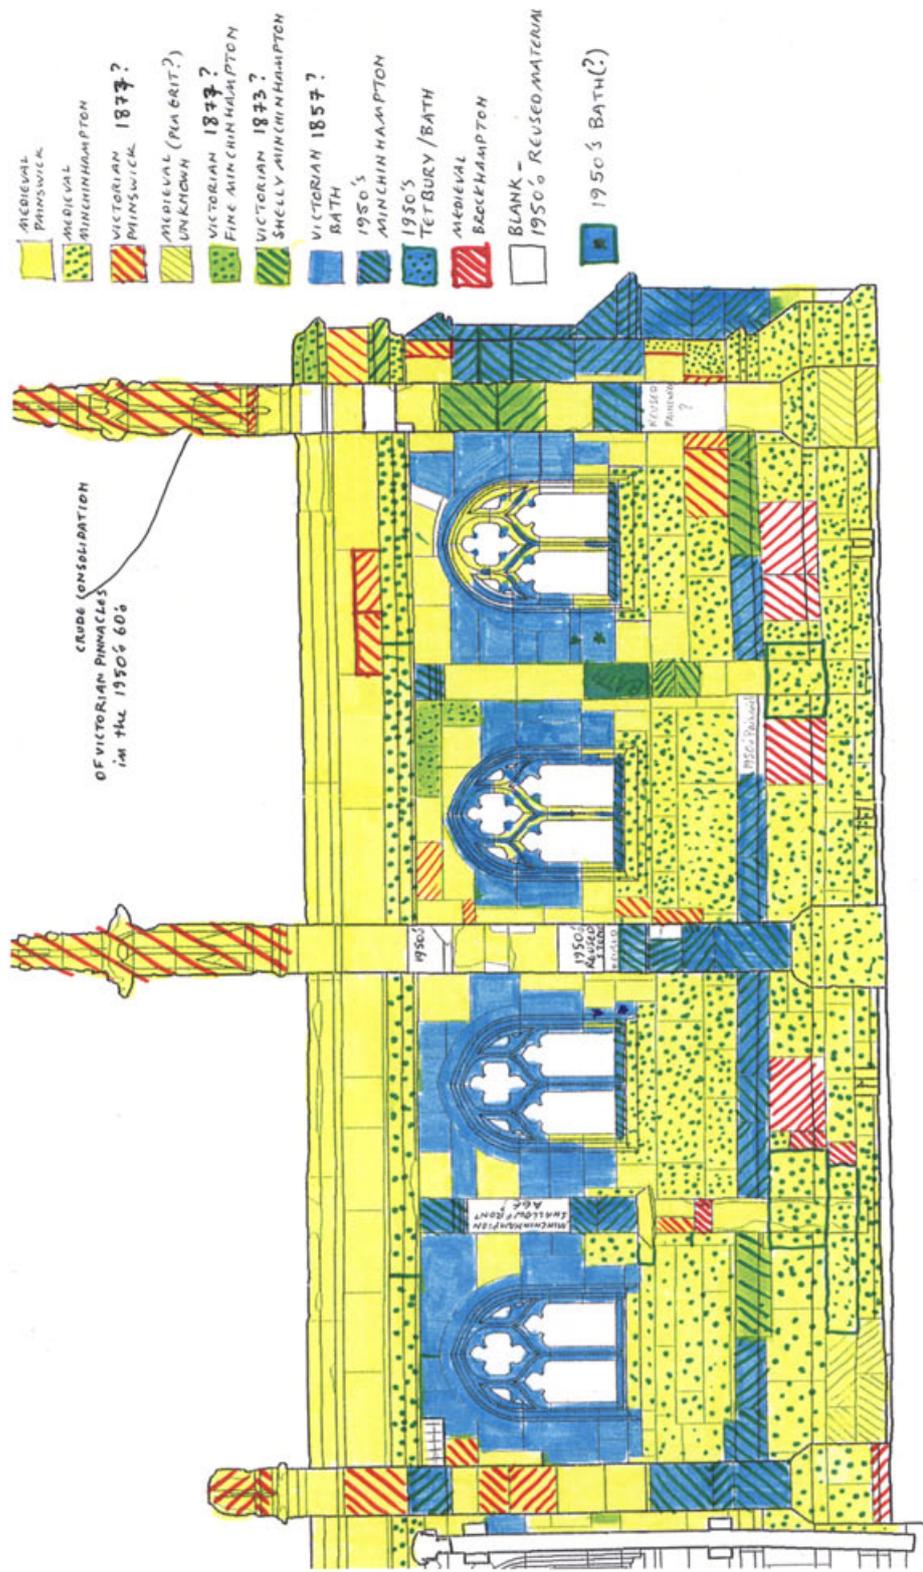
Buttress 4. A great deal of 1960s piecing, some very shallow (52 mm). Left side in 1898 photograph.

Buttress 5. Medieval design severely disturbed; not much of medieval coursing survives. Compare with 1898 photograph. Fracture on upper part of buttress.

Buttress 6. Medieval design severely disturbed. not much of medieval coursing survives. Compare with 1898 photograph.

6 Gloucester Cathedral: cloister lavatorium: elevation of south face (east part) including buttresses 4, 5 and 6. Petrological survey by Pascal Mychalysin.

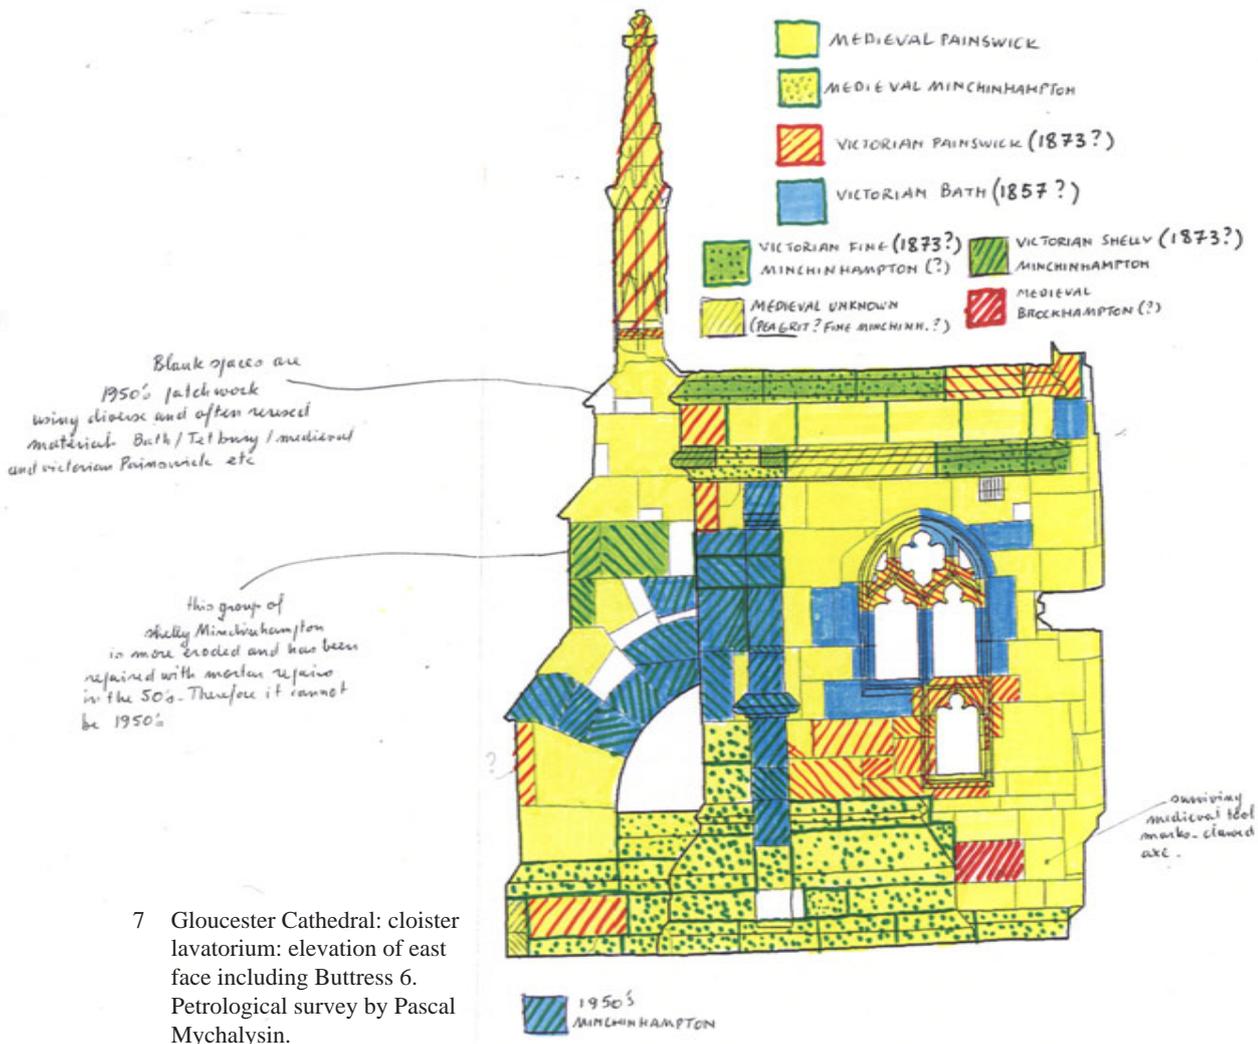
7 Gloucester Cathedral: cloister lavatorium: elevation of east face including Buttress 6. Petrological survey by Pascal Mychalysin.

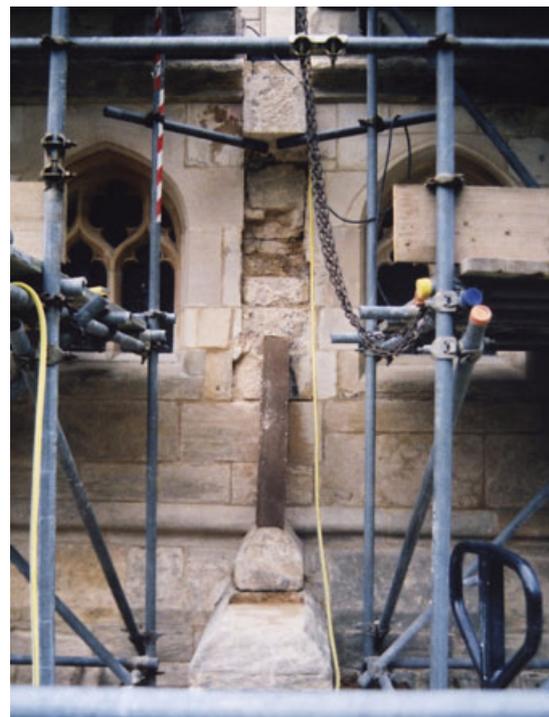
None of the buttress coursing matches with that of the lavatorium itself, and it is clear that the large buttresses (as opposed to the smaller ones which are clearly bonded with and contemporary with the lavatorium) are additions to the original design. This was further confirmed during repair work when it was apparent that the buttresses are only very shallowly bonded to the wall they support (FIG 8).

8 Cloister lavatorium buttresses: most of buttress 5 removed except for plinth, showing shallow bonding with lavatorium wall. View from south (AY/4A).

Buttresses are numbered 1 to 6 (or in Roman numerals I–VI), with 1 being the buttress at the west end of the lavatorium block. The aim of the repairs was to restore as far as possible the medieval design and jointing. Buttress 5 had been so structurally compromised by patching and alteration that it was considered appropriate to take it down and rebuild to the original joint lines to restore structural and archaeological integrity.

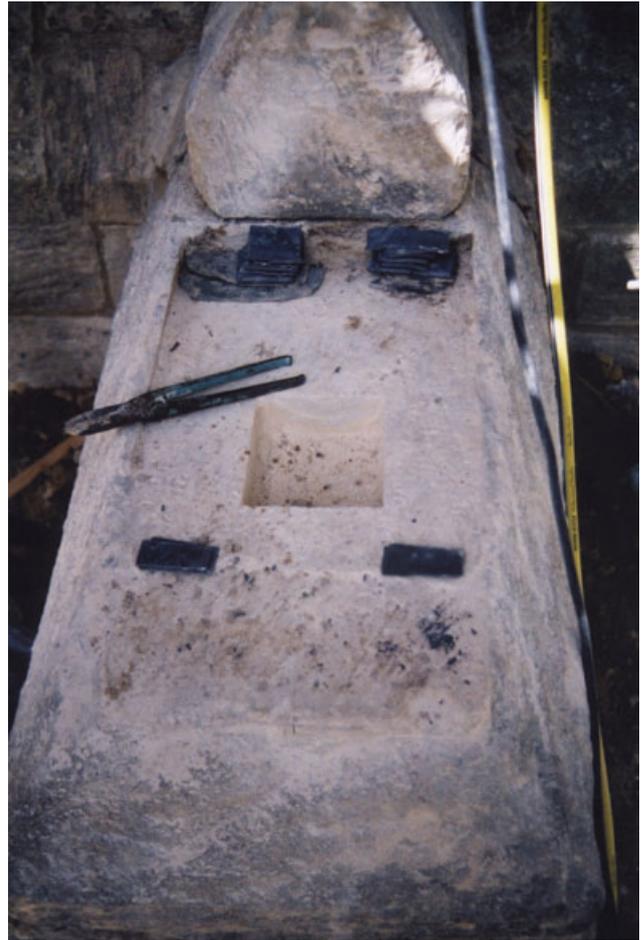
Dismantling of Buttress 5 revealed that the medieval masons had used stone mortice-and-tenon to tie the buttress both to its base (FIG 9) and to the wall (FIG 10).

9 Cloister, lavatorium buttresses 4th buttress from west (buttress 5) base bed of buttress sunk at an angle into base and including mortice. Medieval coursing and method replicated on new stones (AY/6A)

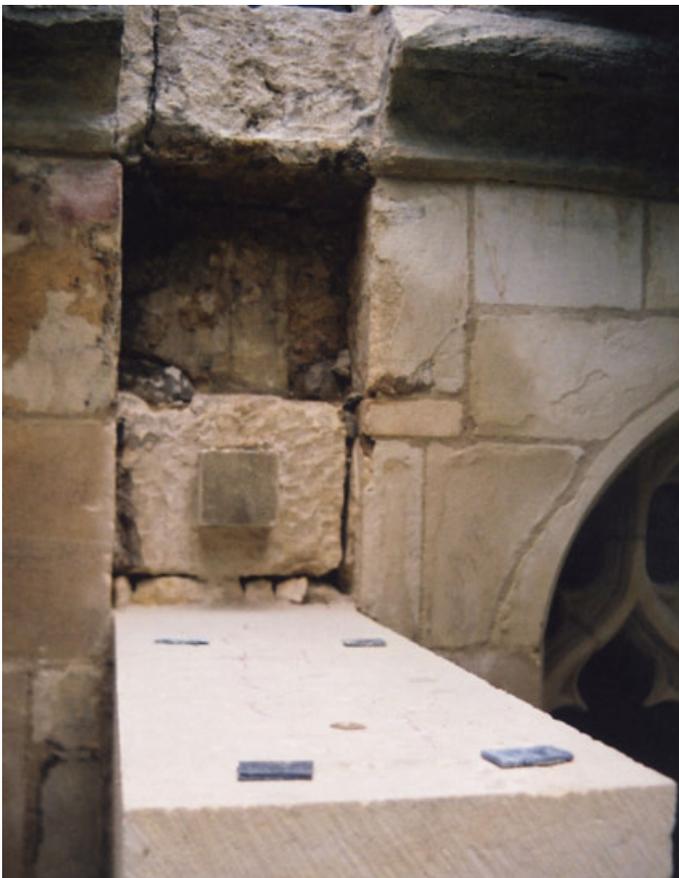
10 Cloister, lavatorium buttresses. 4th buttress from west (buttress 5). Restoration of medieval mortice-and-tenon technique to tie buttress on to lavatorium. View from south (AY/16A)

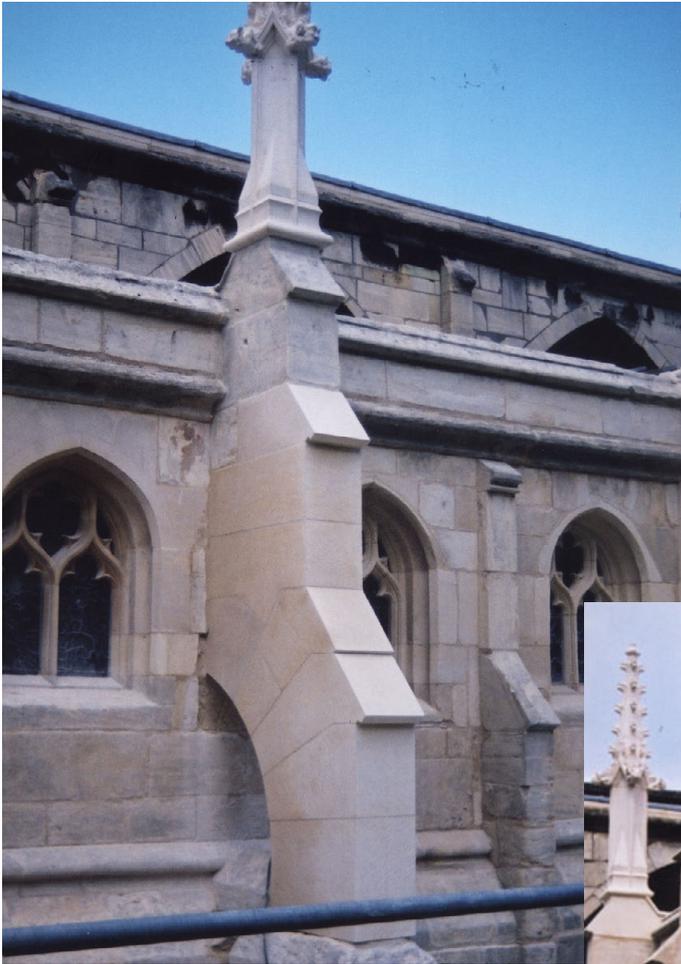
11 Cloister, lavatorium buttresses. 4th buttress from west (buttress 5), completed. (AY/20A)

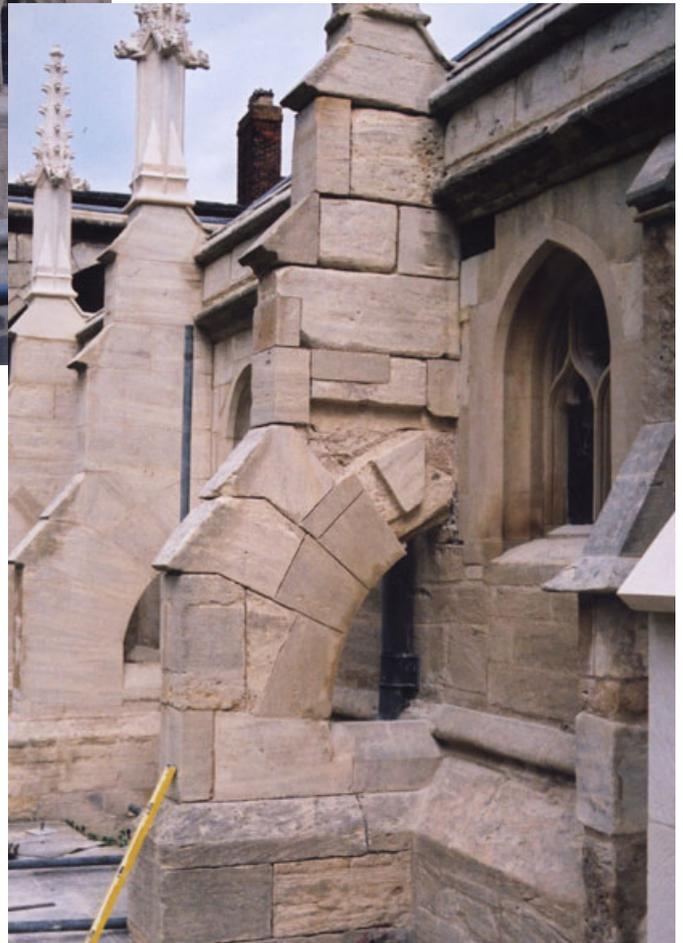
12 Cloister, lavatorium buttresses. Third buttresses from west (no 4): joints cut out exposing 1950s patchwork repairs. View from east. (AY/22A).

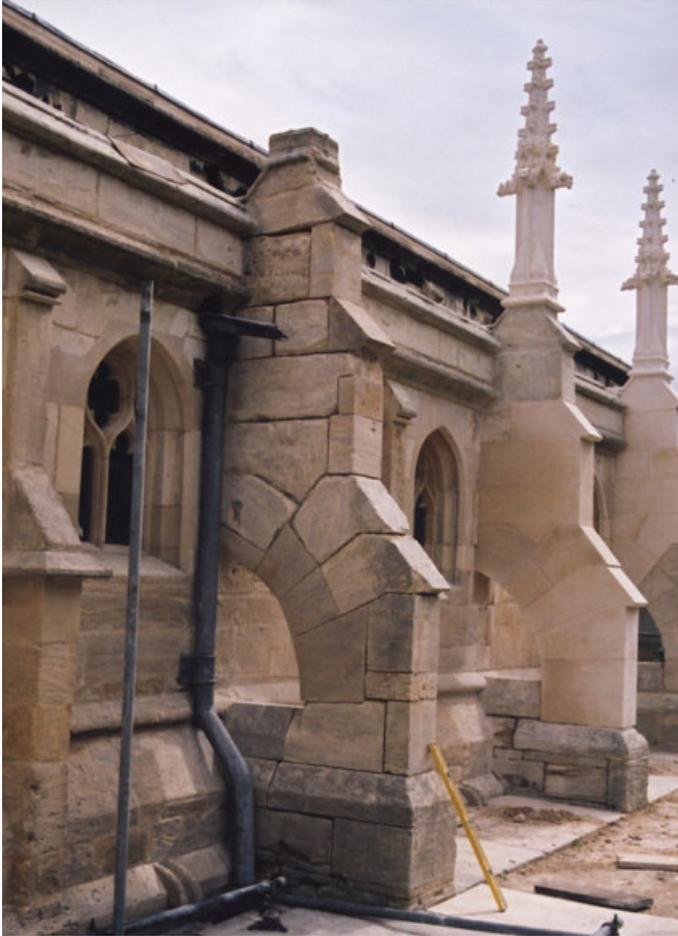
13 Cloister, lavatorium buttresses, 3rd from west (buttress 4); joints cut out. View from west also showing renewed buttress 5 and repaired buttress 6.

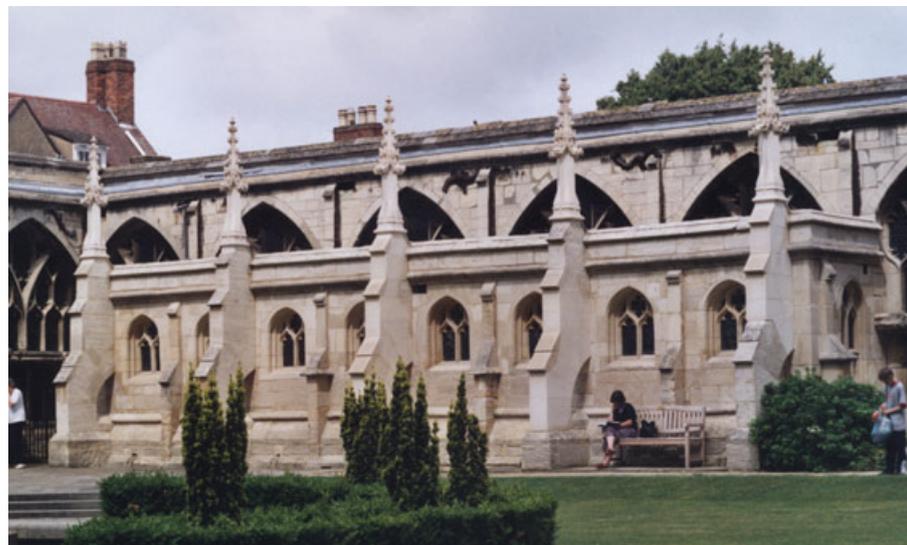
14 The finished buttresses, from the south (AS/20).

The buttress pinnacles being all gone, new pinnacles were designed by Pascal Mychalysin. The central pinnacle (on buttress 4) bears faces carved from life: representing former Clerks of Works, Alan Norton and Tom Dorrington, the former Cathedral Architect, Basil Comeley, and on the north side, Canon Norman Chatfield, who was Fabric Canon in the 1990s.
