GLOUCESTER CATHEDRAL NORTH TRANSEPT,

PHASE 2 , NORTH GABLE

ARCHAEOLOGICAL REPORT 2007

*Archaeology reference number* GCAR 2007/A

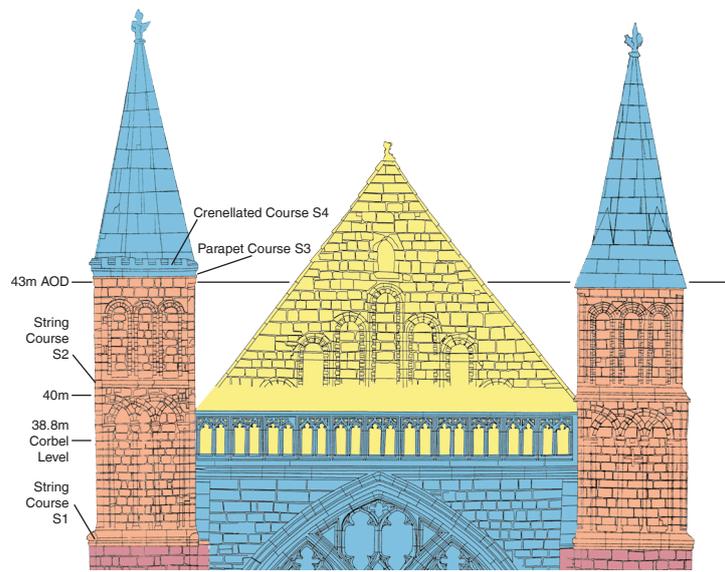
NORTH TRANSEPT  
The North Elevation, Interpretation  
(NE Turret to the Left)

2  
North elevation of north transept: interpretation. The blind arcading was probably in a similar position on the Romanesque gable and was re-set in the 14th century. Most of the ashlar in the gable were re-used Romanesque with some new 14th century stone.

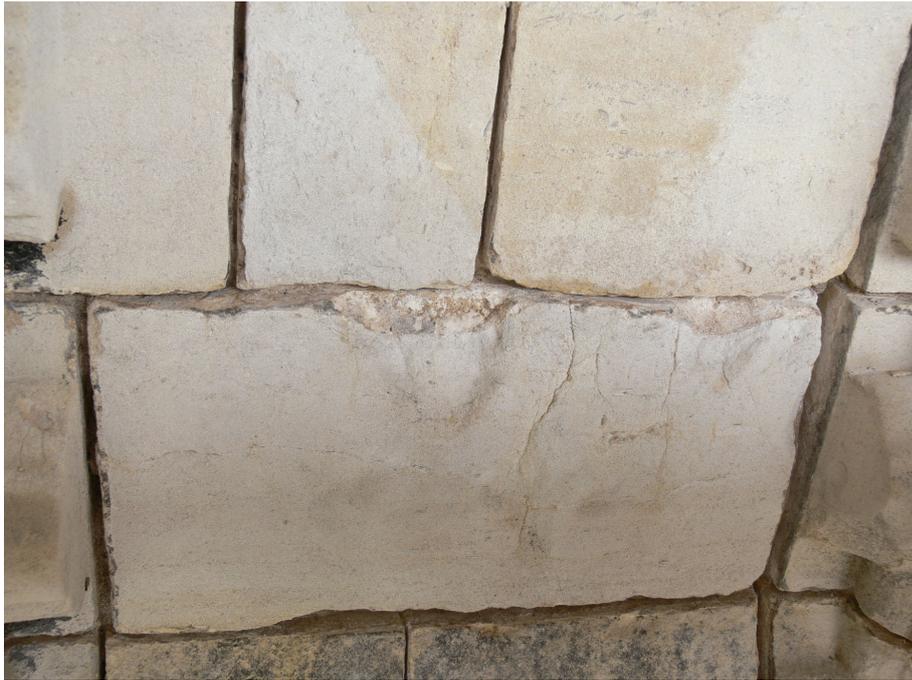
4  
Possible quarry wedge-  
marks on ashlar on the north  
face of the north gable,  
inside central panel of  
arcading.

Several quarrying wedge marks were recognised on the Romanesque fabric of the gable. The best two are located near the floodlight at the back of the gable right hand side (sketch 2). They are identical to similar marks found on Romanesque ashlar on the south transept south-west and south-east turrets.

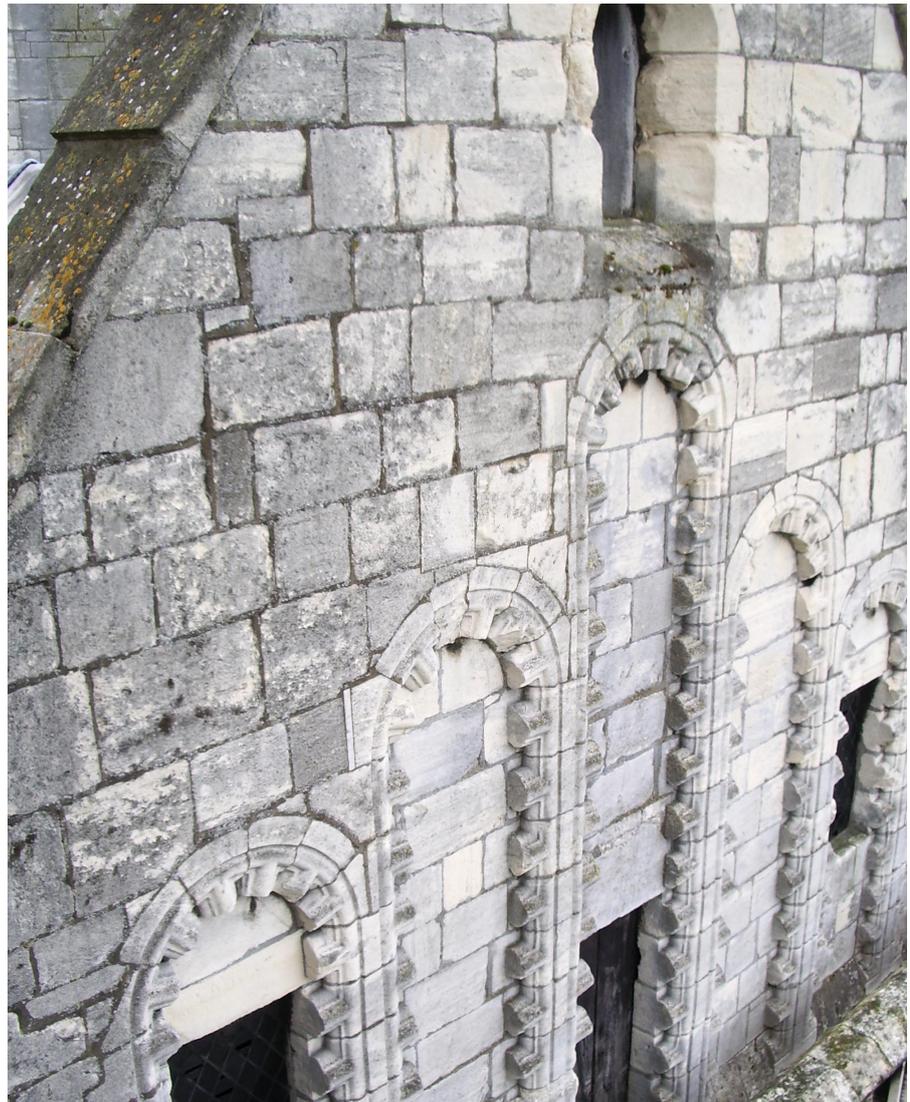
The gable is decorated with blind arcading carrying an unusual decoration for which we have been unable to find parallels; the masons call it 'T-moulding' (Figs 5, 11-14). This is undoubtedly Romanesque, but was reset in the 14th century (the gable rests on the inside face of the north wall rather than on the outside face). The gable was rebuilt using the former decorative detail, but the fact that some of the voussoirs of the blind arches do not quite fit makes it clear that the 14th-century builders had stored the stone imprecisely, perhaps by type of moulding (jamb voussoirs etc) and had some difficulty, as they worked up the stonework, fitting the stones together properly because they were in different positions. Some stones had to be re-carved, copying the old mouldings: this is clear from the fact that at least one T-moulding (WKS 340, Figs 11-13) was created from a Romanesque roll moulding.

5  
North transept north gable  
before scaffolding in 2007:  
the mouldings of the blind  
arcading are an unusual  
Romanesque form called here  
'T-mouldings'.

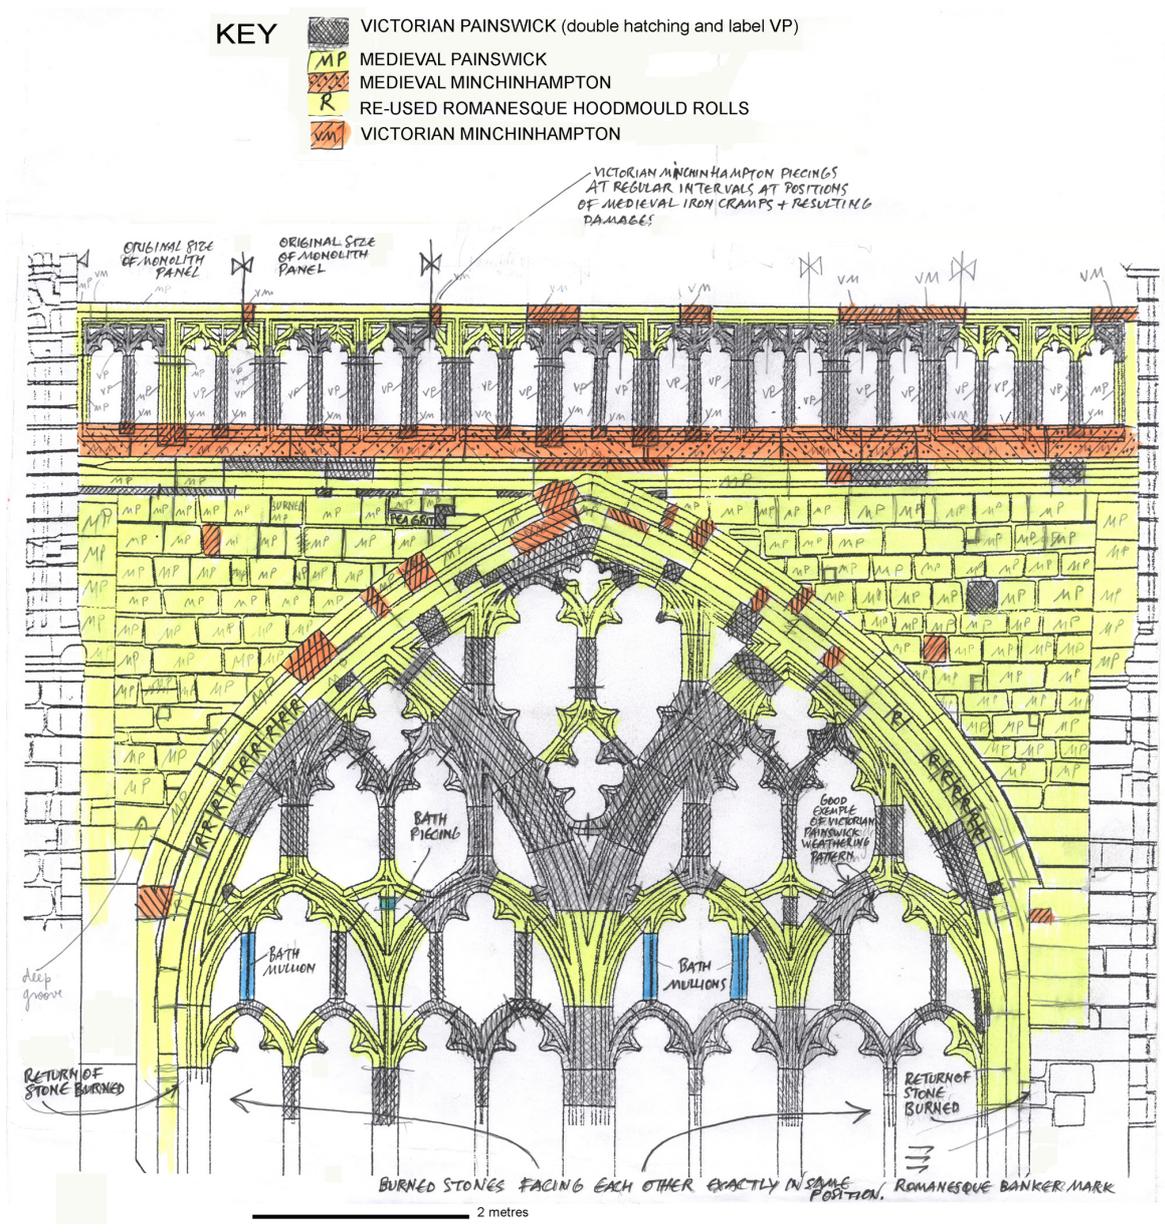
This shows extensive Victorian repair (Figs 6 and 7), and judging by Waller's description of the works done in 1875 (above) it is surprising that there is any medieval stone of the tracery surviving at all.

staircases of the transept turrets (Fig 7). The north window also carries 16 Romanesque rolls reused architecturally in the hood-moulding (Fig 6, marked R), but there were clearly not enough of these to do the whole window, no doubt because by that time in the rebuilding process (the north window was finished in the 1370s: Welander 1991, 217) the stock of reusable Romanesque stone was coming to an end.

These, though basically of 14th century design, have been extensively renewed probably mostly in the late 19th century (see Fig 6).

6 Survey by Pascal Mychalysin of the stone-types and other details of the north part of the north window. Scale approximate.

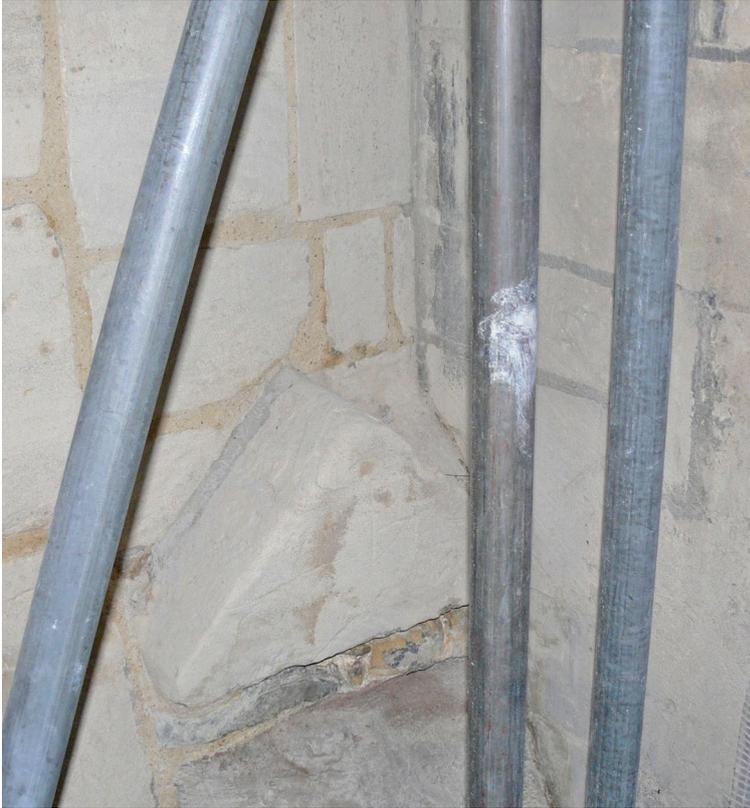
In the well of the window (the space between the window and the library wall) can be seen the stubs of the parapet in front of the window which was chopped out when the library was built (Figs 9 and 10).

9  
The well of the north transept window, looking west, showing sawn-off original parapet: evidence that the library which now replaces the parapet was not then in existence or immediately planned.

The evidence for the chopped-off parapet outside the north window of the north transept makes it clear that, when the window was finished (about 1370), no library was there, or planned.

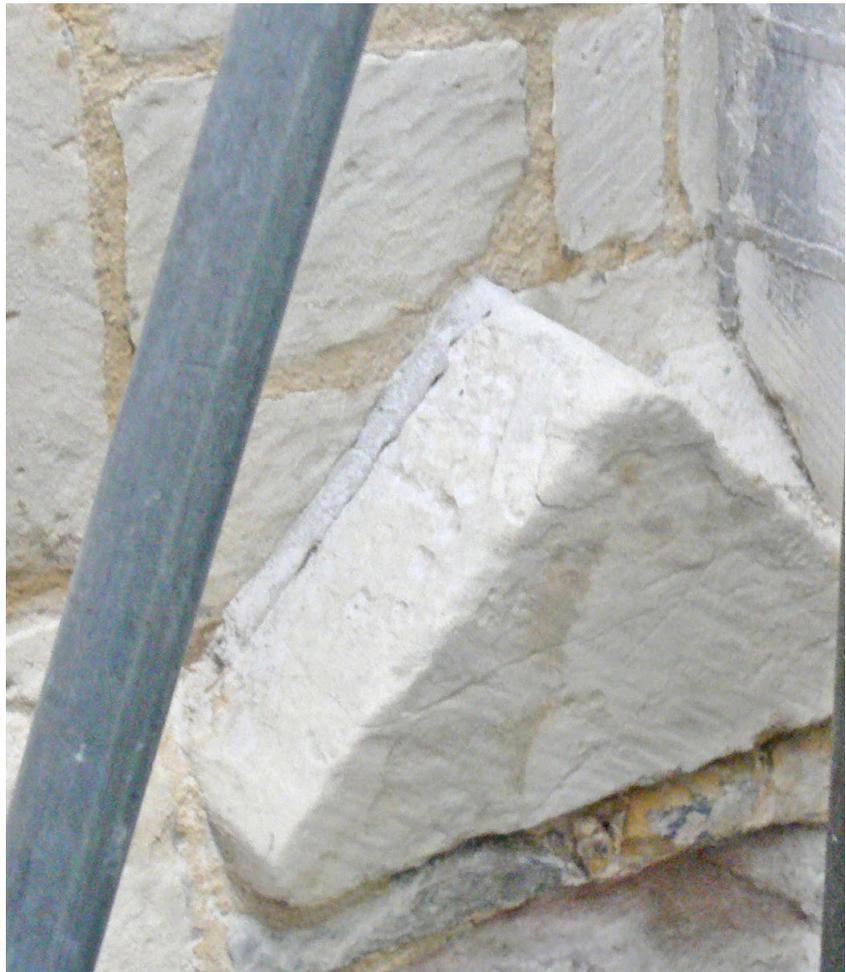
10  
The well of the north transept window looking east, showing the eastern stub of the sawn-off parapet.

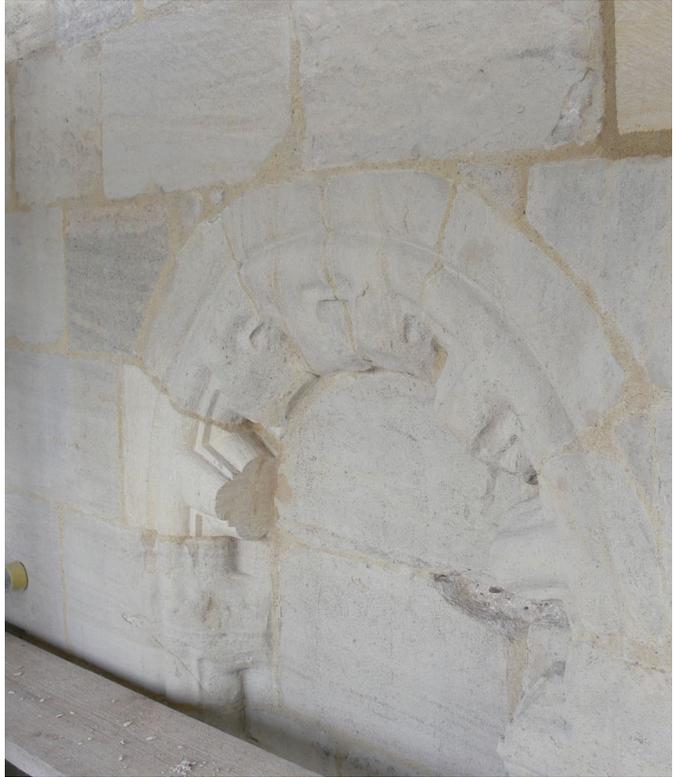
11

T-moulding after replacement with new stone: the T-moulding which it replaced, WKS 340, is pictured in the two photographs below.

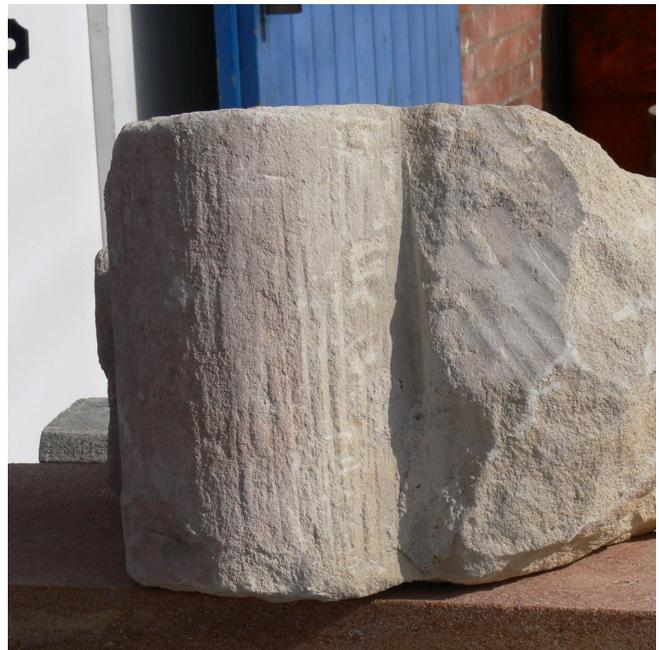
13  
WKS 340: this is a Romanesque roll, recut to a Romanesque style 'T-moulding' in the 14th century.

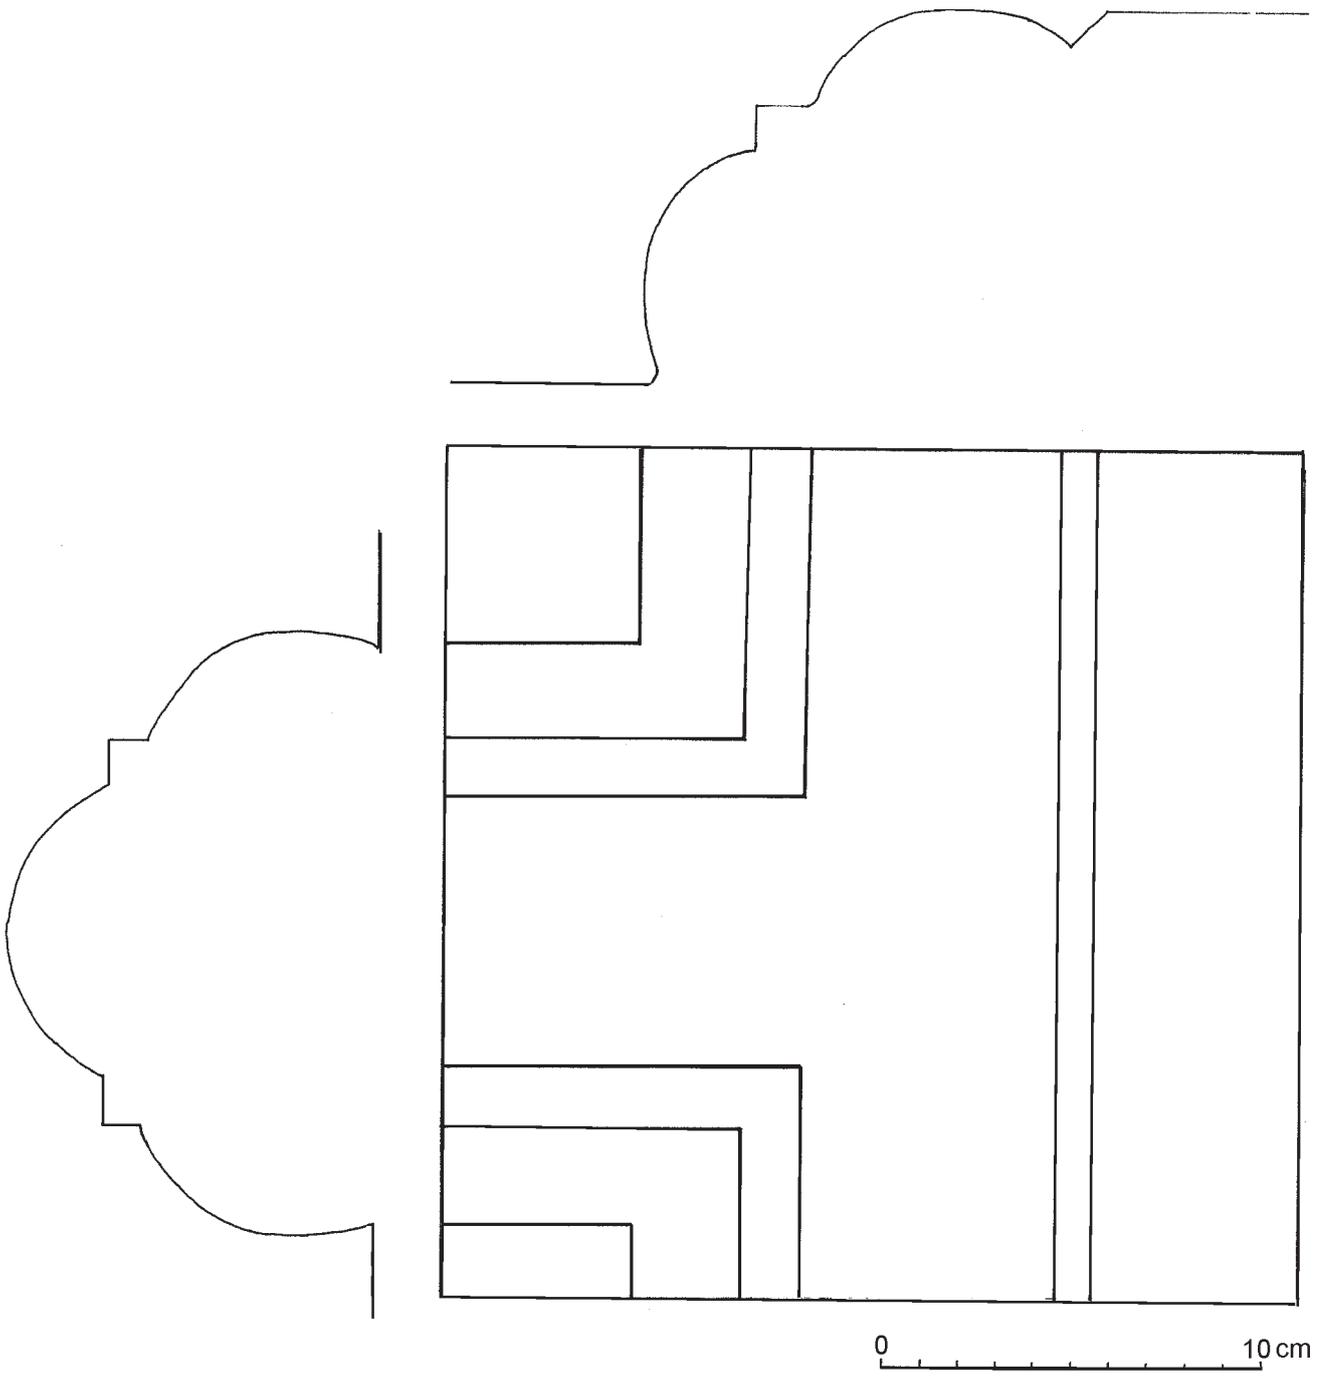
14  
T-moulding: a copy of the masons' template of one of the new T-mouldings from a jamb of the blind arcading on the gable.

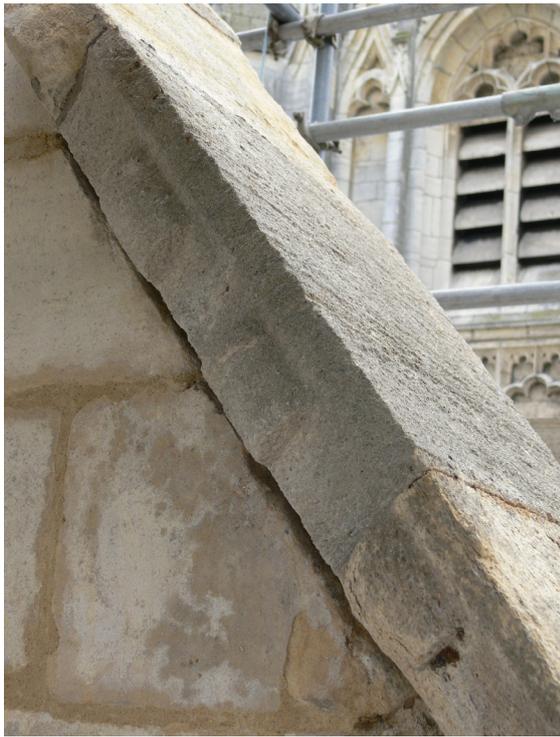
15A  
Round billet on coping stone of north transept, probably re-used from the Romanesque gable.

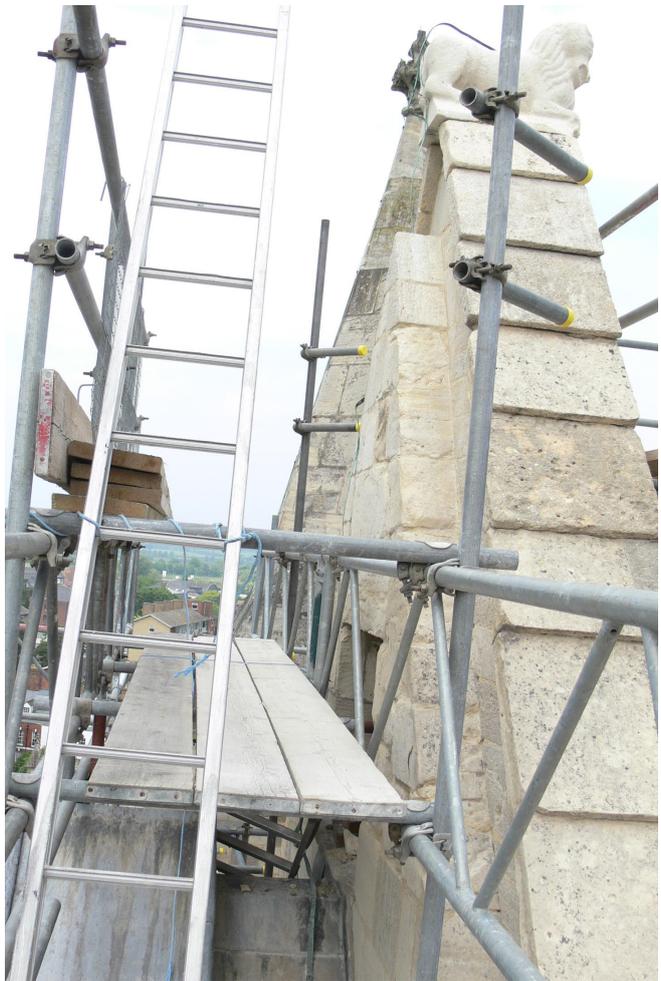
15B  
The rear face of the 14th-century gable, showing the rebate to take the roof.

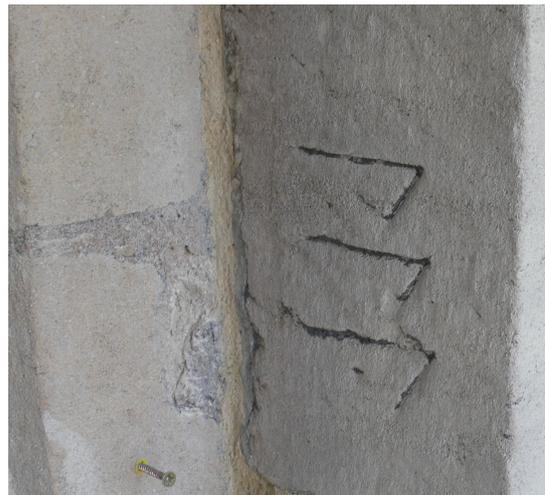
16  
Romanesque masons mark, view to west, on jamb of north window; for position see Fig 7. The dark colour is encrusted dirt which survived cleaning. This mark is one of the most prolific of the 11th-12th century at the abbey.

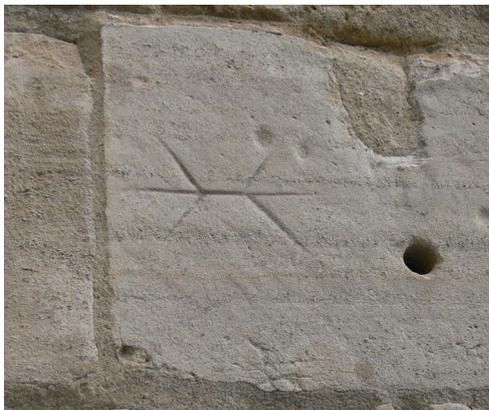
17  
Re-used stone with Romanesque masons mark on inside (east facing) face of buttress

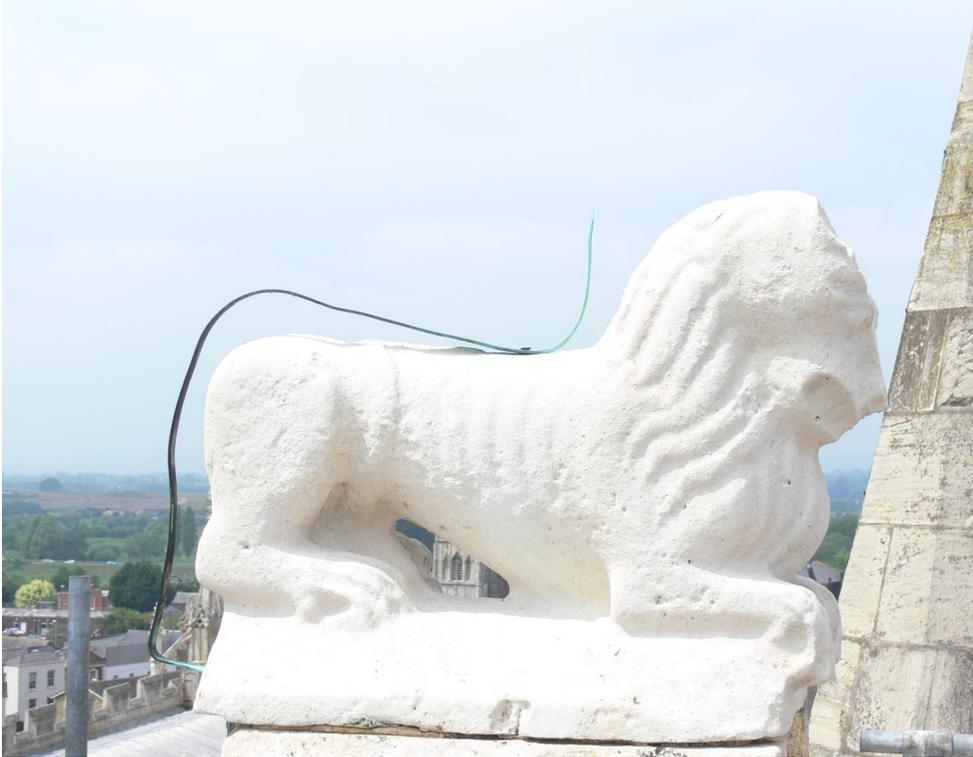
The lion sculpture (Fig 18) at the apex of the gable is made of a pale coloured limestone; its style suggests Romanesque work rather than 14th century. It is made of a good quality, homogenous white limestone which may have withstood weathering particularly well. In fact it is difficult to judge how much a Romanesque piece should weather in 900 years, simply because so little Romanesque high-level superstructure survives.

18  
Lion sculpture on the apex of the north transept gable: possibly Romanesque; in a good hard white freestone which has thus weathered very evenly.

The Lion sculpture at the top of the gable is made of a very distinct type of limestone. After cleaning operations it appeared very much brighter than the rest of the fabric. It is a fine-grained oolitic limestone pale cream/white homogeneous texture with little shells more similar to Ball's Green Stone/Nailsworth than usual Painswick types used on the Cathedral. What makes it stand out is not so much the finer grain than its unusual white colour. It was obviously selected for its Freestone/carving quality. The depth of the coping section of the carving is 2" deeper than copings underneath (23" to 21").

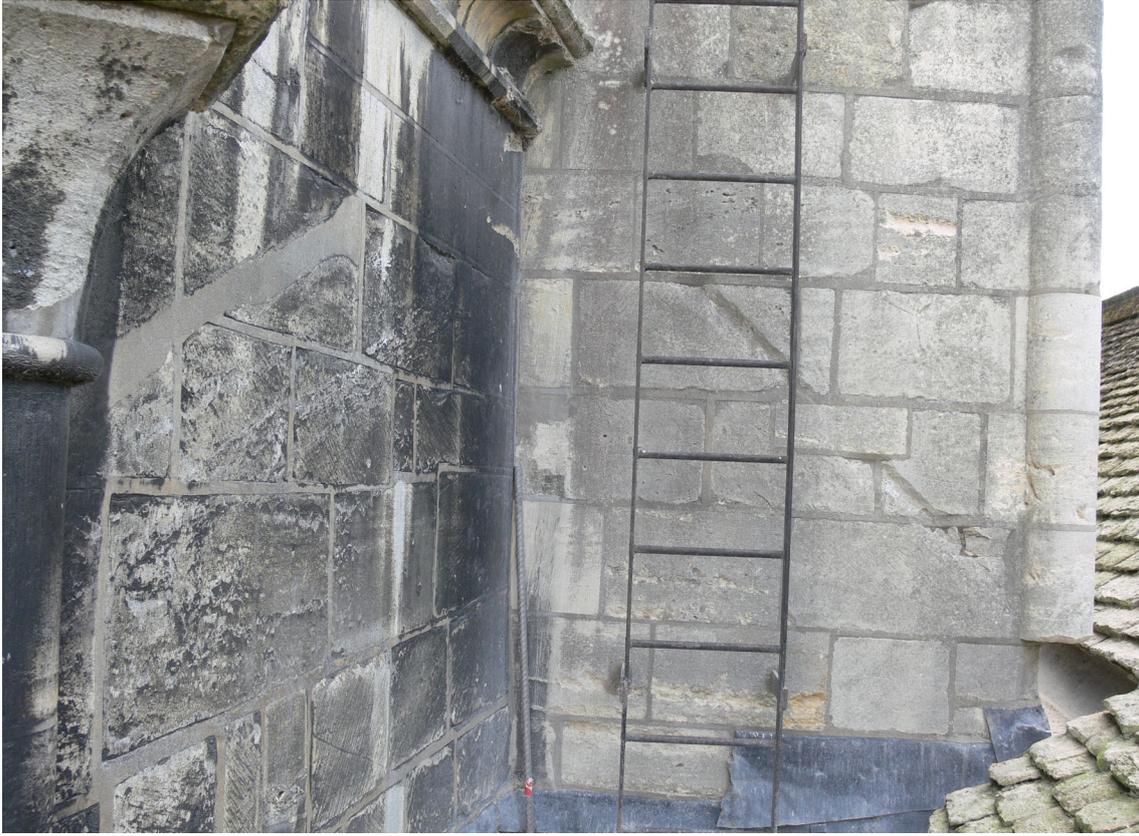
On the east face of the north-east transept turret, at library roof level, there is the line of a pitched roof sloping down both to north and to east (Fig 20). The position of this roof-scar has some significance for the building date of the library: this is discussed below in Appendix 2.

20  
An ancient roof-line against the north transept chapel and the north transept north-east turret. Looking west.

In the angle of the north transept north-east turret, and the chapel of the north transept, there is at library roof level the line of a steep pitched roof (base angle about 43 degrees).

The roof is pitched against both walls with the apex just below the 14th century parapet (P1020175; Fig 20 above).

The scar is very weathered, indicating that it has been out of use for a long time.

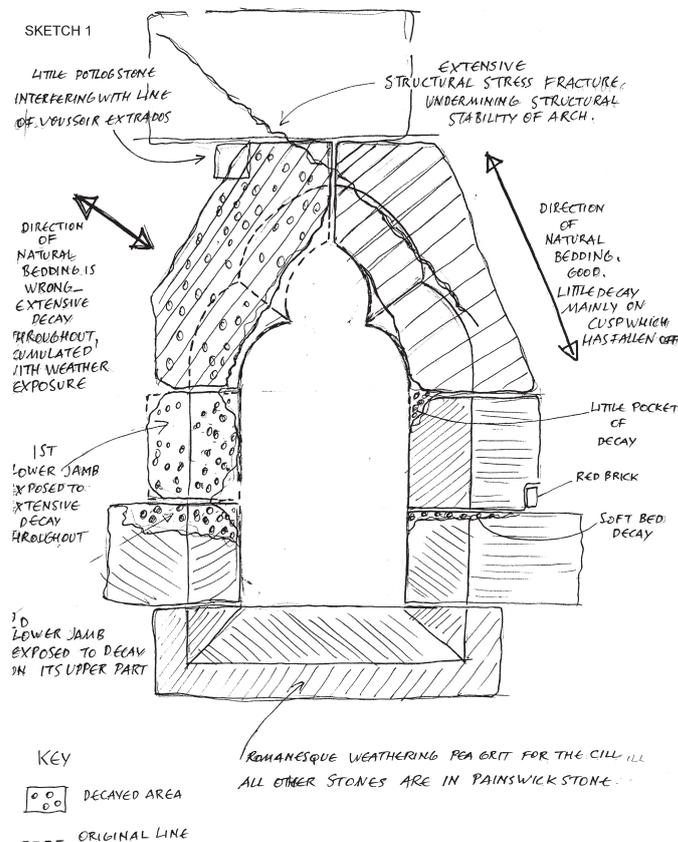
GLoucester Cathedral. NORTH TRANSEPT GABLE. ELEVATION  
TOP WINDOW OF GABLE SURVEY 22<sup>nd</sup> 05 OF PM.

During restoration it was noted that the cill of the trefoil window had been raised and replaced in the past (see Appendix 1 below): the earlier cill showed signs of weathering and sooting. This raising probably took place when the roof was altered in the late medieval period.

The top window of the gable has a trefoil design (sketch 1). It is redundant as pitch of roof was changed. The cill of the window is of Peagrit Stone. On repair it was apparent that the cill had been raised and renewed. Also apparent was that the structural stress fracture seemed to be linked with rusty ferrous nails found in the bedding of the horizontal joints of the jamb stones underneath the trefoil arch: these nails were probably used to secure the wood oak panel which blocked the window.

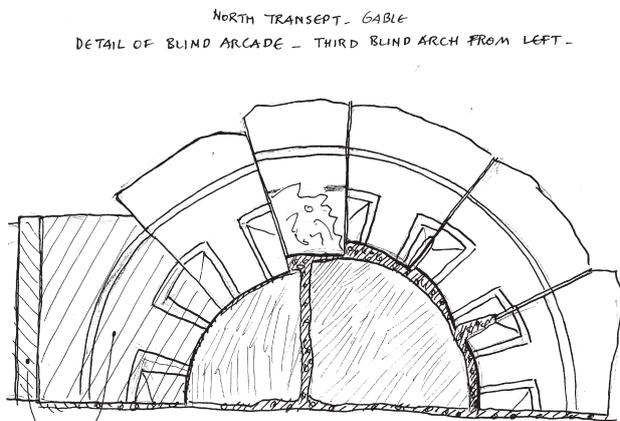
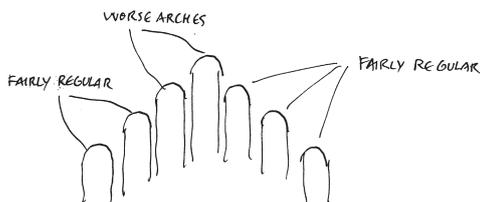
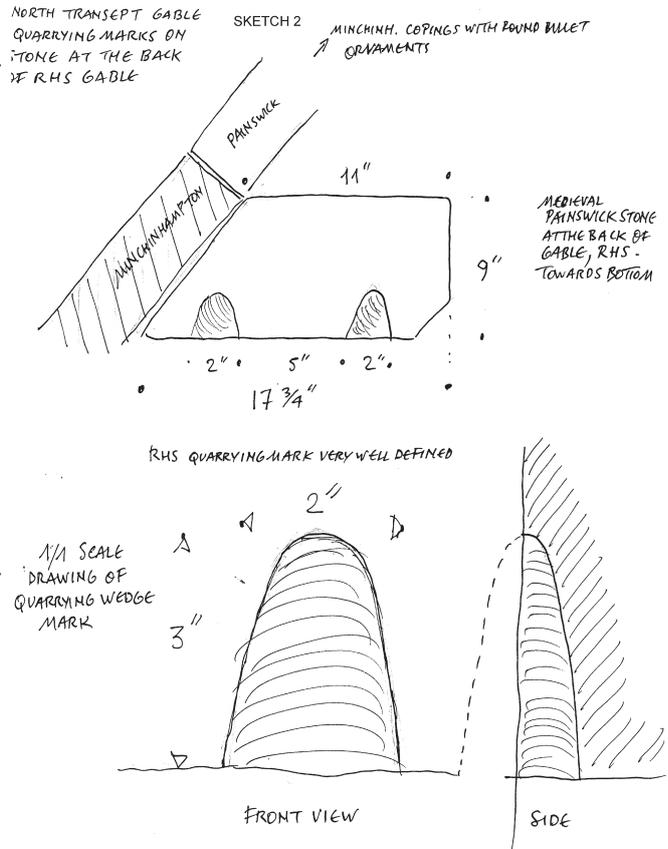
## SKETCH 3

VICTORIAN REPAIRS  
IN PAINSWICK STONE

THE SOFFITS OF VOUSSOIRS DO NOT MATCH EACH OTHER APART FROM THE FIRST TWO TO THE LEFT THIS ARCH IS THE WORST CASE. THE CENTRAL ARCH IS SLIGHTLY BETTER. IT COULD INDICATE THAT DURING THE RECONSTRUCTION OF THE GABLE THE XIVC MASONS HAD DIFFICULTIES IN THE HIGHER STAGE OF BLIND ARCADING RUNNING OUT OF MATCHING MATERIAL PERHAPS.

The lower parts of the arcading was successfully replicated from the Romanesque design but the 14th-century builders ran into difficulties completing the arcading; the voussoirs of the two highest are grossly offset (sketch 3).

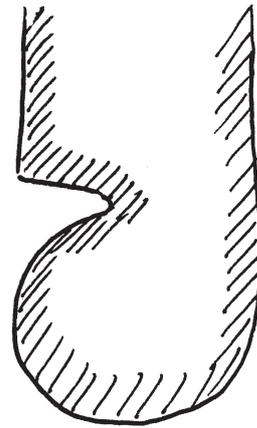
SKETCH 4

On the main arch of the tracery window directly below the hood-mould section can be found 16 small stones forming a roll-mould section around the tracery. These are very probably reused Romanesque. This would be very much in keeping with 14th-century practice of integrating Romanesque moulded stones into a 14th-century design, although compared with the south transept this re-use is on a very small scale and doesn't involve more than one sort of design (a roll as in sketch 4).

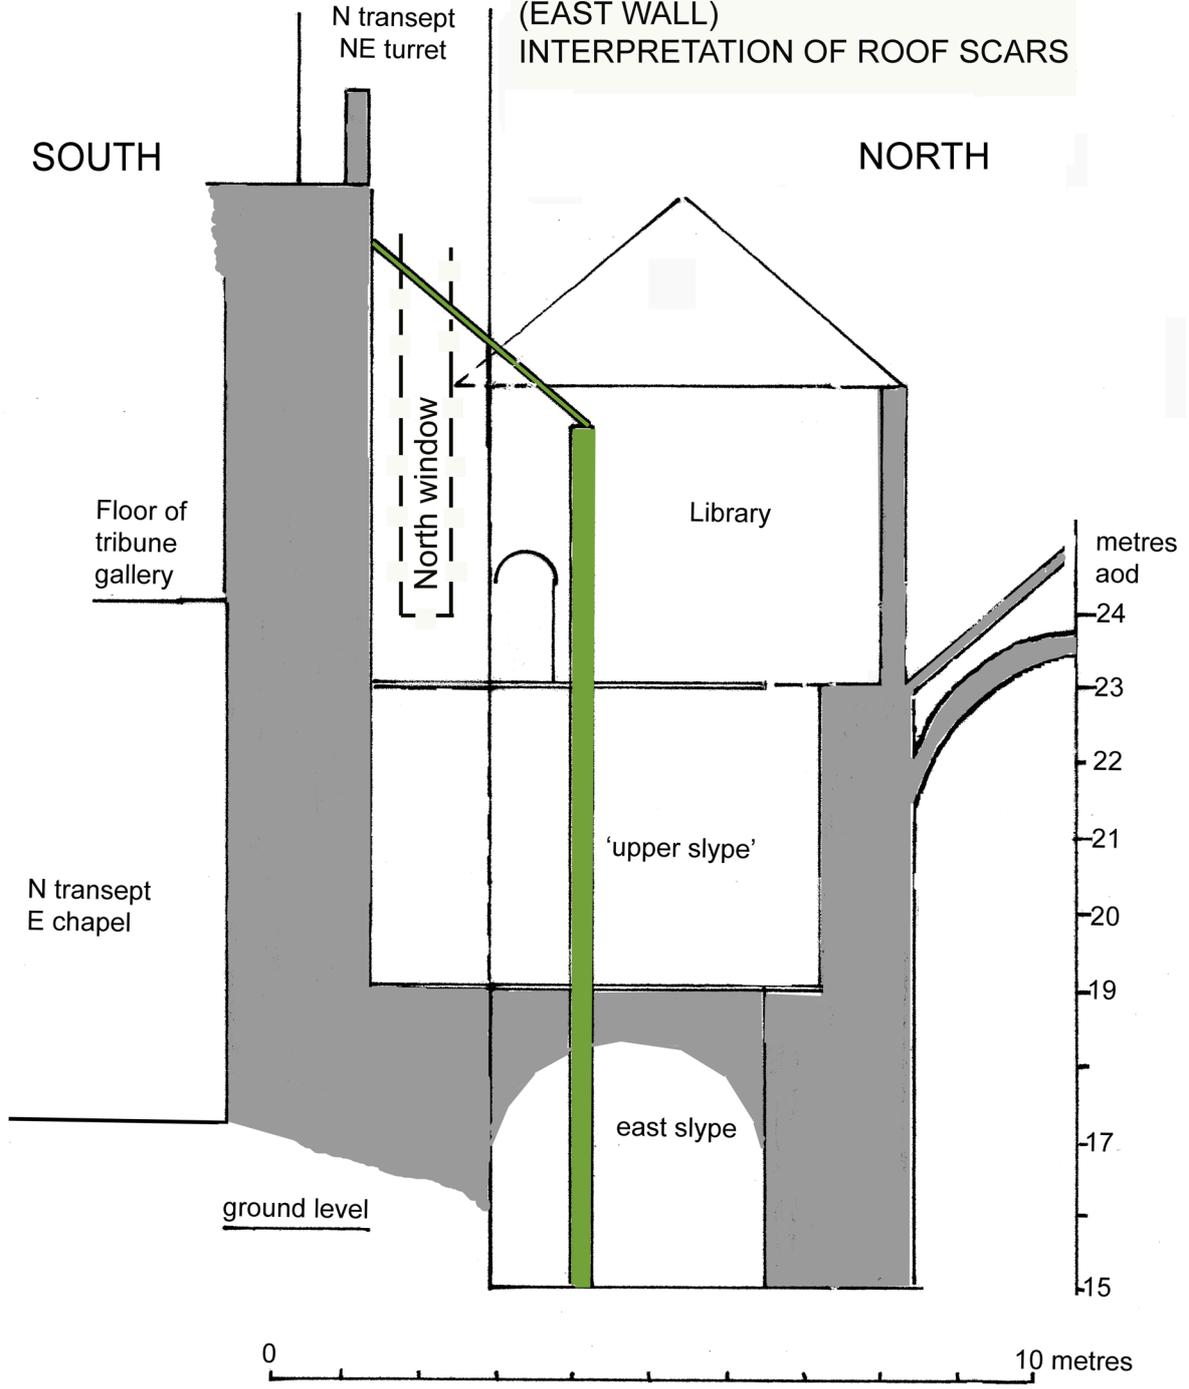
DIAGRAMMATIC SECTION S/N  
 AT N TRANSEPT NE TURRET  
 (EAST WALL)  
 INTERPRETATION OF ROOF SCARS

The roof scar under discussion here represents a structure which predates the eastward extension of the library and muniment room but which relates to a building on the same level as the library. It indicates that there was, in fact, a room where the library is now, but the evidence of the chopped off parapet shows it cannot have been in existence before about 1380.
