ARCHAEOLOGICAL RECORDING
AT THE SOUTH EAST END
OF GLOUCESTER CATHEDRAL, 2000

**A study of the elevations of the south ambulatory and
adjacent chapels**

Gloucester Cathedral Archaeological Report 2000/F
Cathedral project no 1900-5043

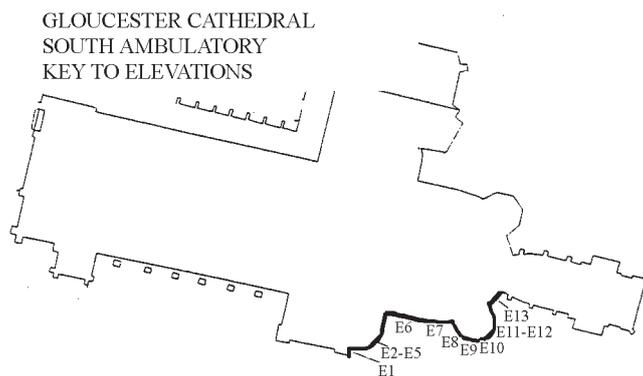
Fig.1. St. Andrew's chapel, Gloucester Cathedral.

Other points on the Romanesque fabric include the dating of the segmental arch head of the lower window in elevation 4 (Fig. 1, W2/E4) as 11th, rather than 14th, century. The arch has the same profile and dimensions and it springs from the same height as the 11th-century segmental arches of the south eastern radiating chapel. But it has been

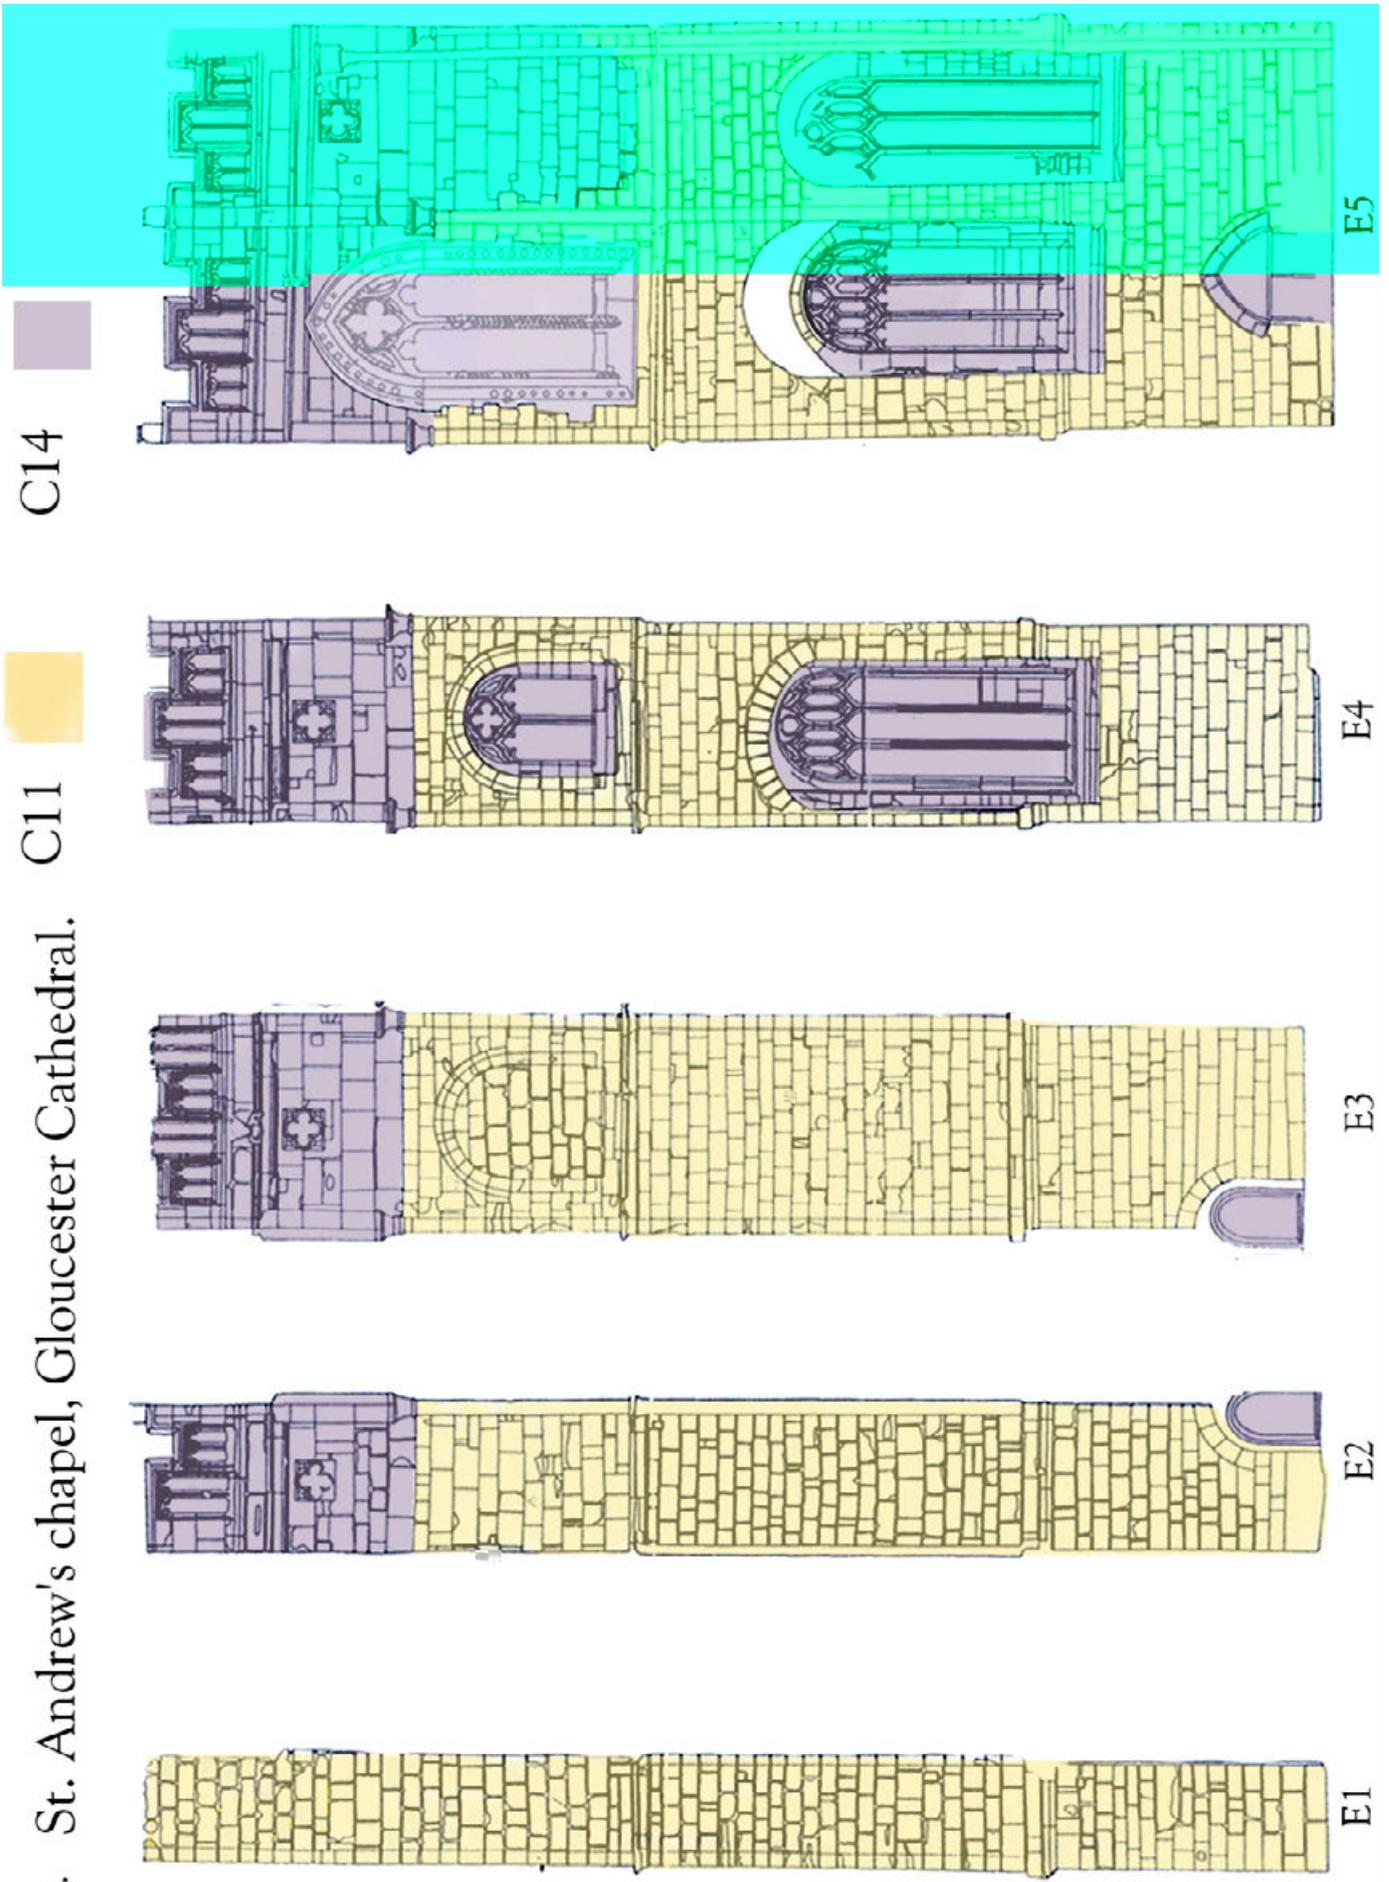
Fig.2. South Ambulatory/ Tribune and Radiating Chapel, Gloucester Cathedral

Elevations 6 and 7 (Fig. 2) describe the south wall of the ambulatory / tribune gallery and are considered together. Figure 2 shows that the clear boundary between the work of the 11th and 14th centuries, seen in the two chapels, does not extend across the outer wall of the tribune gallery.

This greater extent of 14th-century rebuilding may be partially due to the windows; the small round headed windows in the south transept east chapel and the south radiating chapel were formed by opening up the 11th-century blind arches and inserting a window with tracery. This entailed no disturbance to the masonry surrounding the arch. The small round headed windows in the tribune gallery are, however, entirely 14th-century with a continuous double wave moulding. These walls were originally decorated with blind arches; these were replaced by the present windows, which would have necessitated the dismantling of the one or two of the 11th-century courses above. It should, however, be noted that the exterior skin of the tribune wall was rebuilt to a far greater degree than the interior wall.

The area of masonry between the windows, above the upper string course, on elevation 6 is assessed as being 11th-century for around nine courses above the string, although this may be overstating the survival of the 11th-century work. Here the wall has been re-pointed, in places, in both the 14th and 20th centuries. Nonetheless 11th-century mortar was seen deep in the joints between blocks of the fifth course above the string, above this point the phasing is less certain, but the relationship of the courses with the window stones suggest that they may be part of the Romanesque work.

The masonry between the round headed windows of elevations 6 and 7 can be dated with a greater degree of confidence. Here the medieval mortar is clearly visible; the limit of the 11th-century masonry has been mapped by the extent of the 11th-century mortar. The result accords well with the character of the masonry. The Romanesque work in the wall shaft survives to a height of at least six courses; possibly seven, but not more, for above this point the stones carrying the shaft are integrated into the 14th-century work.

To the left of the round headed window on elevation 7 only a small area of 11th-century masonry remains. The right hand termination of the wall marks the angle with the westernmost wall of the south east radiating chapel. Here the mortared joints are largely intact making a reliable estimate of the date on the basis of the mortars difficult.

The wall above the upper string in **Elevation 8** (Fig. 2) also contains the bases of a blind arch with the masonry above rebuilt, removing any further traces of the arch, as has been described for elevation 5.

The bases are judged to be in situ. A butted joint rises through the three courses above the left hand base at the point where the roll moulding of the arch has been removed. The masonry to the left of this joint is 11th century while that to the right is 14th century in date. The course above this level is haphazardly keyed into the right hand wall shaft in a manner that suggests that it is later work.

On the right hand side of elevation 8 the wall shaft showed 11th-century mortar to within one course of the capital. The stone immediately below the capital is a 19th-century Bath type replacement. Apart from the blocks carrying the wall shaft moulding little remains of the 11th-century work; the boundary between phases illustrated in figure 2 is fairly certain, there being a possibility that a few in situ blocks remain unrecognised in the bottom three courses.

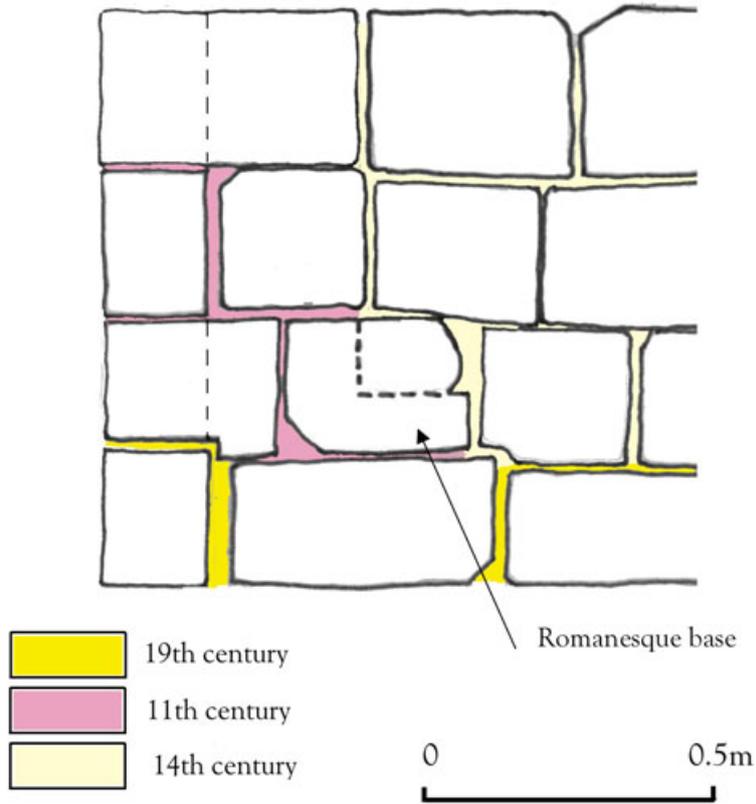
Fig. 6. Elevation 5, south transept - east gallery chapel

Elevation 5 (Figs.1, 5, 6) contains a two-light ogee reticulated window, with ballflowers, that has been dated to 'between c. 1325-30' (Morris 1985:104), above the upper string course in the left hand bay. The right hand bay contains two bases which are all that remains of an 11th century blind arch, with a continuous roll moulding, as seen, for example, in elevation 3. The question as to the date of the destruction of this arch and the rebuilding of this area of masonry, a sequence that finds an exact parallel in elevation 8, can be initially addressed through observations of the mortars.

However, the extended masonry includes the heads of two ballflower windows dated by Morris (1985:104) to c.1320 (the window in the north radiating chapel), and 1325-30 (the window in the south transept east gallery chapel - E5). This implies that the windows precede, by at least fifteen years, the wall into which they are set. It therefore appears that the ballflower windows were set in their present position significantly later than the date at which they were commissioned, or carved. The windows have been altered. Richard Morris has written, in terms of design, of how the lower tracery arches are omitted in the ballflower window in the north radiating chapel (Morris 1985:104). The same arches were either omitted or removed from the ballflower window in elevation 5. The springing points remain on the medieval jambs of this window and have been reproduced on the 19th-century replacement mullion (see Figs. 6 & 7).

The stone that forms the apex of the arch has a slightly different moulding from the rest of the window (see Figs. 6 & 8). It does not quite fit and is not a later replacement which, again, suggests that the window has a complex history.

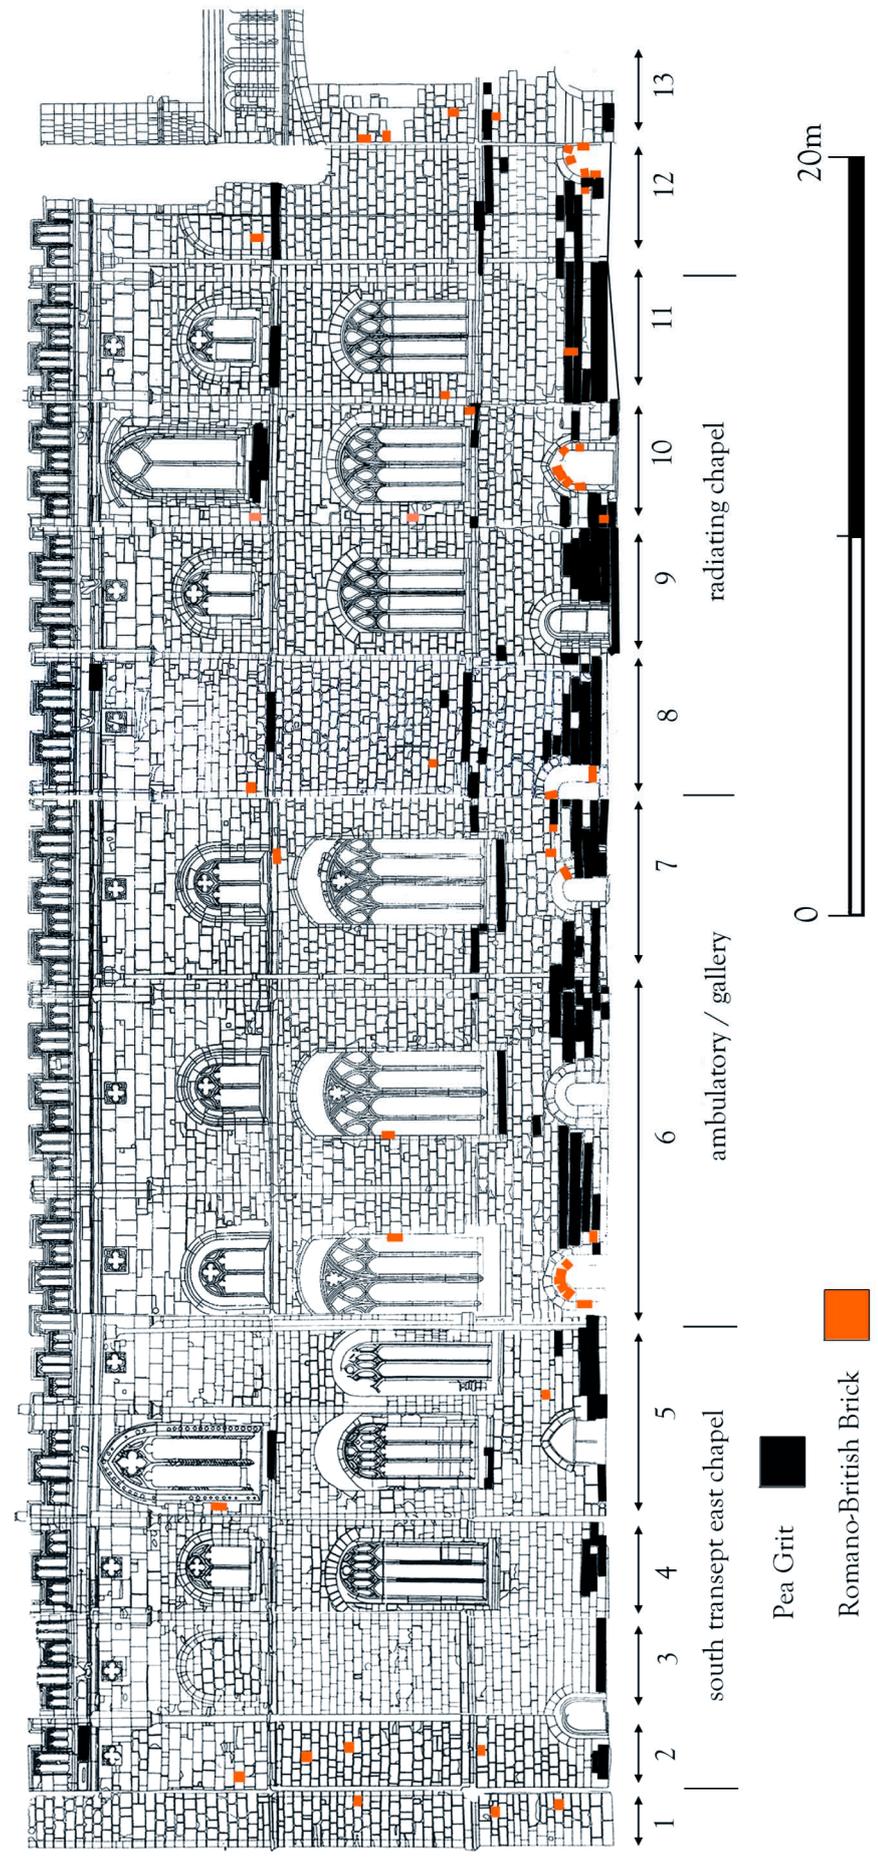
Fig. 11

Pea Grit has not been identified on earlier surveys of building stone at the cathedral. Large blocks of Pea Grit are found in the lower courses of masonry (coded green on the original petrological drawings: here see Fig 11). The physical and chemical properties of much of the rock quarried from this formation make it particularly resistant to weathering and it has been used as a weather stone in Mid and North Gloucestershire since the twelfth century.

It is possible to trace the extent of the Romanesque masonry around the south side of the building by following the large blocks of Pea Grit westwards from south transept east chapel. They run around the south transept and into the easternmost bays of the south aisle. Further west, in the south aisle, these large blocks of Pea Grit are scattered about the fabric having been, again, reused in the early 14th-century rebuilding.

Gloucester Cathedral - South Ambulatory, Transeptal and Radiating Chapels
 Distribution of Pea Grit and Romano-British Brick
