the south clerestory of the nave of Gloucester cathedral:
archaeological recording in 2001

Gloucester Cathedral Archaeological Report

The South Clerestory of the Nave of Gloucester Cathedral: Archaeological Recording in 2001

GCAR 2001/F

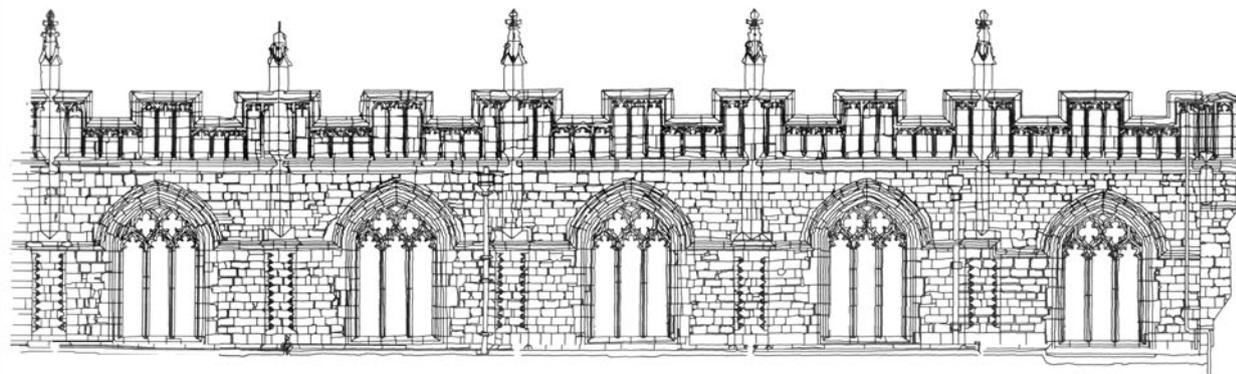
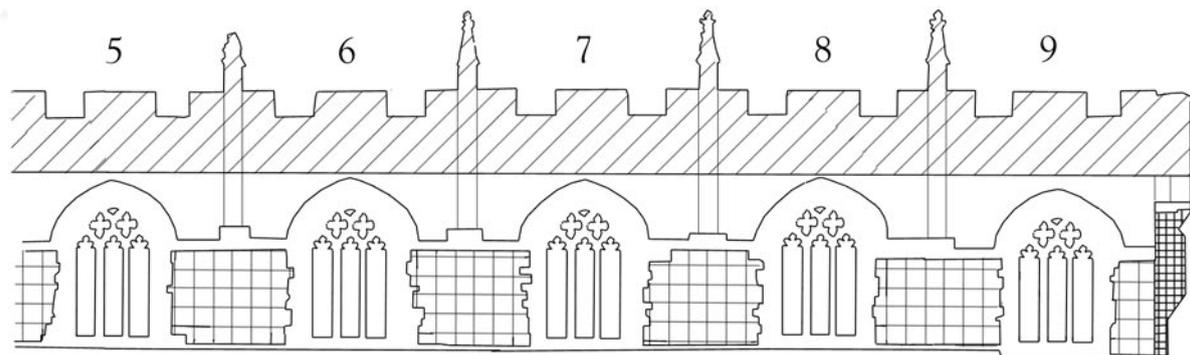
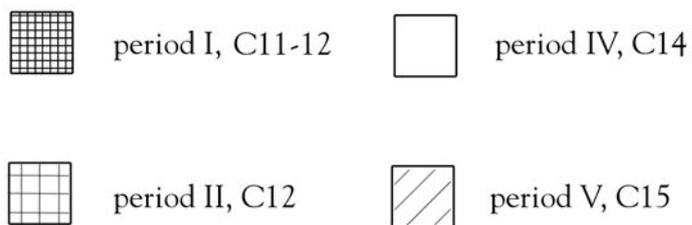
Fig.2 Gloucester Cathedral, Eastern Bays of South Clerestory - Interpretation

The Period I fabric is represented by a strip of masonry at the extreme east of the clerestory, in the angle formed by the south wall of the nave and west wall of the south transept. It is an undecorated buttress rising from the south aisle roof line and terminated at the top by a short length of Period IV string course. Where the buttress rises from the south aisle roof it projects from the wall face by 0.21m. At 0.75m above this point it is chamfered back; above the chamfer it projects 0.13m from the face of the clerestory wall. On the interior face the Period I work extends to the top of the wall forming the wall plate.

On the exterior the Period II masonry is preserved between the Period IV windows and the stringcourse that runs between them. It consists of an ashlar wall face with pilaster buttresses marking the divisions between the bays. The buttresses are decorated with angle rolls clasped by a stepped curved moulding that resembles chevron. The pilaster buttresses are 0.8-0.9m wide and project 140-150mm from the face of the wall.

A narrow strip of masonry at the east end of the clerestory belongs to the first phase of Romanesque building at the cathedral (Period I – 1089-1100). The masonry between the windows, below the mid-wall string course, including the decorated Romanesque pilaster buttresses belongs to Period II (early 12th century). The outward lean of the wall was, in Bays 5 and 6, corrected as the Period II construction progressed. In places, on the interior face, the top of the Period II masonry is level with the top of the vault, giving the impression that the vault was simply built on top of the pre-existing Romanesque clerestory.

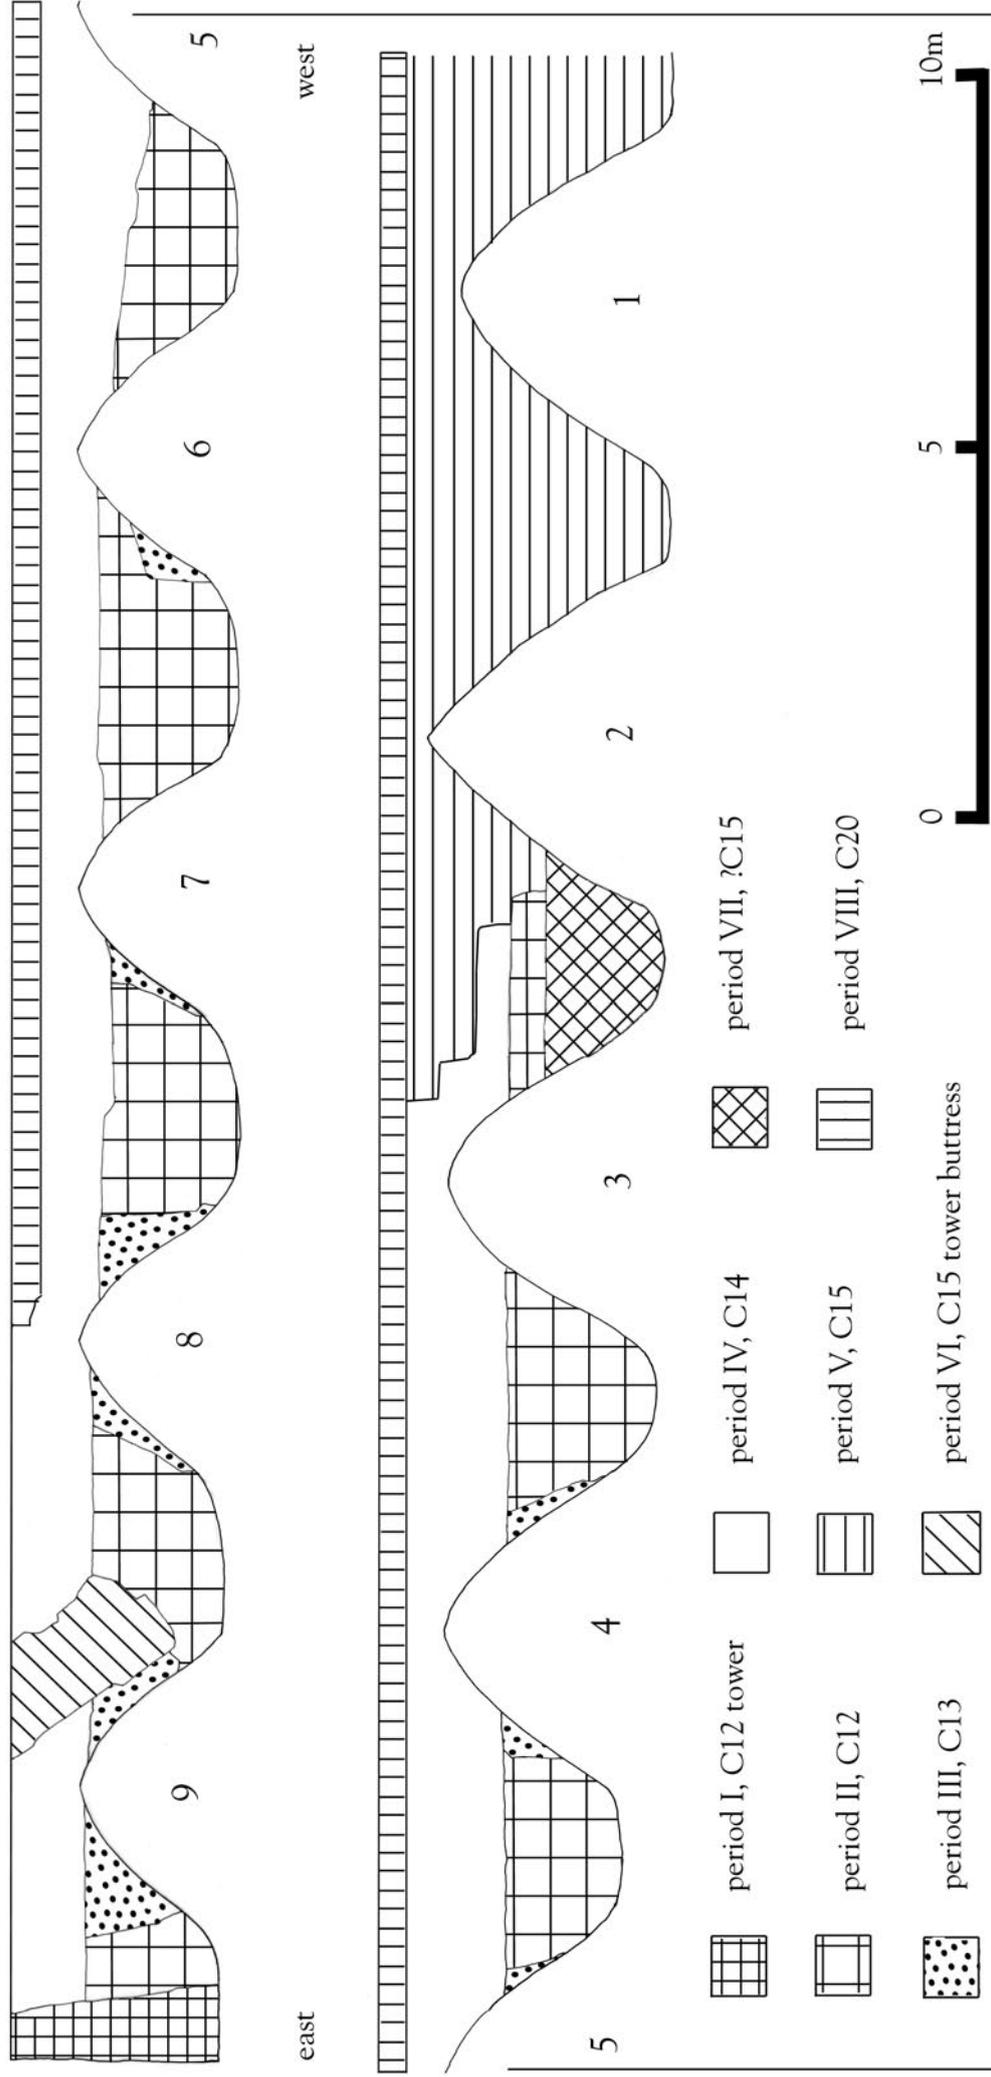
Fig.3 Gloucester Cathedral, Upper South Clerestory, Interior

The Period III masonry shown on Fig 3. consists of short lengths of roughly coursed rubble that project from the Period II (12th century) wall where it meets the ends of the vault. These small areas of masonry are reinforcing walls, tying the vault into the Period II wall and translating the thrust more evenly into that wall. They are more extensive and project further on to the vault in Bays 7, 8 and 9; projecting from the face of the wall by 400mm in Bay 9. They occur in every bay with the 13th century vault, except Bay 3.

extends intact to Bay 4. Bay 3 marks the junction of the Period IV masonry with work of a later period. The sketch of the interior face supports this interpretation (Fig.3).

The Period IV masonry on the upper interior face of the clerestory, above the vault, extends from the Period I (1089-1100) work, in the east, to the boundary with the larger ashlar belonging to Period V (15th century) in Bays 2 and 3. The masonry is built on Period II stonework, as well as Period III work around a number of the vaults. On the west side of Bay 9 the masonry of the tower buttress (Period VI) dissects the Period IV stonework, extending down in to the Period II wall. The top of the Period IV masonry forms the wallplate in Bay 9 and the eastern part of Bay 8; west of Bay 8 the top two courses of the Period IV wall has been removed and replaced by a concrete wall plate during Period VIII (1953).

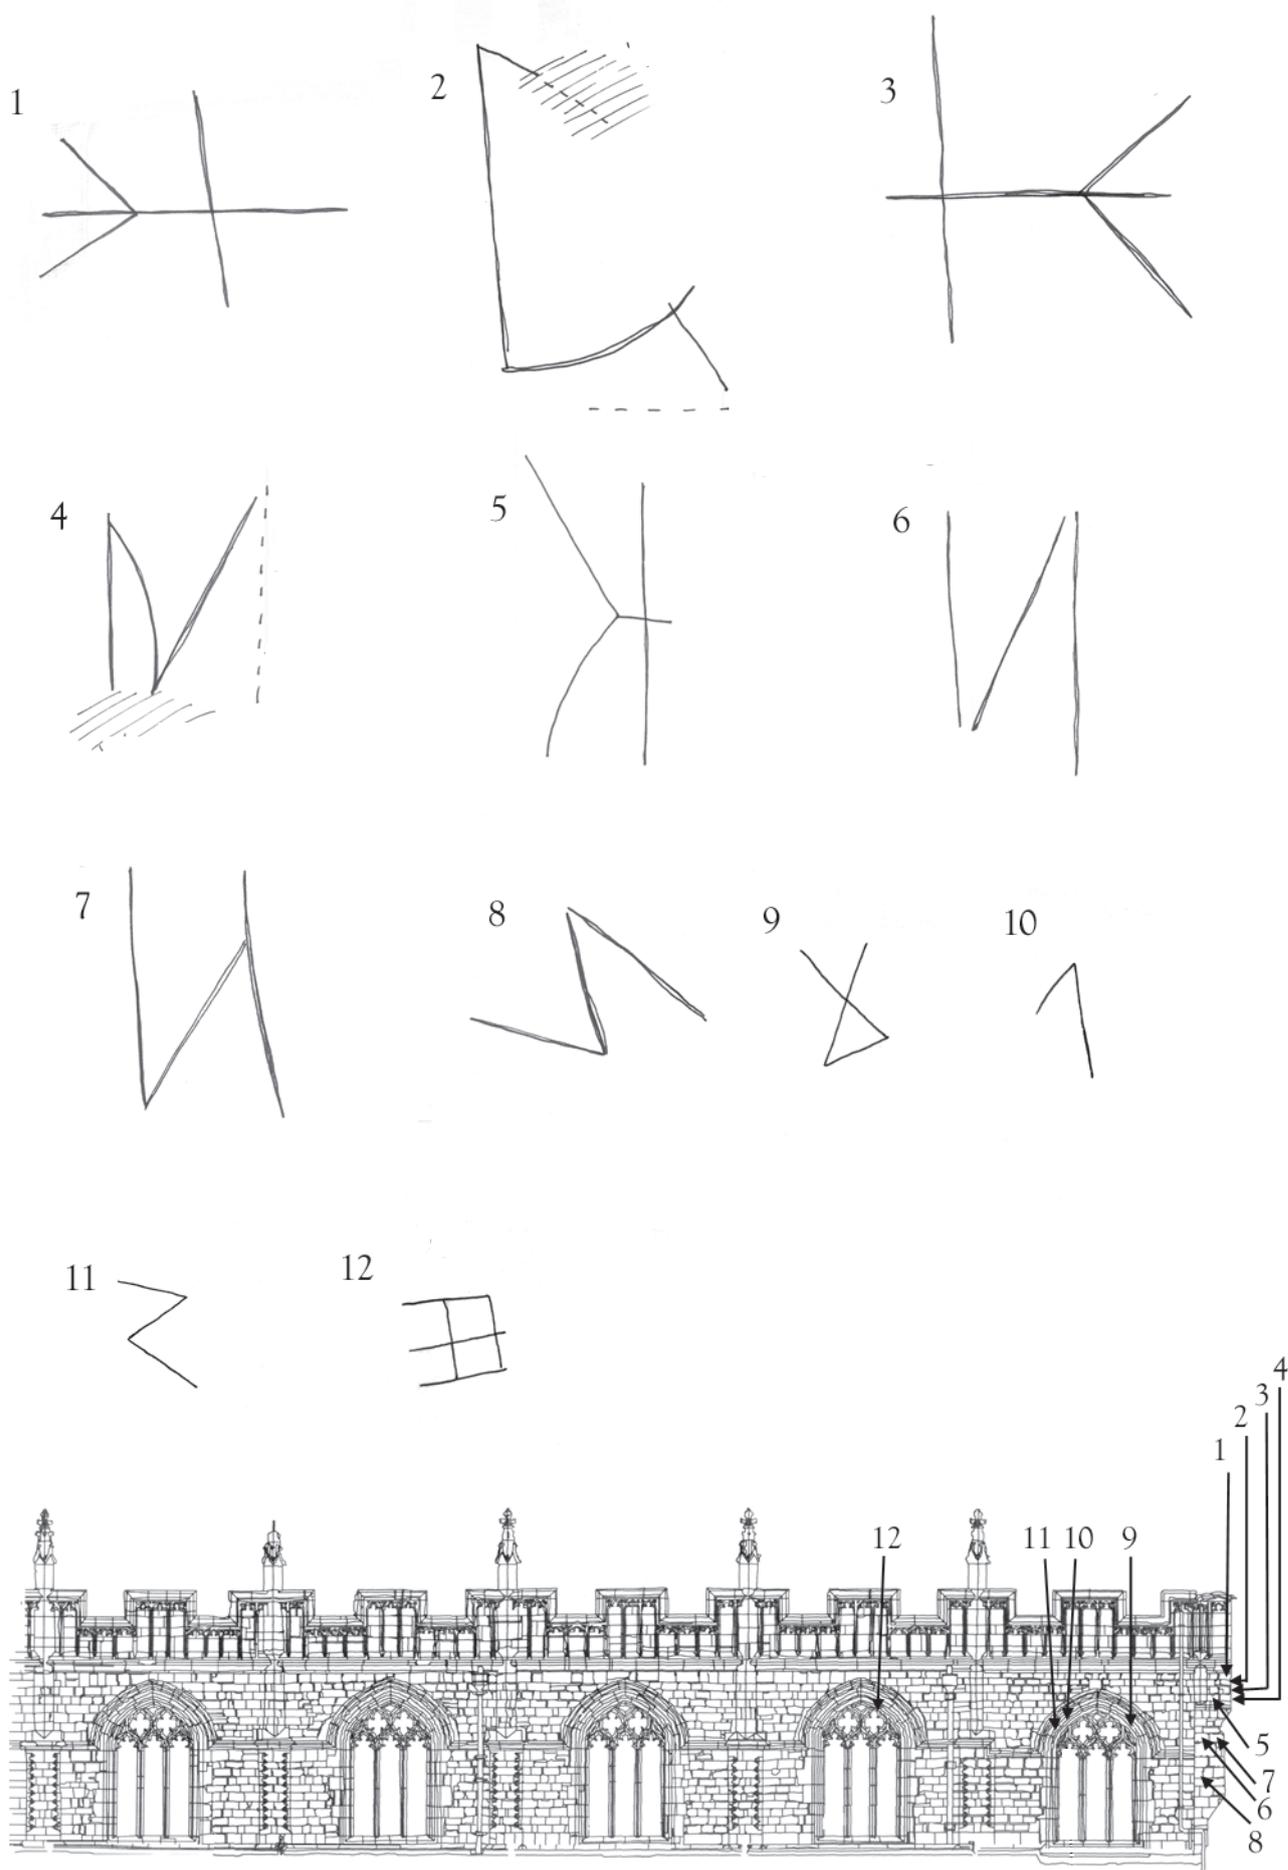
Fig.4 Mason's Marks
Scale 1:2

The Period I work contains three mason's marks in contrast with the Period II masonry where none were recorded (Fig. 4; 6,7,8). However the marks are very faint and their appearance exclusively on the earlier masonry is due to its protected position by the angle with the south transept. The three marks are the same reverse 'Z' form that is found on work of differing periods at the cathedral, however the size and roughness of execution accord with an 11th or 12th century date.

Four mason's marks were recorded on the exterior of the windows, a further fourteen were recorded on the interior tracery, mouldings and splays (Fig. 4, 9-12; Fig.5). The marks are smaller and more precisely cut than the Romanesque marks. Some of them are commonly used in all periods and thus no use for dating. The '[' mark is unusual, it, and related forms, have been recorded on 14th century decoration on the exterior of the south ambulatory and on the interior moulded surrounds of the north and south tribune gallery windows. The swastika and reverse swastika (Fig. 5, 3i, 3ii) are also unusual, this mark has been recorded on the tracery and splay of a 14th century window in the south ambulatory (Bagshaw 2000:20).

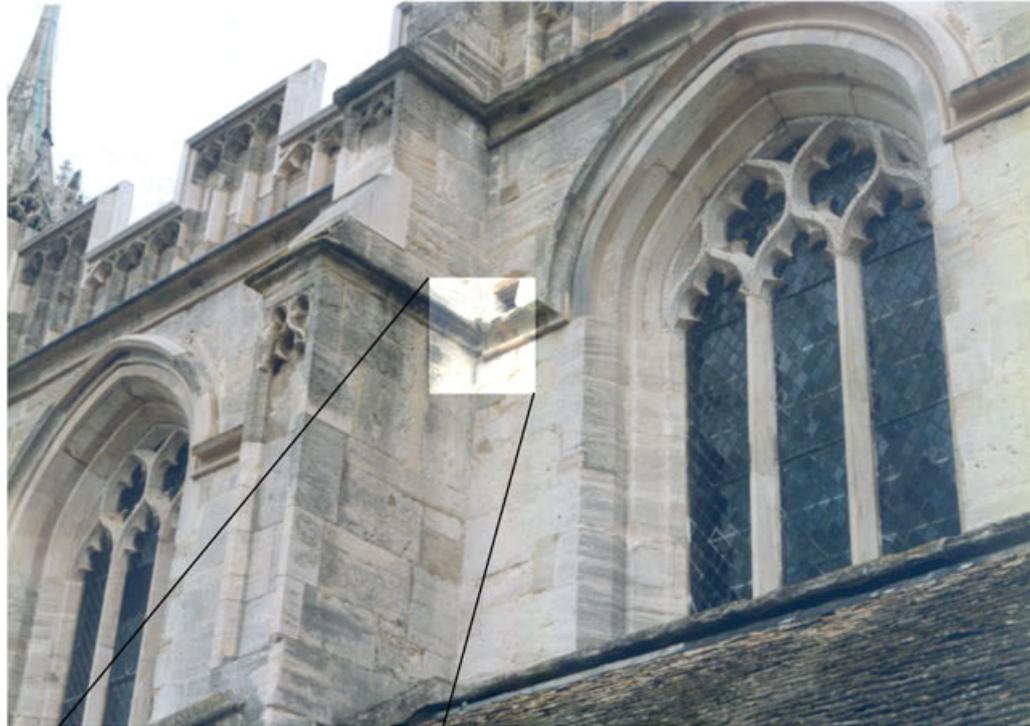
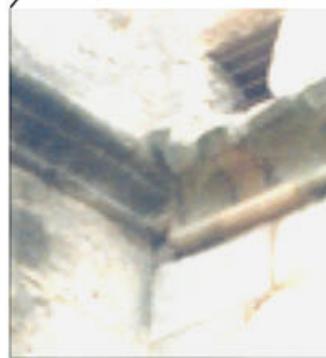
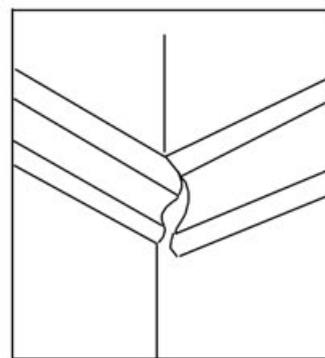
Fig.6 South Clerestory, Nave - Bay 2

The windows have acute four centred arches with ogee reticulated tracery (Fig.6). The tracery is composed of three lights with cinquefoils in their heads topped by two reticulations framing quatrefoils. There is a triple stepped chamfer arrangement on the jambs, reduced to a double chamfer around the arch heads. The hoodmoulding is a continuation of, and carries the same moulding as, the string course that runs between the windows. It also follows the projecting profile of the Period II buttresses that mark the divisions between the bays. Above the string course the buttresses are chamfered back to a triangular profile. The profile of the string / hoodmoulding is: a small angular moulding, a hollow and chamfer.

The stepped chamfer moulding becomes common in the Severn Valley from the 1320s and remained in use into the 15th century (Morris 1979:8). At Gloucester Cathedral it is, for example, used in the proto-Perpendicular windows in the east and west walls of the south transept, as well as in 15th century windows, such as those in the Lady Chapel and the South Porch.

The profile of the string course / hoodmoulding is one of the most commonly occurring Perpendicular forms (Paley 1891:96). Related forms occur in both 14th and 15th century work at the cathedral, however the moulding with the most similar profile is the hoodmoulding of the south window, south transept, c.1335-7. Where the string course meets the 15th century string course at the west end of the clerestory, in Bays 1 and 2, the two do not match, the 15th century moulding is smaller with a different profile (Fig. 6). This can also be seen in Bays 1 and 2 on the north side of the clerestory.

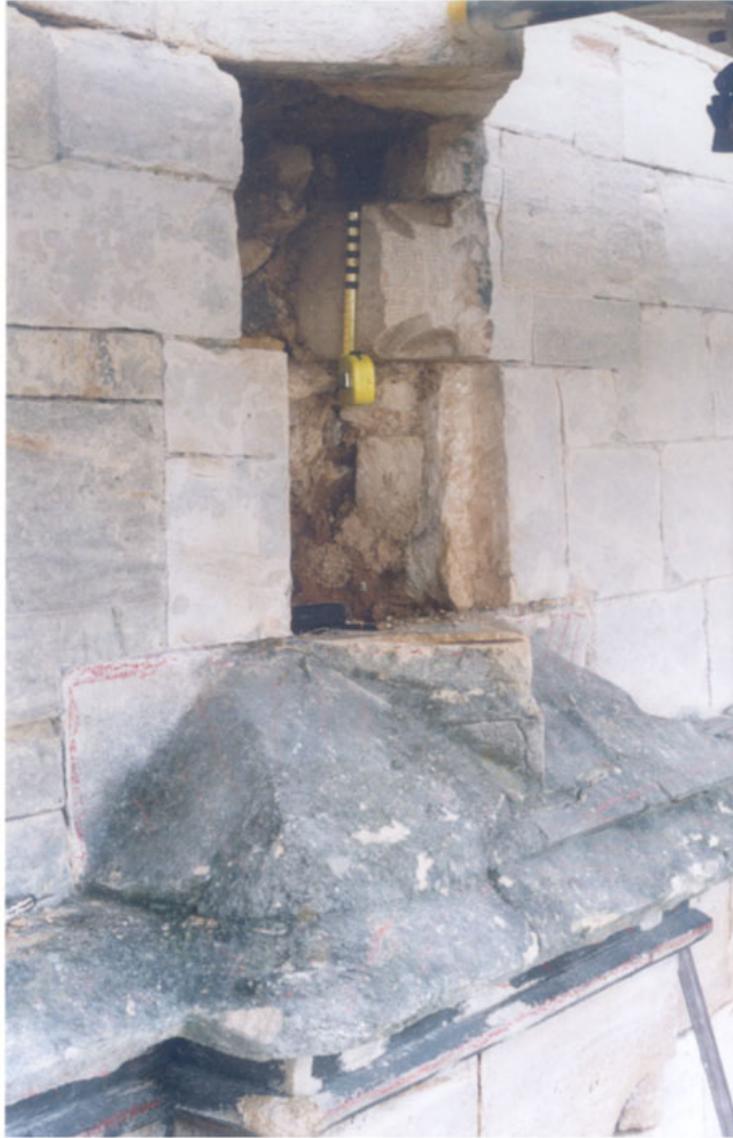
Fig.9. Base of triangular wall shaft, Bay 5 - 6

The triangular wall shafts mark the divisions between the bays, above the mid-wall string course. They rise from large blocks of Lower Freestone chamfered back in such a way that the rectangular profile of the Period II buttresses are transformed into more narrow projections with a triangular profile. The wall shafts are 0.5m wide except for the two either side of Bay 9 which are 0.31m in width. This same arrangement of narrower triangular wall shafts occurs at the equivalent position in the north wall of the clerestory, possibly indicating that the Period IV work was begun at the east end.

The removal of the 19th century Bath stone repairs revealed that the original (Period IV) chamfered blocks, at the base of the wall shafts, are larger than is shown on the elevation drawings, extending deep into the wall face either side of the shafts; the block in this position between Bays 5 and 6 is, for example, 0.85m wide (Fig. 9). The shafts are in course with the surrounding ashlar. There is no discernible change in the mortar, in both joints and core, between the shafts and the wall face. These observations suggest that the shafts belong to the same episode of building as the wall in which they are set.

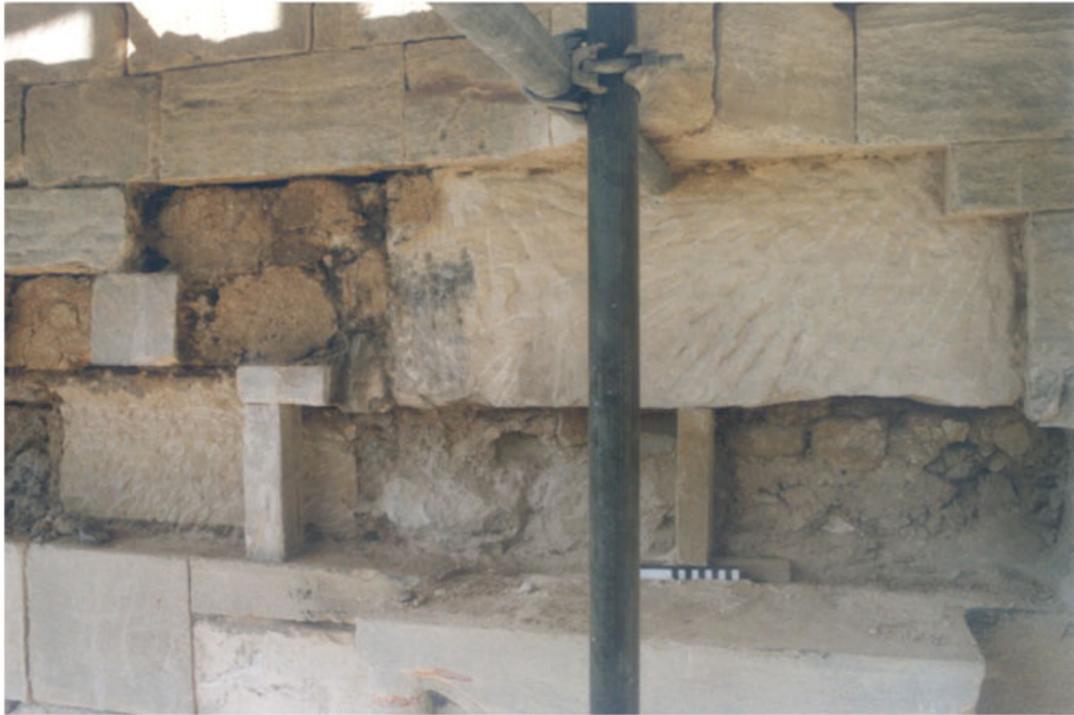
Fig.10. Gloucester Cathedral, East Bays of South Clerestory
19th and 20th Century Repairs

The wall shafts were originally built with blocks of Lower Freestone, most were replaced in the mid-19th century with pieces of Bath stone. Where this Bath stone has been removed it showed that the Period IV wall shafts were constructed with reused Period II stone. In the wall shafts below pinnacle 7 and 8 it was possible to see that the decoration on the Period II (12th century) pilaster buttresses has been re-cut and turned in for use in the wall shafts (Fig. 8). Blocks with this pilaster decoration have been identified on the interior face also in Period IV (see below).

The exterior wall face belonging to Period IV wall was built using recycled Period II (12th century) ashlar. The ashlar is laid in level regular courses and, as with the work of preceding periods, is peppered with mid-19th century repairs in Bath stone (Fig. 10). Although the western bays are beyond the present survey area it would appear that the exterior Period IV masonry

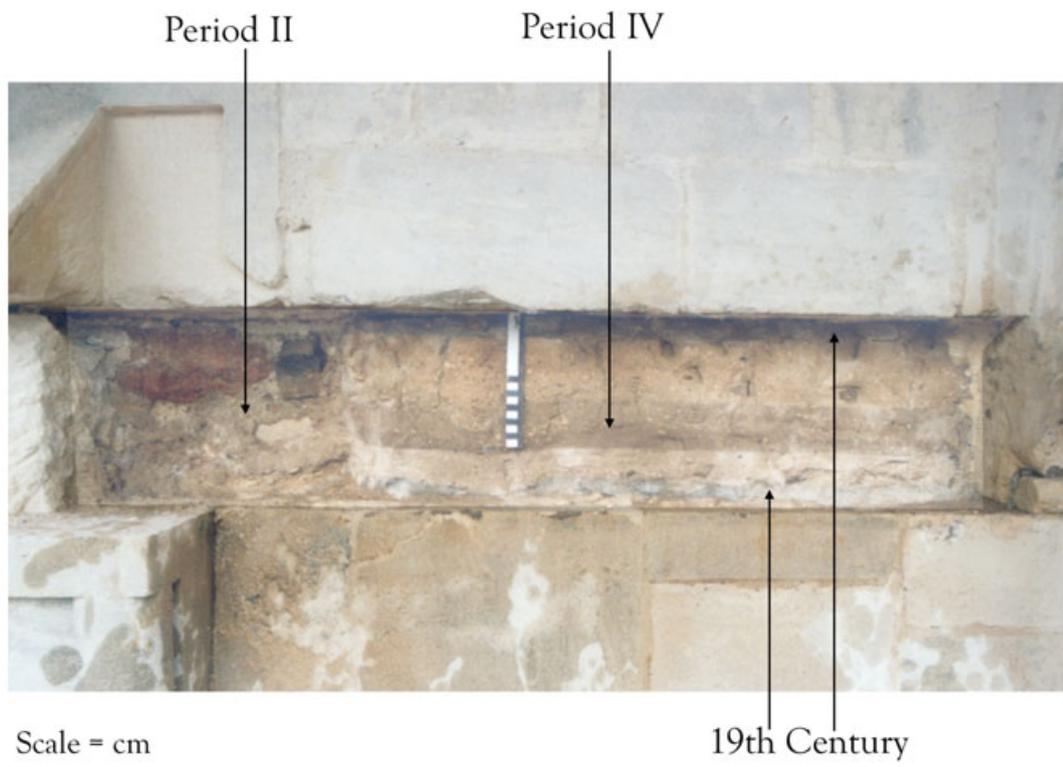
Fig.12. Reused decoration in the interior faces

The stones were grouped according to their decorative types and frequency the their locations were plotted on simple bar charts (Fig.12). The horizontal axis represent the north and south walls of the clerestory, with the bays numbered 1 to 9; the bars show the frequency and location of the decoration. The most frequently occurring types of decoration are described and discussed below.

The distribution of stones bearing this decoration is of interest as 19 of the total 21 blocks recorded are in the south wall (Fig.12) This is the result of the complete dismantling and reconstruction of the 12th century (Period II) south clerestory wall above the string course, whereas the 12th century north clerestory wall was left largely intact, apart from the insertion of new windows. This shows, as does the example of the chevron, that much of the material found reused in the upper clerestory walls was derived from the 12th century clerestory and the concentration in the south wall indicates that the stone did not travel far, not even across the vault, between its removal from, and reuse in, the Period IV clerestory walls.

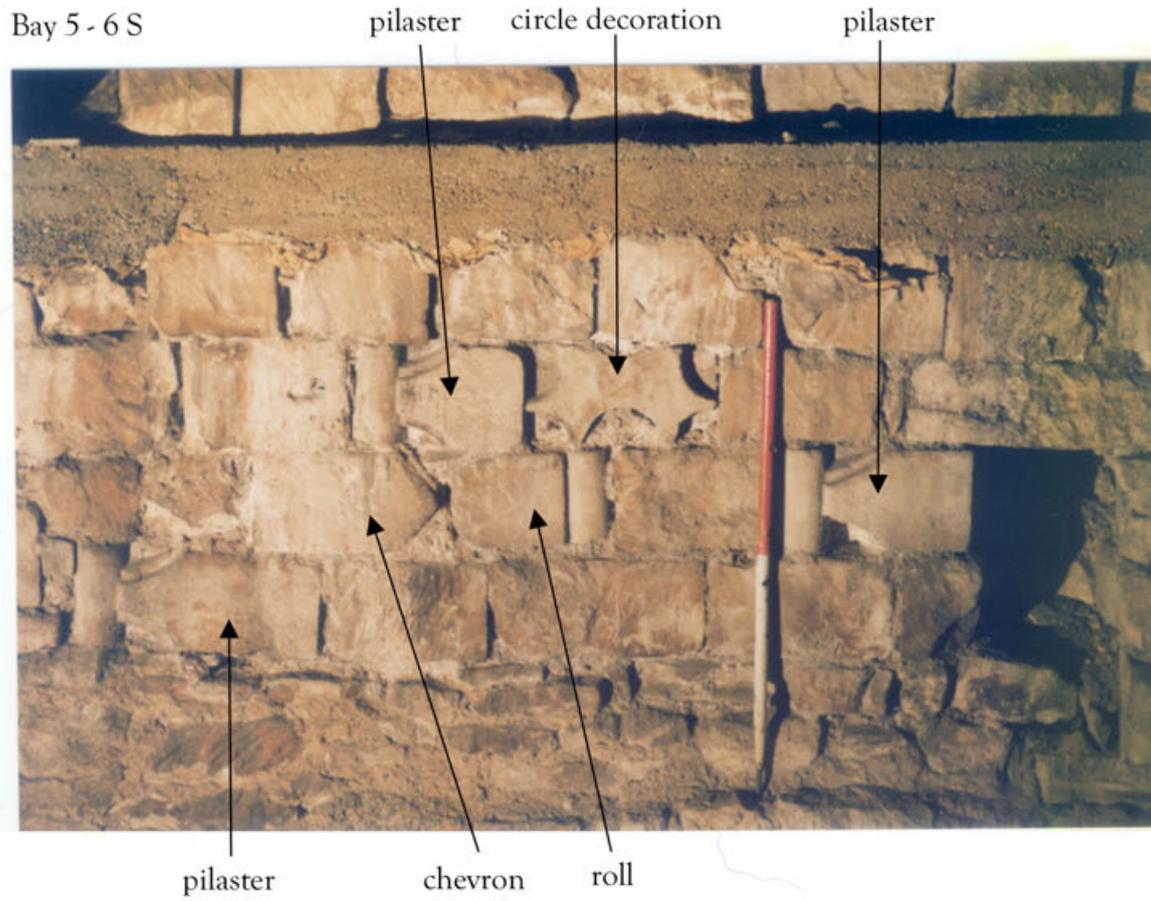
Fig.16. Reused decoration in Period IV interior masonry

A Romanesque mason's mark is visible on one example (Figs. 15, 16). This mark was also recorded on a block with the clasped roll decoration, found at the angles of the pilaster buttresses on the exterior of the clerestory, but later reused in the Period IV raising of the interior clerestory wall (B3-4S). The mark has also been identified on the top stage of the turret at the south west angle of the south transept.
