archaeological recording of the monastic
infirmary at Gloucester cathedral

Gloucester Cathedral Archaeological Report 2001/G

Archaeological Recording of the Monastic Infirmary at Gloucester Cathedral

Steve Bagshaw

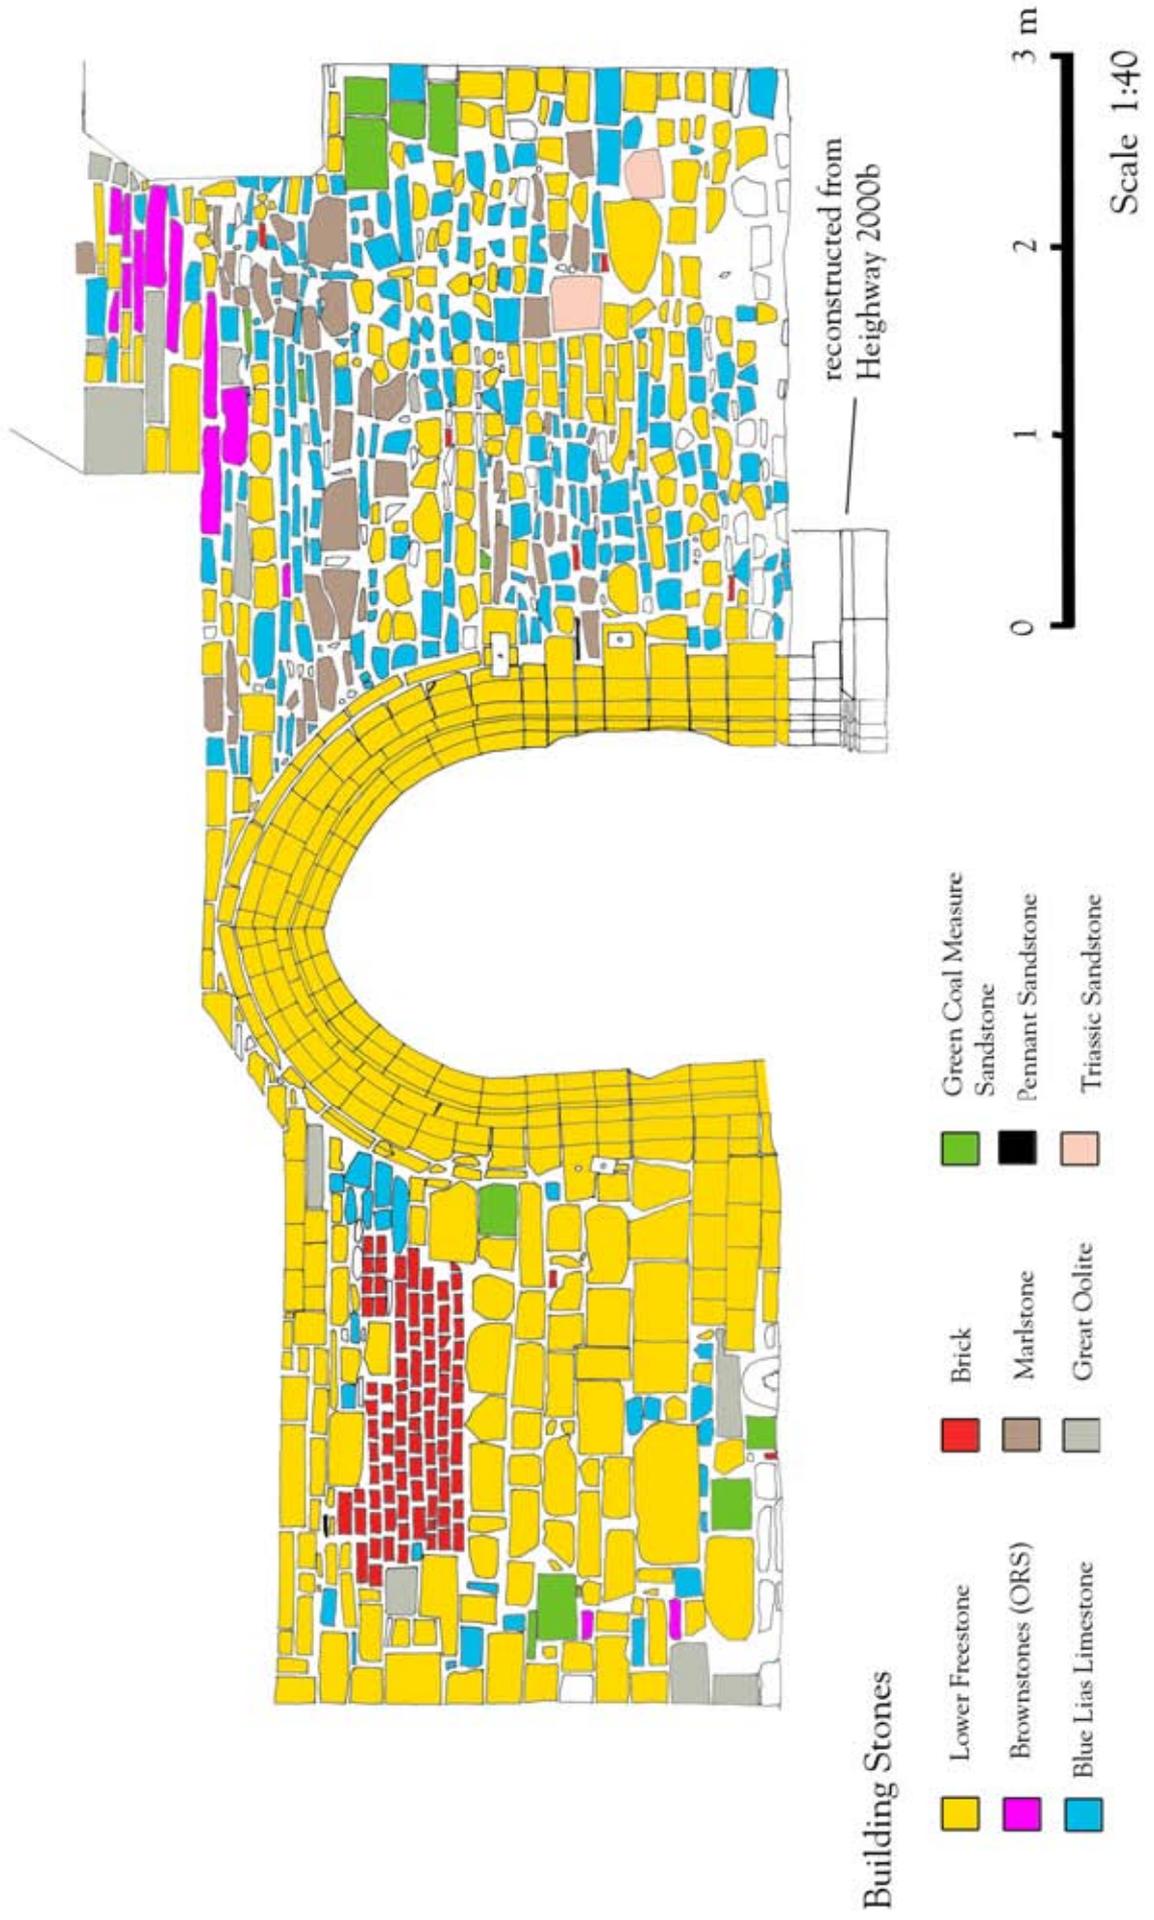
Fig.2

Gloucester Cathedral ~ Infirmary, west wall, west face

West Elevation (Figs. 2, 3)

The arrangement of mouldings on this west face of the doorway differ from those on the original east face, or rear-arch, where the first subordinate roll and angle fillet can still be seen around the arch head. The remainder of the Period I mouldings on the eastern face appear to have been cut away in order to facilitate the insertion of a flattened two-centred arch, belonging to Period III, with a plain chamfer on the jambs and arch head (Figs. 4, 7). However in contrast to the inserted jambs and arch of the east face the chamfered blocks on the western face are in course with, and in places cut from the same stones as, the Period I roll mouldings and so are judged to be an integral part of the original doorway.

The head of the arch formerly possessed a hoodmoulding with a fillet and roll profile. This hoodmoulding is preserved on two stones on the north side of the arch; elsewhere it has been crudely cut back flush to the face of the wall.

The doorway is composed of stone from the Lower Freestone formation of the Inferior oolite Group.

The Period I stonework, extending south from the doorway, consists of roughly coursed rubble. The coursing in the lower part of the wall corresponds with that of the stonework of the south jamb of the doorway. Above the level of the springing of the arch the courses become increasingly irregular, this is apparently due to the irregular size of the stone used in the upper part of the period I wall. A band of larger blocks of Marlstone mark the upper limit of the surviving Period I masonry, this band is also apparent at the same level on the east face of the wall and stone with a similar petrology is also present

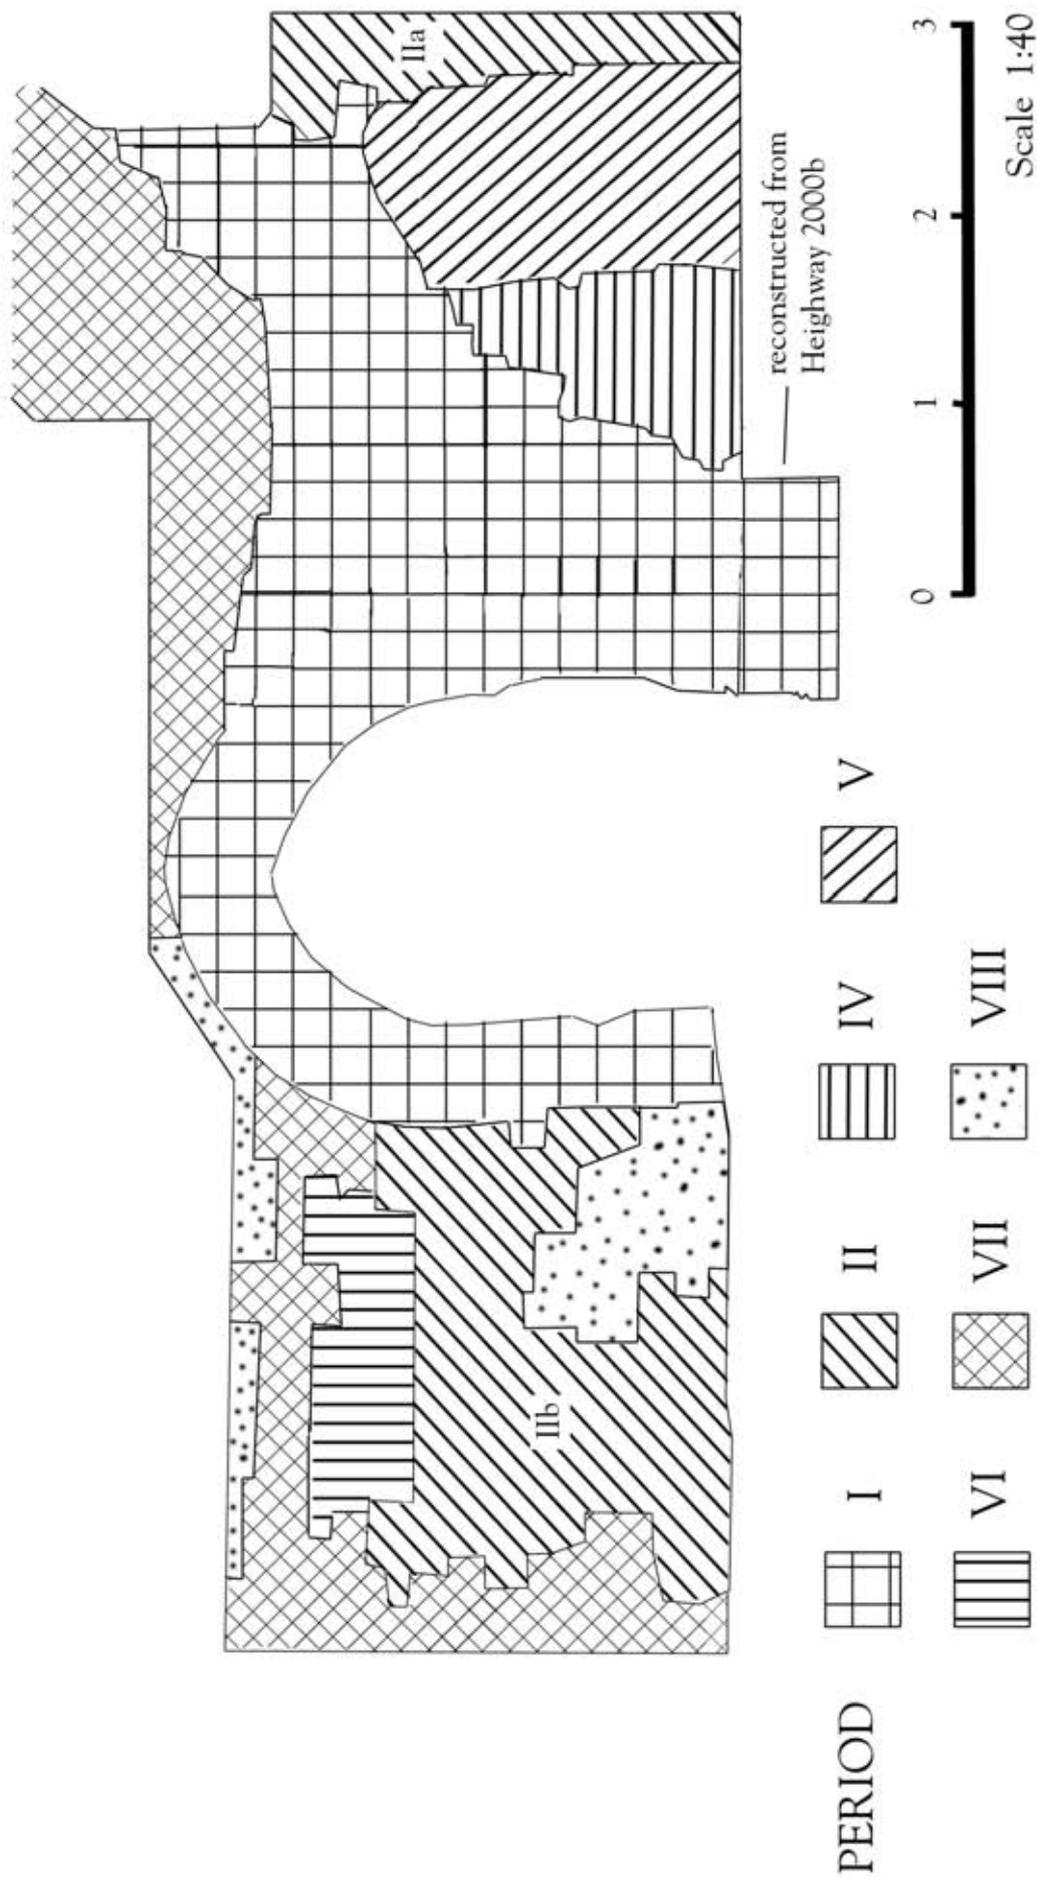
Fig. 3

Gloucester Cathedral ~ Infirmary, west wall, west face
 Interpretation

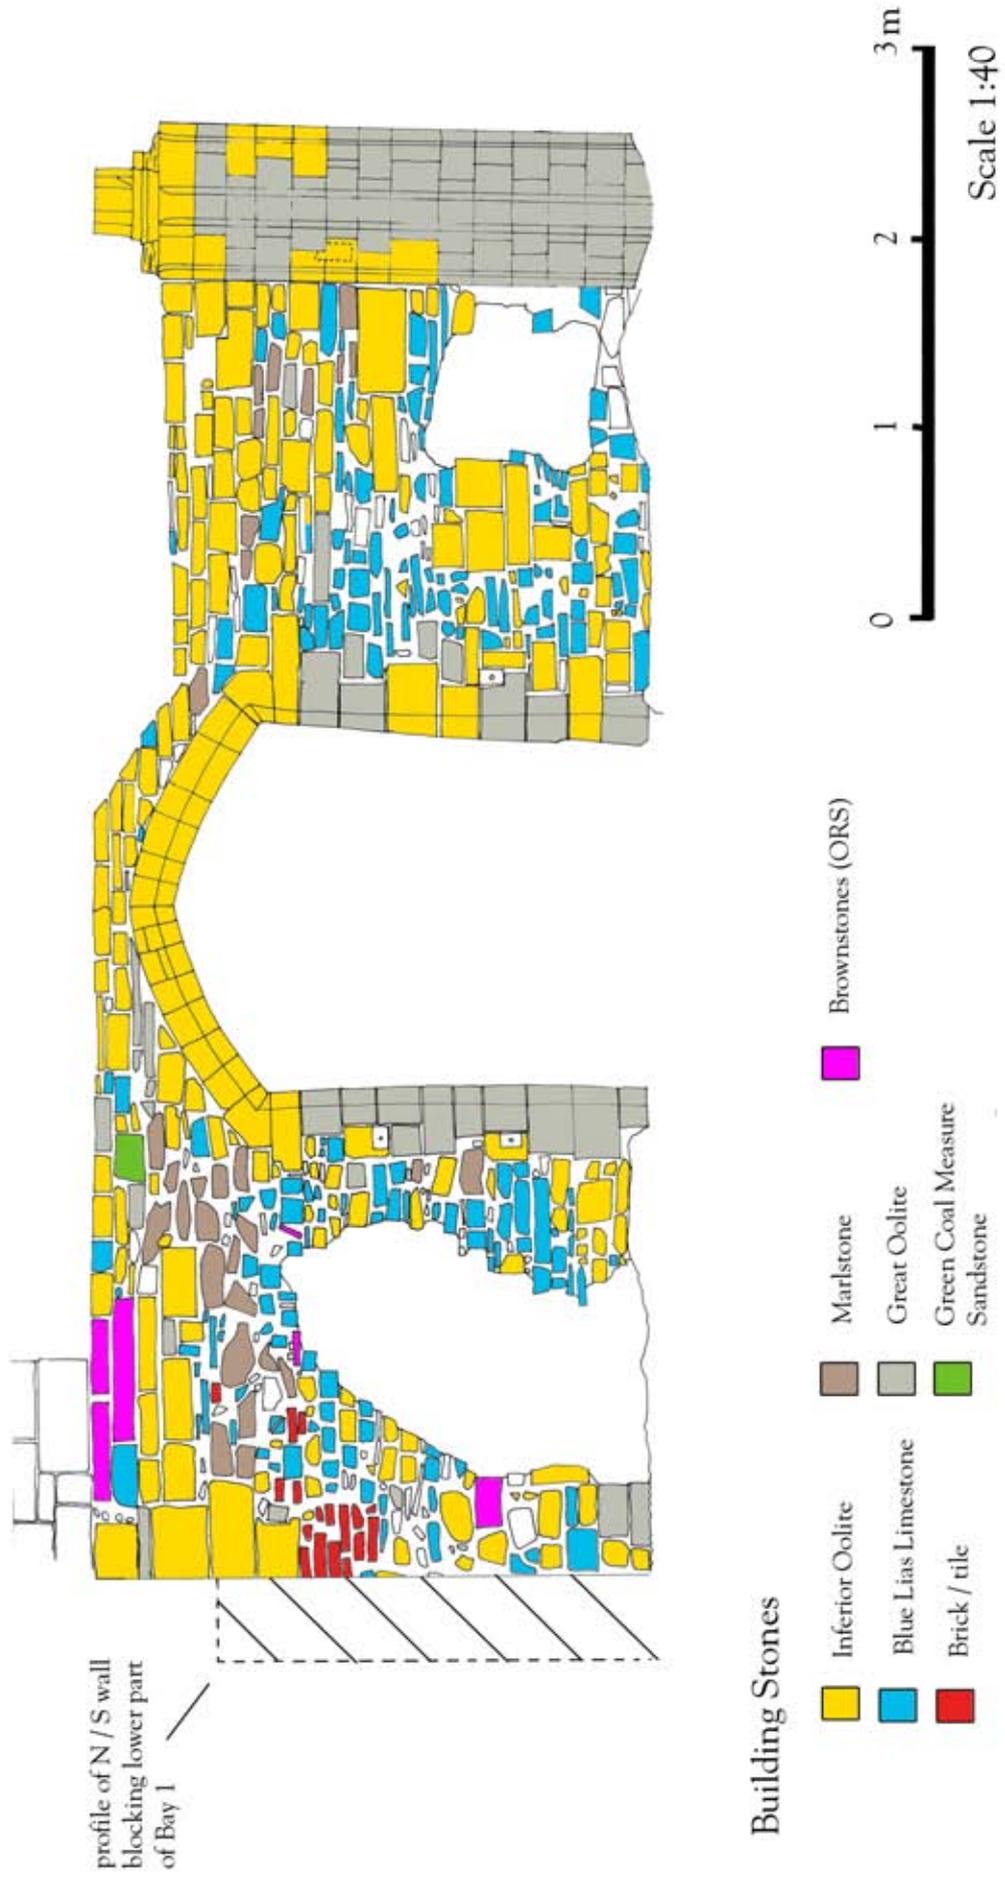
Fig.5

Gloucester Cathedral ~ Infirmary, west wall, east face

The masonry is primarily composed of roughly equal quantities of Marlstone, Blue Lias Limestone and Inferior Oolite, with four fragments of brick or tile, a piece of blue /grey Pennant Sandstone tile and a piece of green Pennant Sandstone.

The upper limit of the Period I masonry is formed by the boundary with 19th century stonework; evidently the wall was cut back and replaced at this level during the remodelling of the monument in the 1860s. To the south the Period I work appears to have been cut back for the insertion of the north jamb of a post medieval opening, the blocking of which also abuts the Period I work.

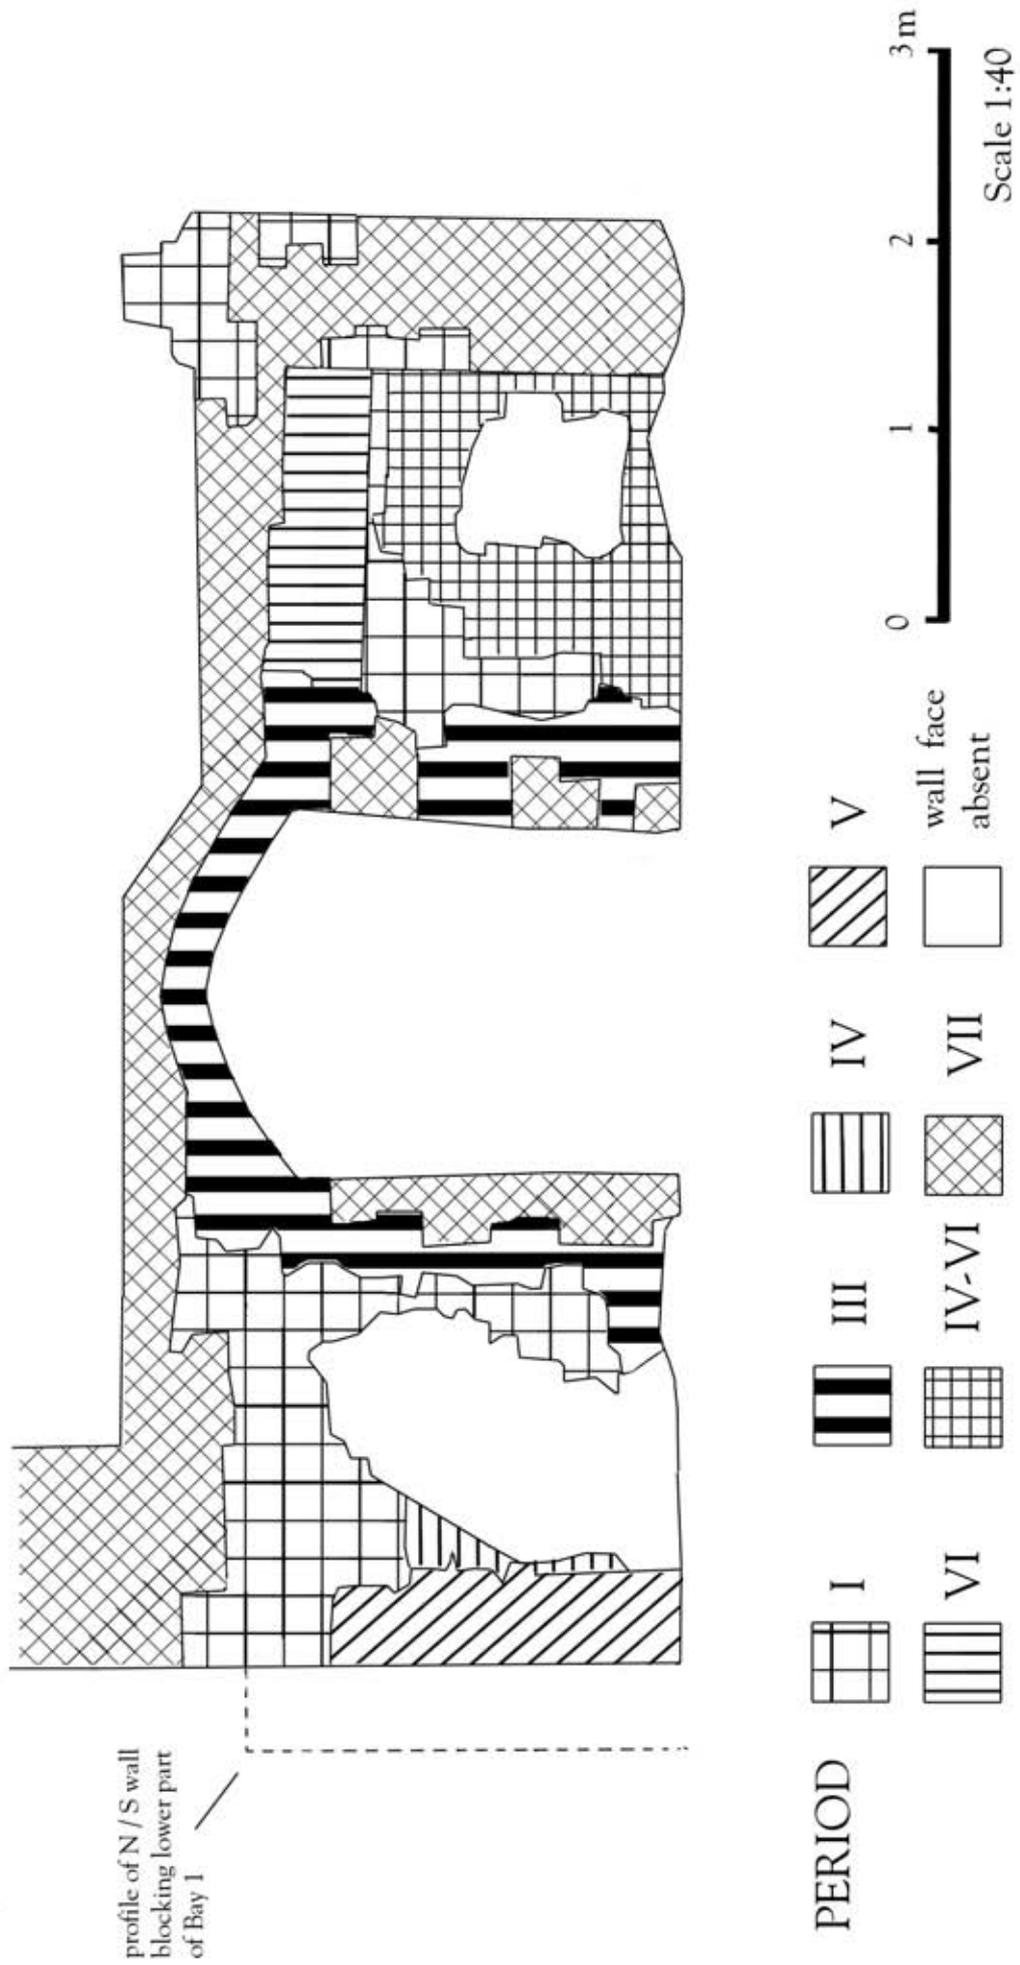
Fig.6

Gloucester Cathedral ~ Infirmary, west wall, east face
 Interpretation

The masonry belonging to Period IV is in the lower part of the wall, south of the doorway. It describes a triangular area of the wall 1m wide at ground level, rising to a height of 1.6m at its apex and primarily consists of elongated blocks of Inferior Oolite and Blue Lias Limestone laid in level courses. The concentration of Inferior Oolite, particularly in the upper part, makes the stonework of this period conspicuous on the petrological drawing. The stonework, at the junction with Period V, projects from the surrounding masonry by around 50mm.

The Period VII stonework is located in the upper part of the wall on both the north and south sides of the central doorway, where it has not been replaced by Period VIII repairs. Additionally, a strip of masonry forming the northern termination of the surviving wall face belongs to this period. It is largely constructed from freshly quarried stone of various lithologies, with a small quantity of reused material, laid in level courses and bonded with a hard, dark grey Portland type mortar. This mortar, along with the coursing and distinctive varieties of stone make the identification of the stonework of this period relatively secure.

A small number of stones at the top of the wall above, and to the north, of the central doorway belong to Period VIII, as well as a larger repair adjacent to the north jamb of the doorway at the base of the wall. The blocks are of various dimensions but have been machined so that their perfectly flat faces and straight edges make the repairs easy to identify. The stone is a pale, fine grained Middle Jurassic oolitic freestone (possibly Clipsham) and is devoid of tooling marks. These repairs probably belong to the mid 20th century.

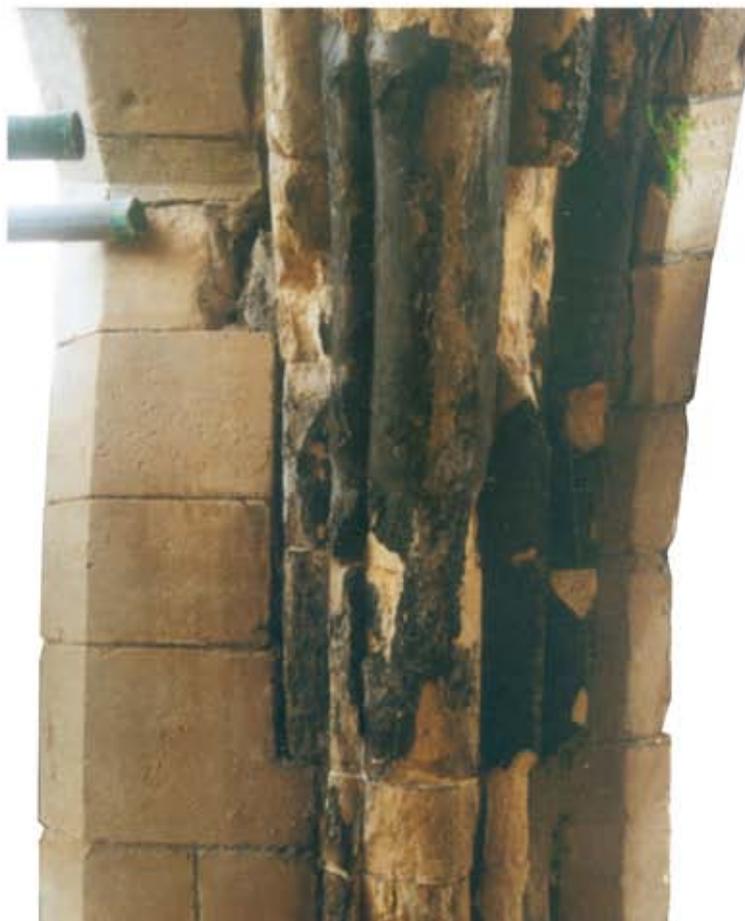
Fig.7

West doorway, south jamb / intrados

Most, or all, of the jamb stones have been replaced during Period VII, however the head of the arch and the springers are late medieval (Period III) and show that the doorway was built using Lower Freestone. On the south side of the jambs and arch there is clear evidence, in the form of a strip of adjacent infilling masonry, of the doorway being inserted into the wall, in other words, at this point the wall face is earlier than the door mouldings.

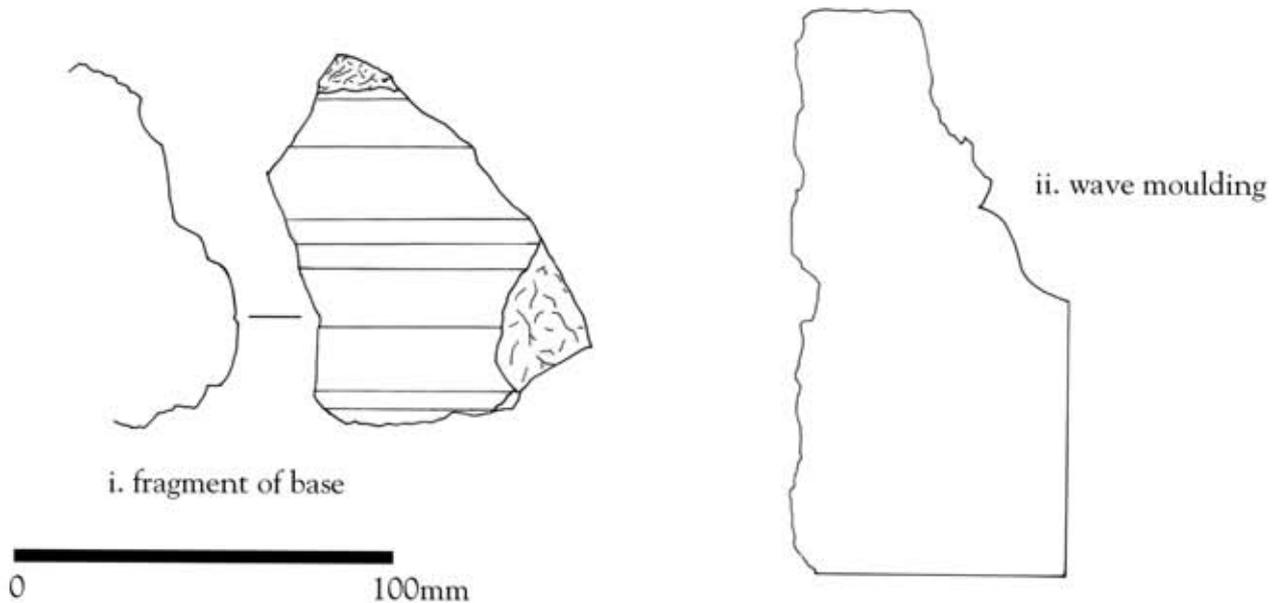
Fig.8

West wall ~ reused moulding fragments
Scale 1:2

A fragment of moulding was removed from the core on the south side of the doorway during the process of repair (Worked stone No. 329; Fig. 8.i). The moulding is a part of a base which, if complete, would have had a diameter of approximately 260mm at its maximum. It is therefore too small to have served as a base for anything other than a decorative column and may, for example, have been part of an engaged half column. It has a double hollow moulding, was turned on a lathe and is cut from Lower Freestone. The moulding appears to be Romanesque but, in view of its association with large quantities of Romano-British tile, an earlier date cannot be ruled out.

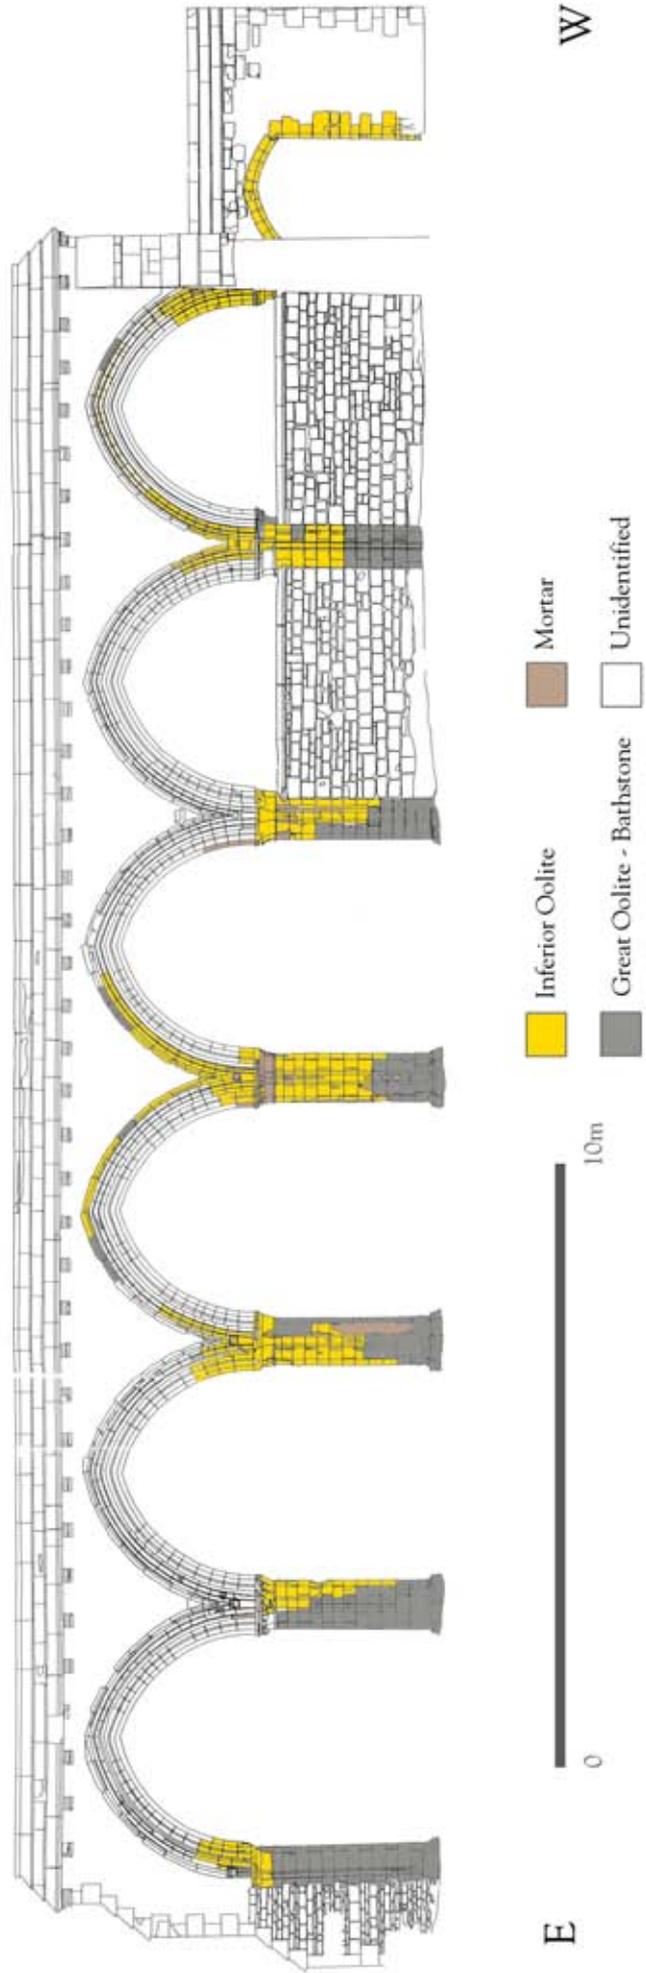
Fig.9

Gloucester Cathedral Infirmary : south arcade, north elevation ~ petrology
 Scale 1:100

Description of the South Arcade (Figs. 9-12)

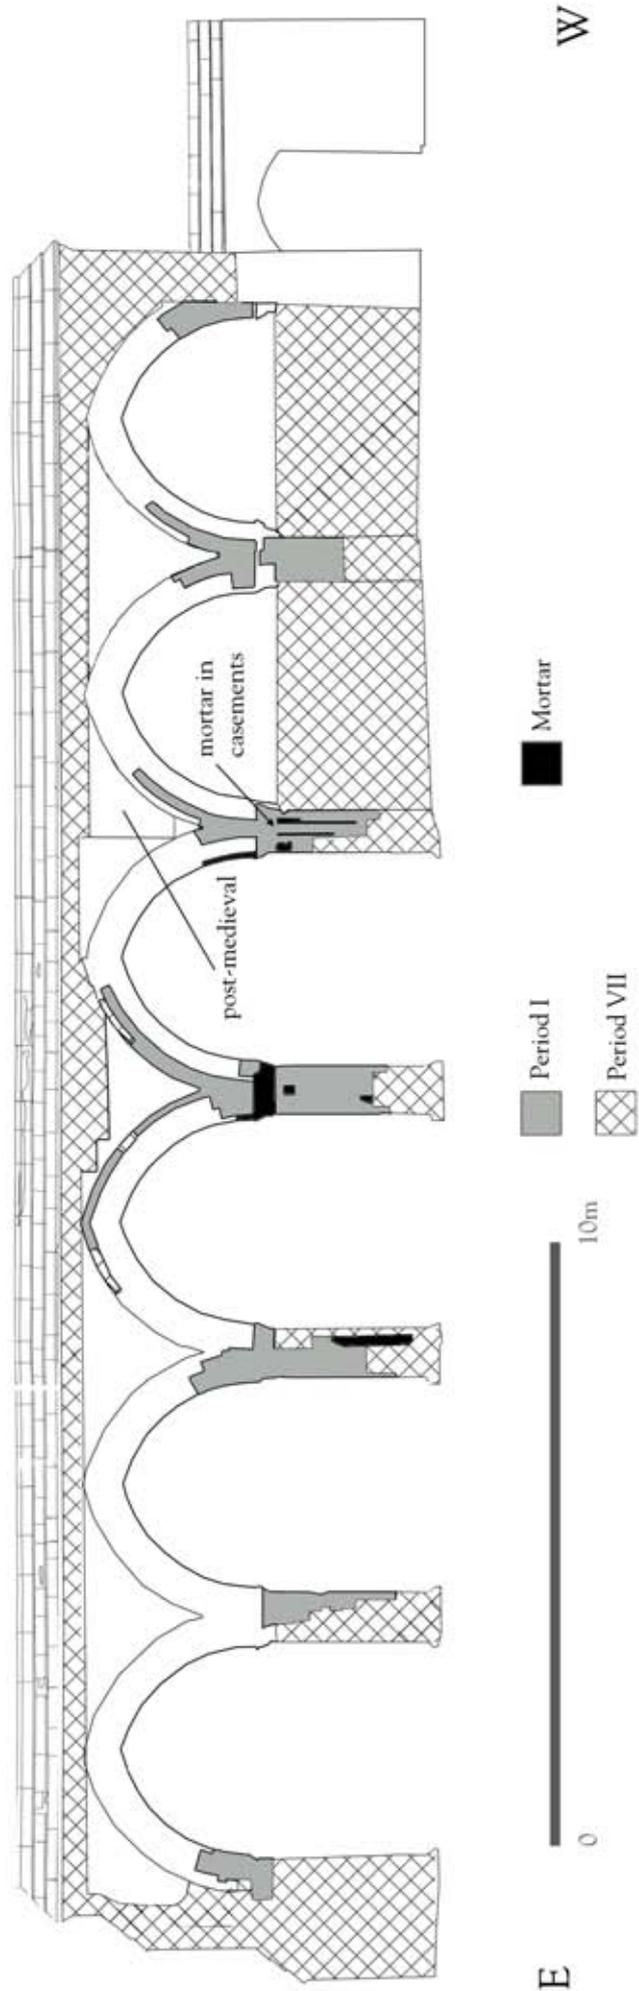
Fig.10

Gloucester Cathedral Infirmary : south arcade, north elevation ~ interpretation
Scale 1:100

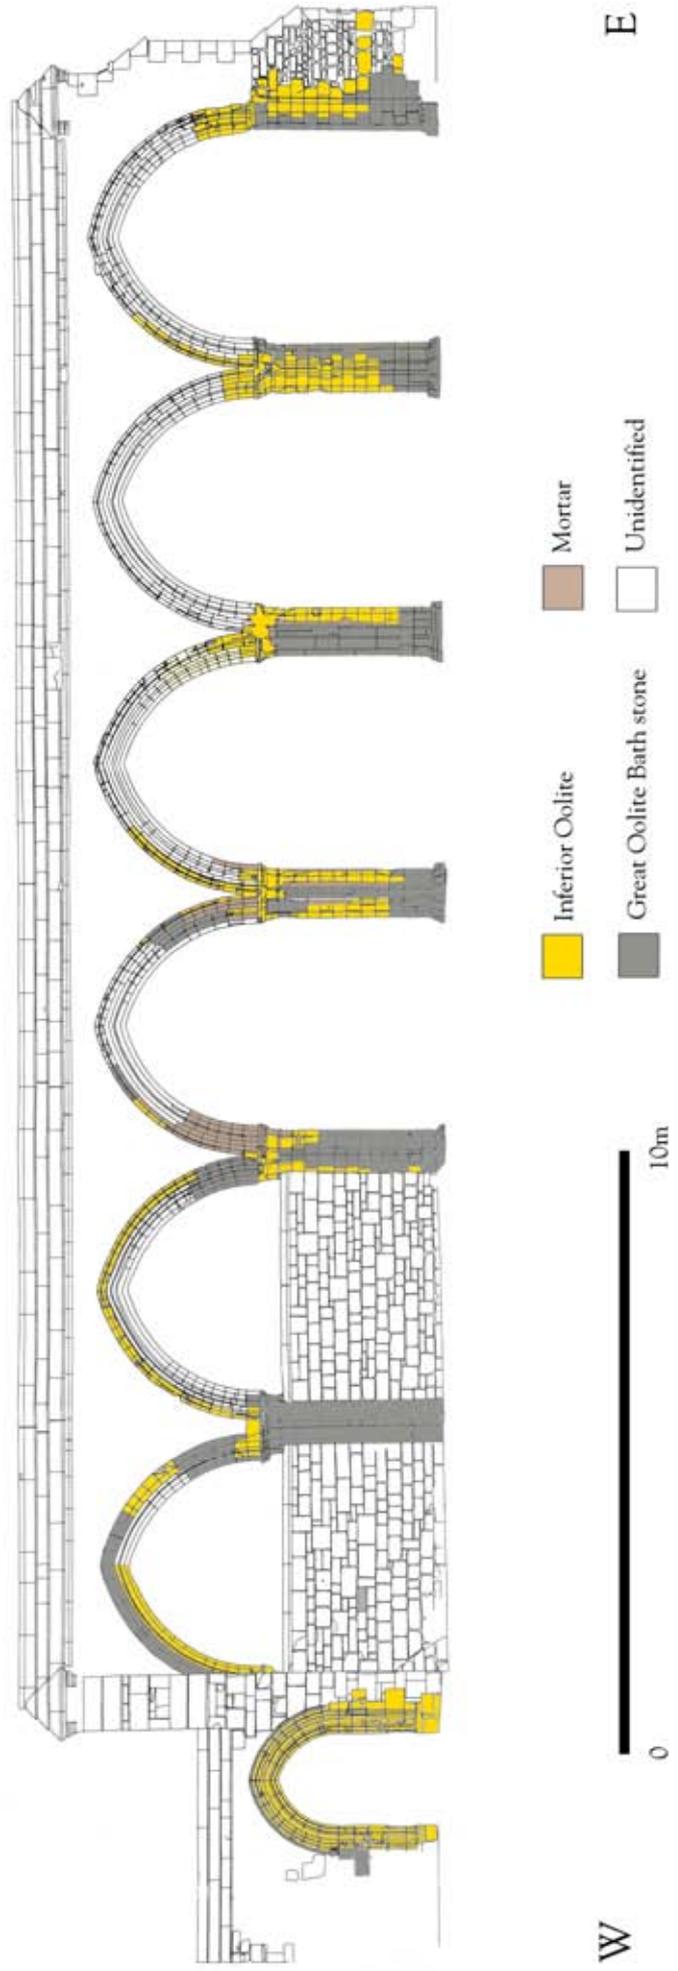
Fig.11

Gloucester Cathedral Infirmary : south arcade, south elevation ~ petrology
 Scale 1:100

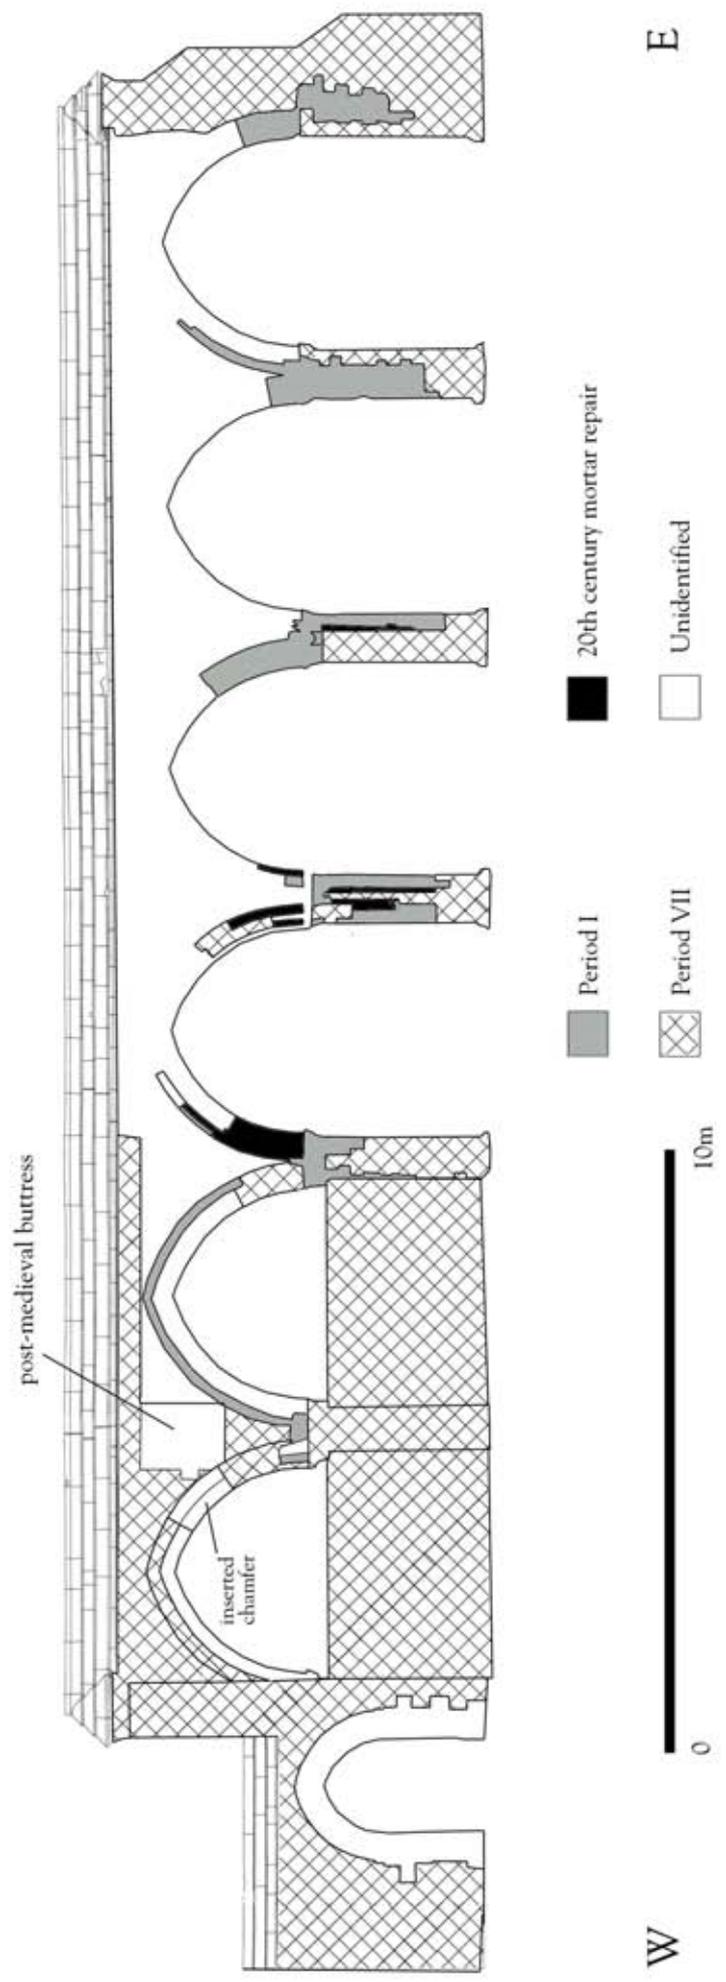
Fig.12

Gloucester Cathedral Infirmary : south arcade, south elevation ~ interpretation
 Scale 1:100

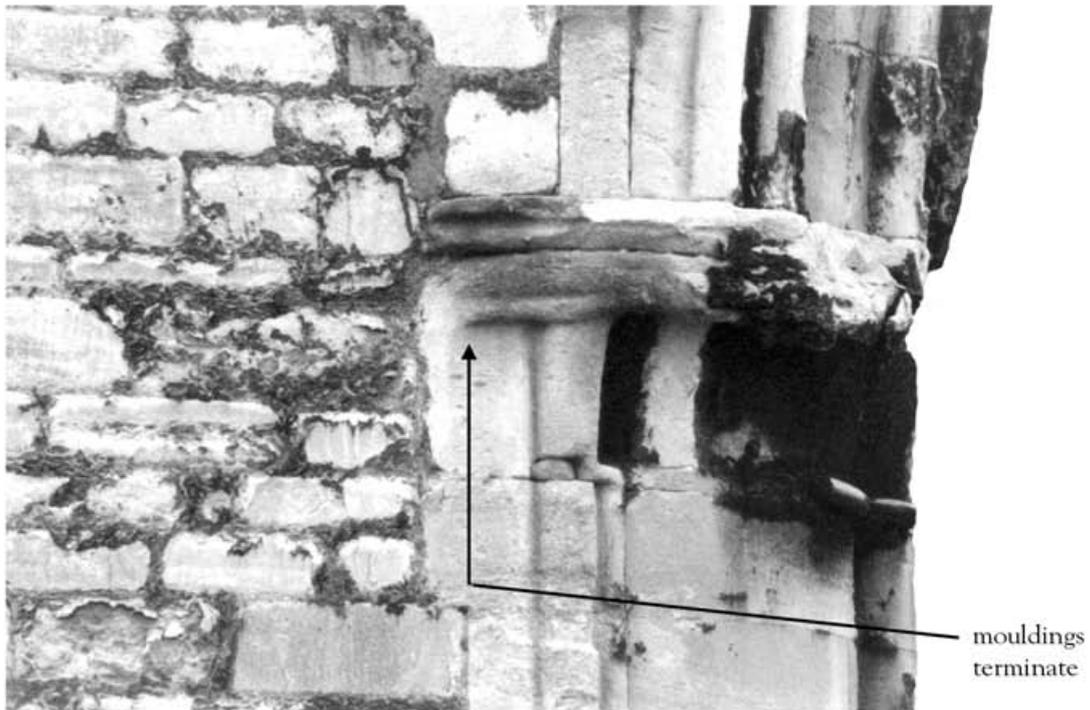
Fig.13

South arcade, south elevation ~ west respond

The shaft, or respond, is obscured by the abutting Period VII cross wall. The respond differs from the attached half column found at the west respond of the north arcade or the east end of the south (Fig.13); no such column exists at the west respond of the south arcade where the capital is attached to a block with a flat face and what remains of the shaft shows that it was a slender (approximately 120mm), three fillet, freestanding column standing in front of a flat ashlar respond.

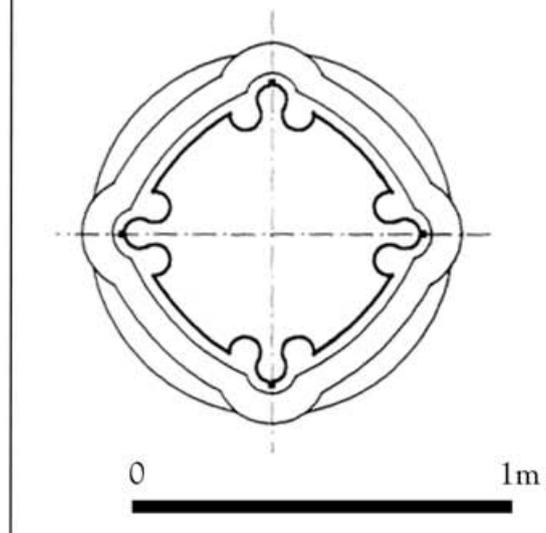
Fig.14

Column profile

In plan the column has the same profile as columns 2, 4 and 5 (described above-Column 2; Fig.14). At the base of the column the bottom three to four courses and base are cut from Bath stone so belong to Period VII. As far as it is possible to tell these repairs reproduced the medieval courses. Above the fourth course, on the north elevation, the stonework is original.

The plan has the same profile as columns 2, 3 and 5 (described above: Column 2; Fig.14). It was subject to extensive repair during Period VII; the base is a shelly Bath weatherstone

The plan has the same profile as columns 2, 3 and 4 (see above-Column 2; Fig.14). Both north and south elevations show that the eastern half of the column, along with the base, was mostly replaced during Period VII but, in contrast to columns 3 and 4, the medieval course heights appear to have been reproduced in the stone work of Period VII.

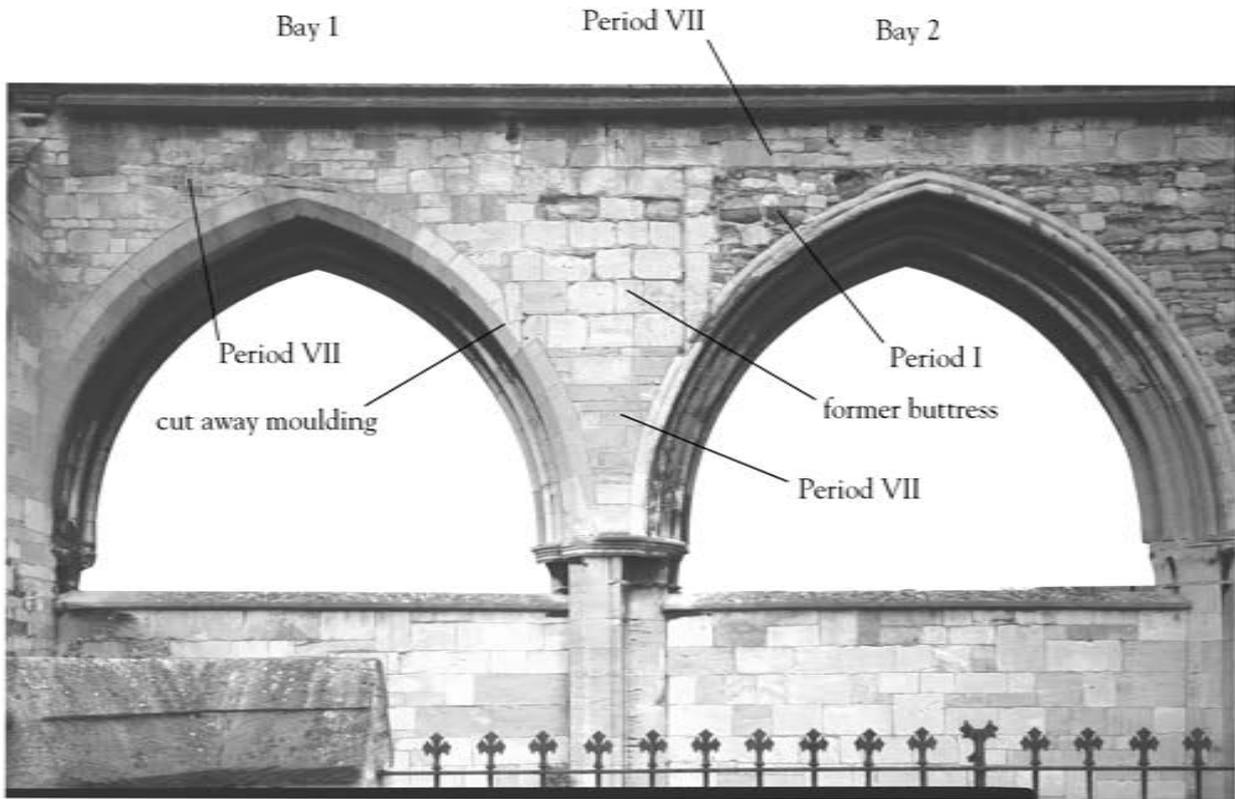
Fig 15. South arcade, south elevation: bays 1 and 2

2 & 3. West respond and Column 1 (Figs. 15, 16)

The column and respond mouldings of Bay 1 differ in several respects from the equivalent mouldings on the other surviving responds and columns. The significant differences are these: the west respond possesses no half column as do the other surviving responds, the mouldings on the west side of Column 1 consist of plain chamfers as opposed to the arc-casement-engaged shaft configuration found on the other columns; Column 1 is wider on its east-west axis than the other columns so that, for example, the drip moulds between the arches are connected by a short horizontal section of roll and fillet as opposed to meeting in a 'V' as they do on the other arches.

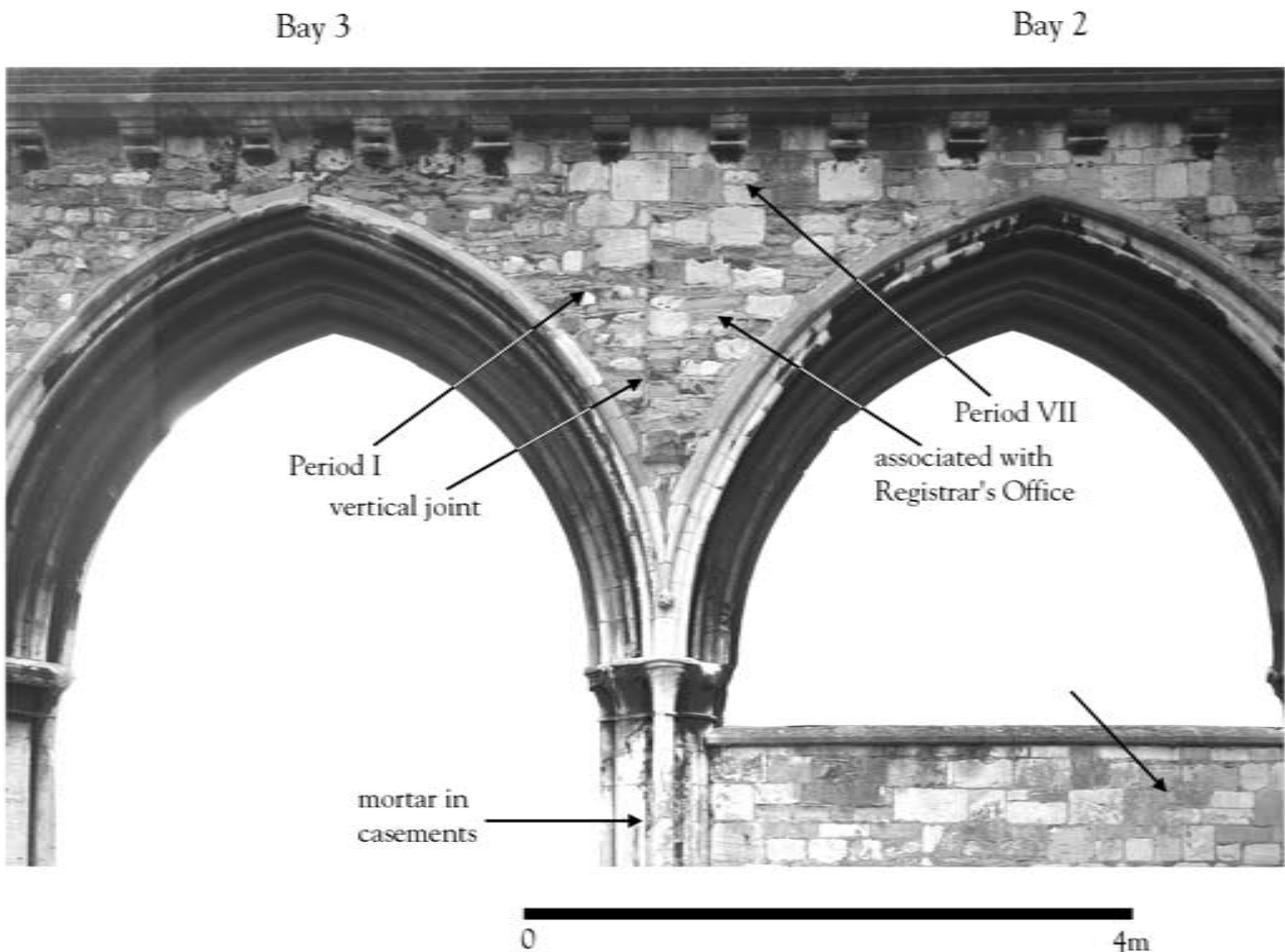
Fig 16. South arcade, north elevation: bays 2 and 3

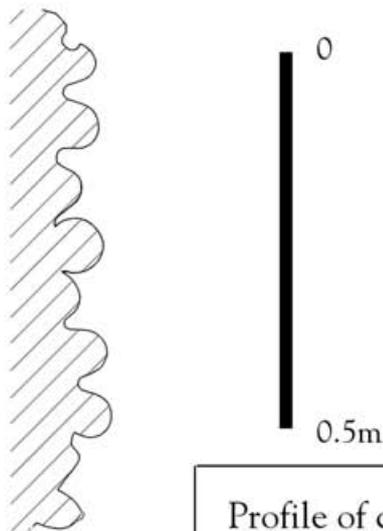
Fig.17

South door moulding
Scale 1:10

A medieval doorway with moulded surround is shown at the west end of the south arcade on the elevation drawings. The opening is 1.5m wide and 2.65m above ground level at the apex of its two centred arch. The mouldings rise without bases from a plain, stilted, 'sub-base' 350mm in height and run continuously around the jambs and arch on the chamfer plane, uninterrupted by capitals. The moulding profile (Fig.17) shows seven rolls, ranging in size from 50-75mm in diameter, arranged in a roughly symmetrical manner about the central, largest, roll. Some of the rolls are set back from the chamfer plane and undercut to differing degrees giving the composition a lively meandering quality typical of Early English work. One of the rolls has a beak which suggests, in Gloucestershire, a date sometime in the first half of the 13th century (Morris 1992:6).

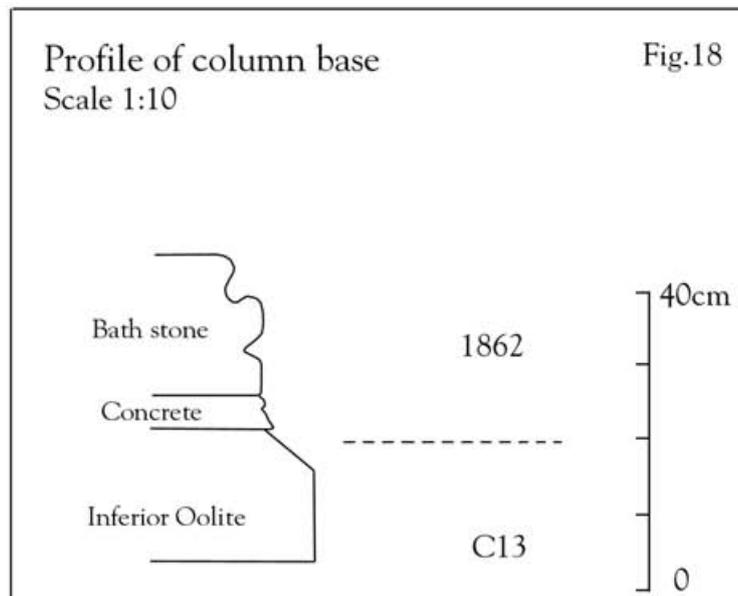
Fig.18

Profile of column base
Scale 1:10
