archaeological recording of the monastic
infirmary at Gloucester cathedral

Gloucester Cathedral Archaeological Report 2001/G

Archaeological Recording of the Monastic Infirmary at Gloucester Cathedral

Steve Bagshaw

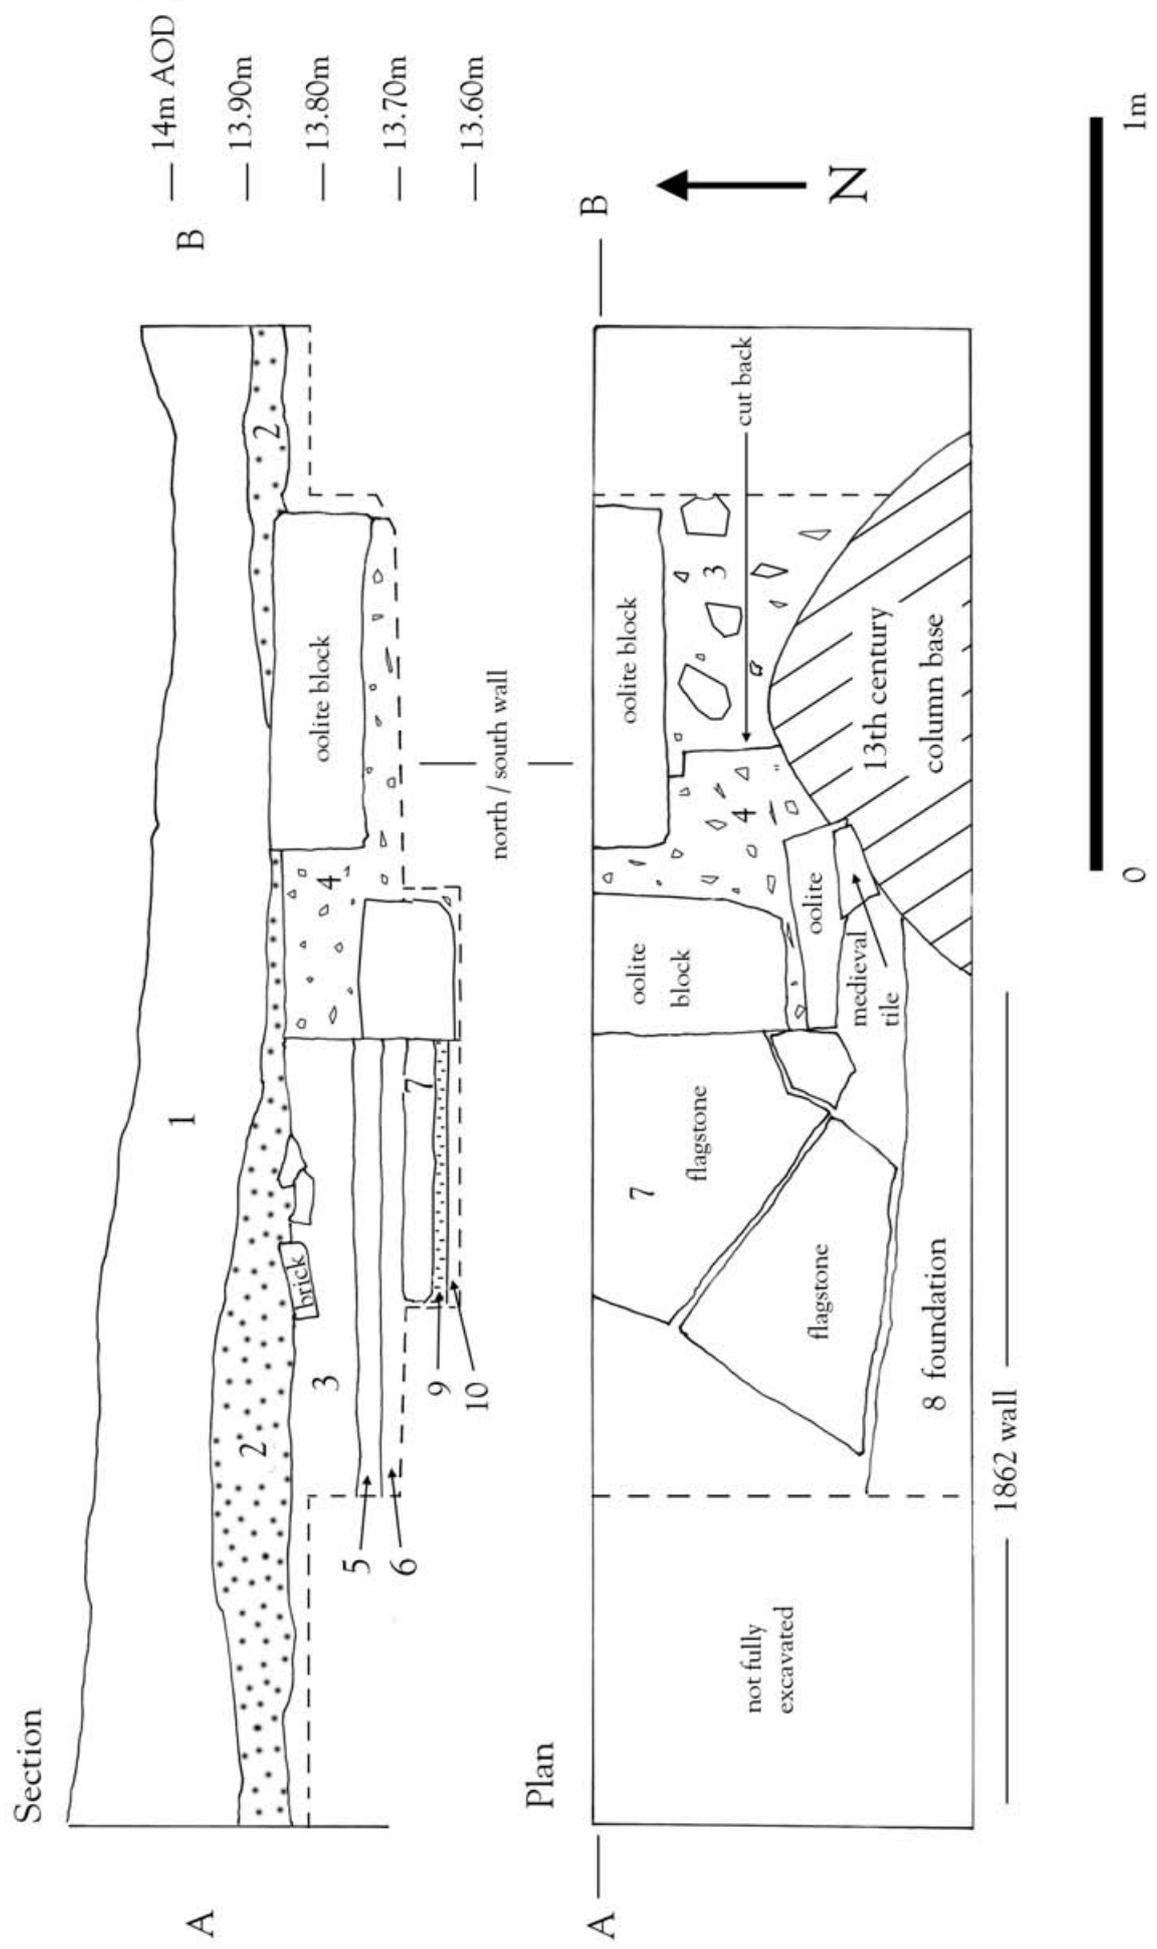
Fig.19

Gloucester Cathedral Infirmary - Excavation by the South Arcade
 Scale 1:10

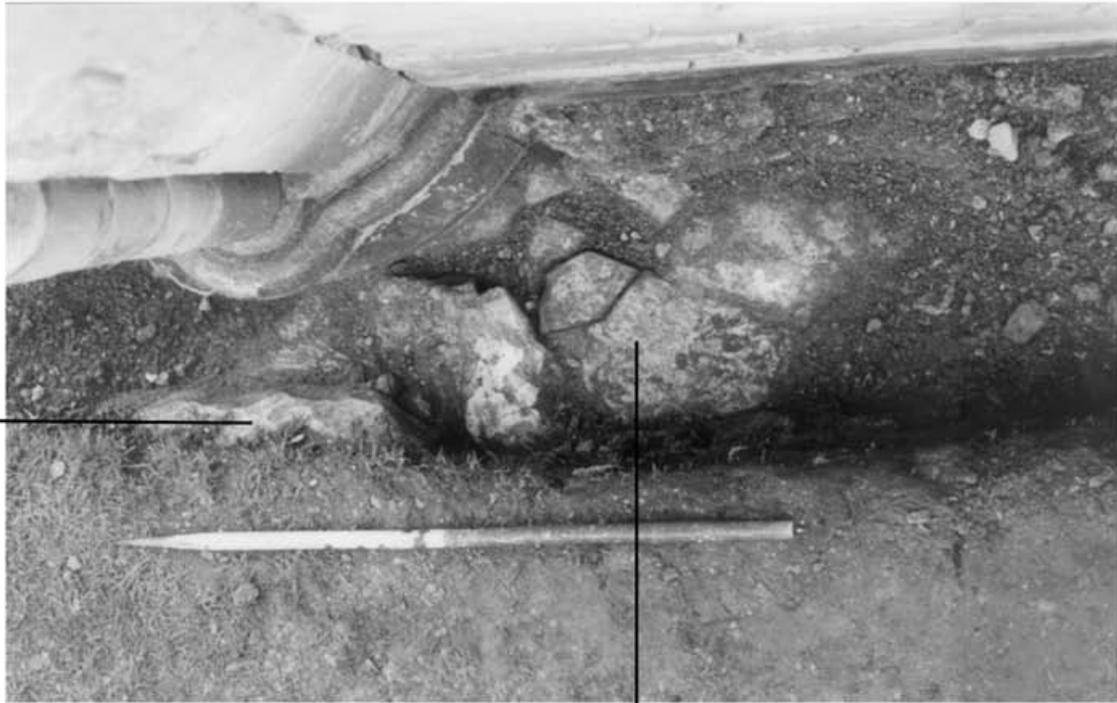
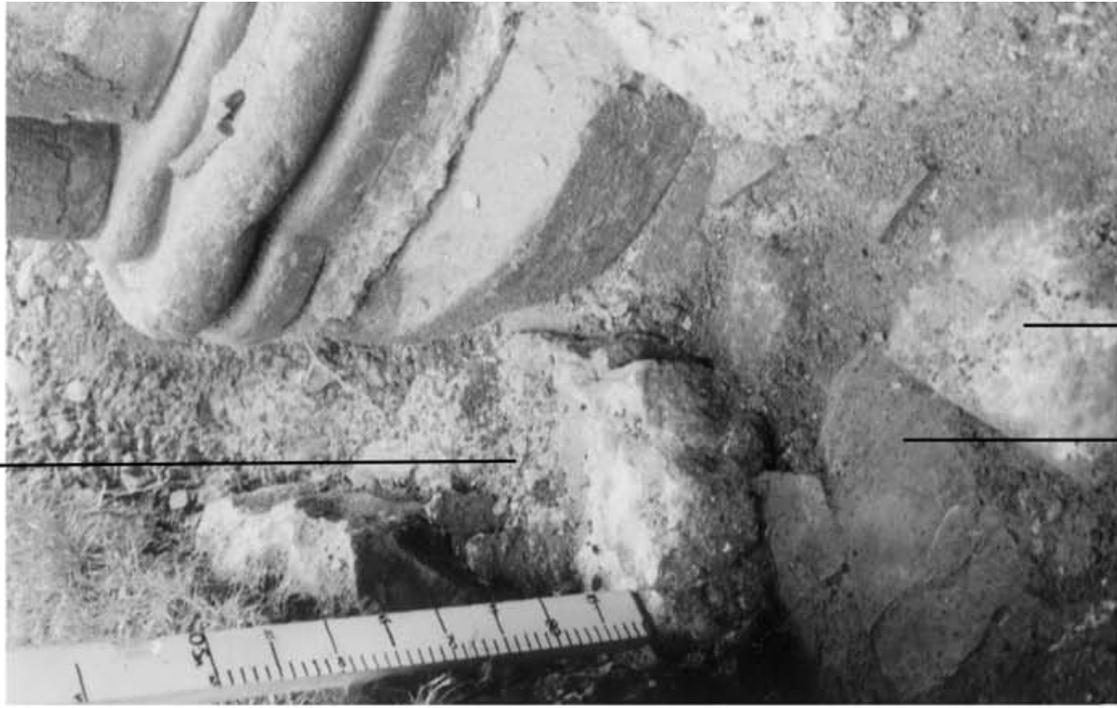
Fig. 20

north / south wall

stone floor II

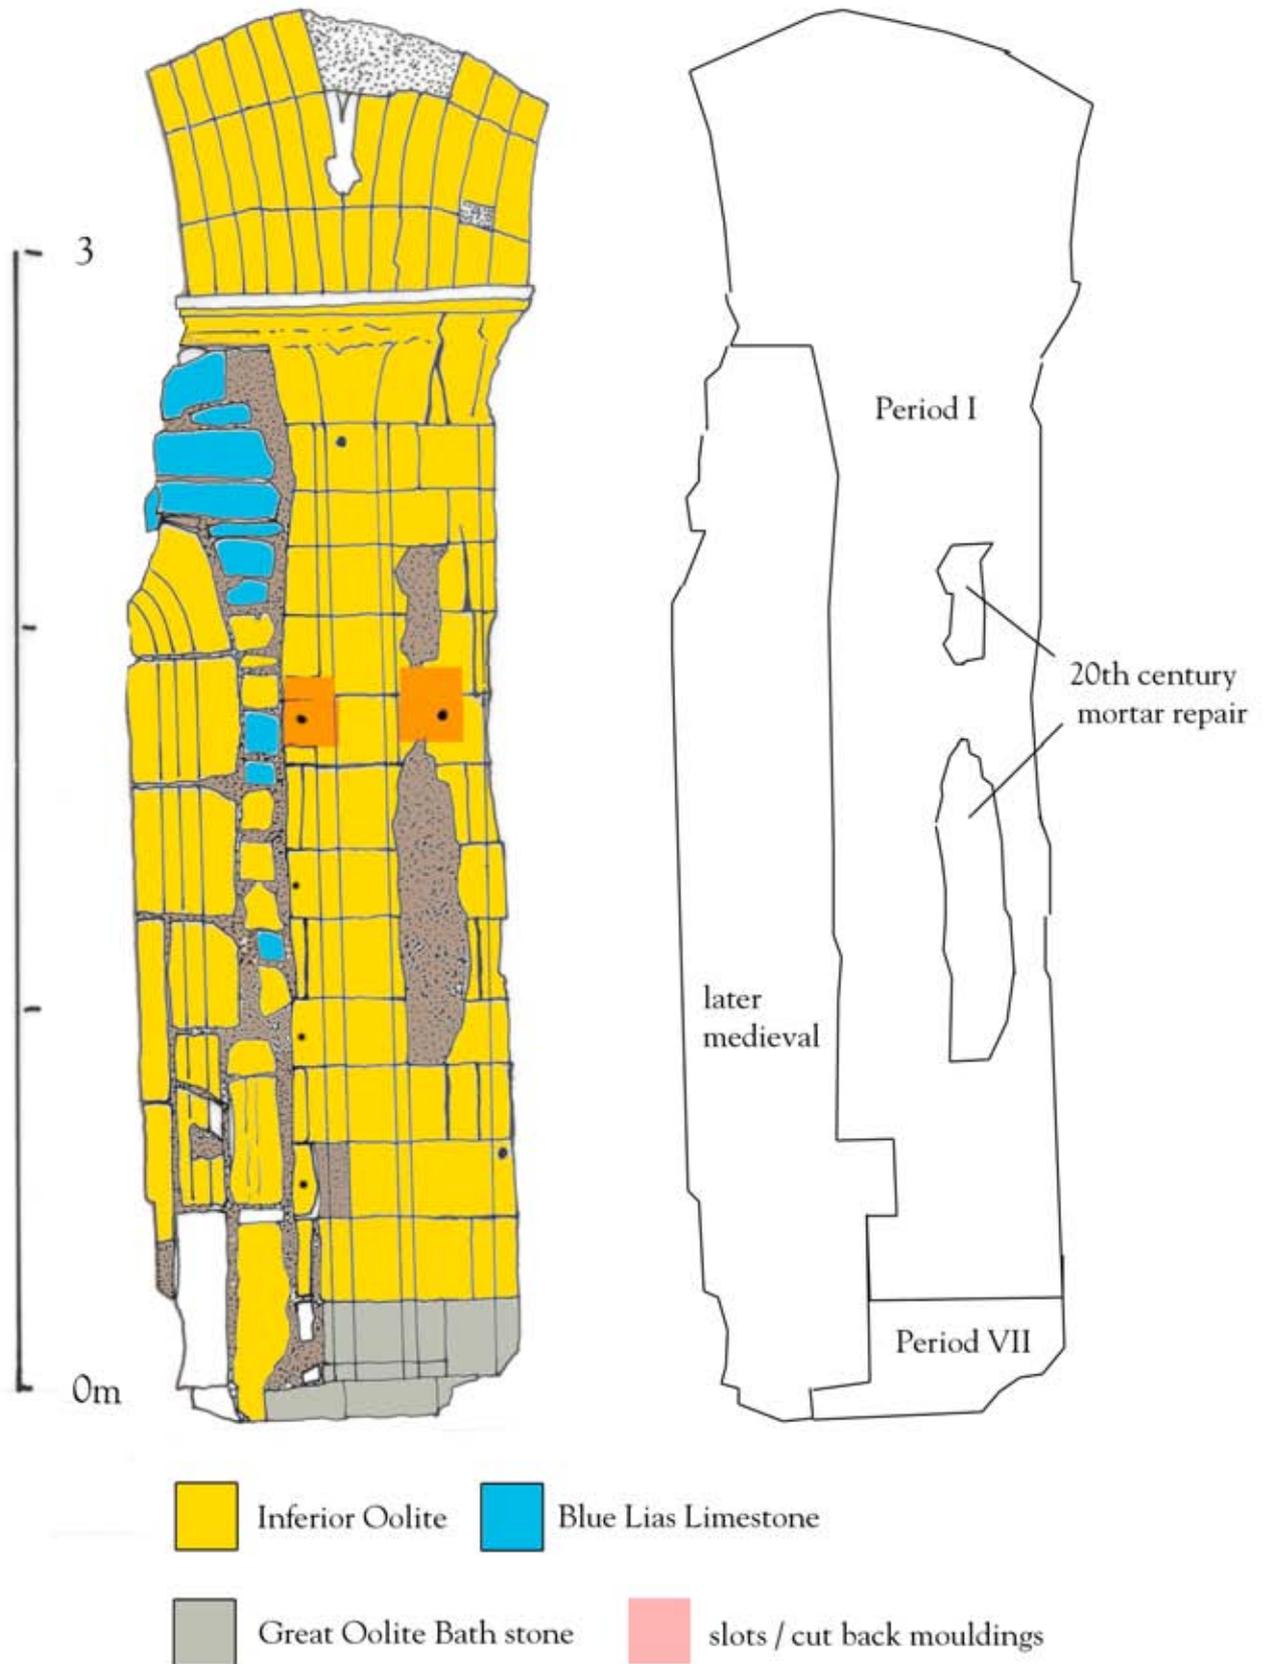
The column originally had the arc-casement-shaft moulding profile found on columns 2-5 of the south arcade. The moulding at the neck of the capital has weathered away; the bell unit is undecorated and what remains of the abacus has the bold, deeply undercut mouldings found on the south arcade. The column shafts do not have fillets and the base is concealed by the topsoil.

The arch mouldings springing from the abacus appear to be Period I work in situ. Unlike Column 1 of the south arcade the roll and fillet hoodmouldings of the arches meet in a 'V' shape, without the short horizontal connecting length of roll and fillet moulding. At the time of writing the arch stones were topped off with a bed of hard 20th century mortar.

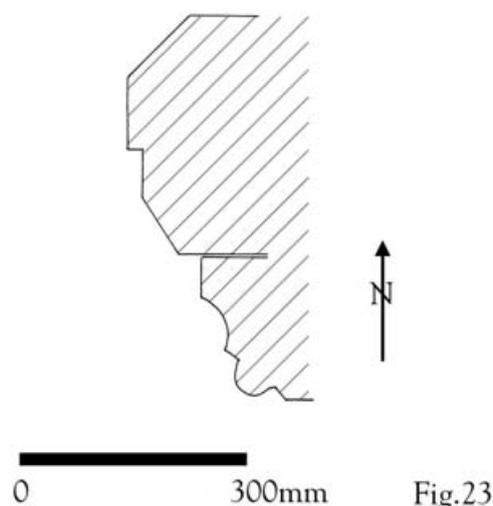
Column 1, doorway moulding
Scale 1:10

The roll and hollows ran continuously around the jambs and arch of the doorway, without interruption by capitals, and are terminated 0.55m above ground level by a rectangular block giving the moulding a stilted appearance. The bottom stone carrying the chamfer moulding has disintegrated, the stone above it has a slot, 70 x 30mm, cut into the flat inner face; presumably for a bolt.

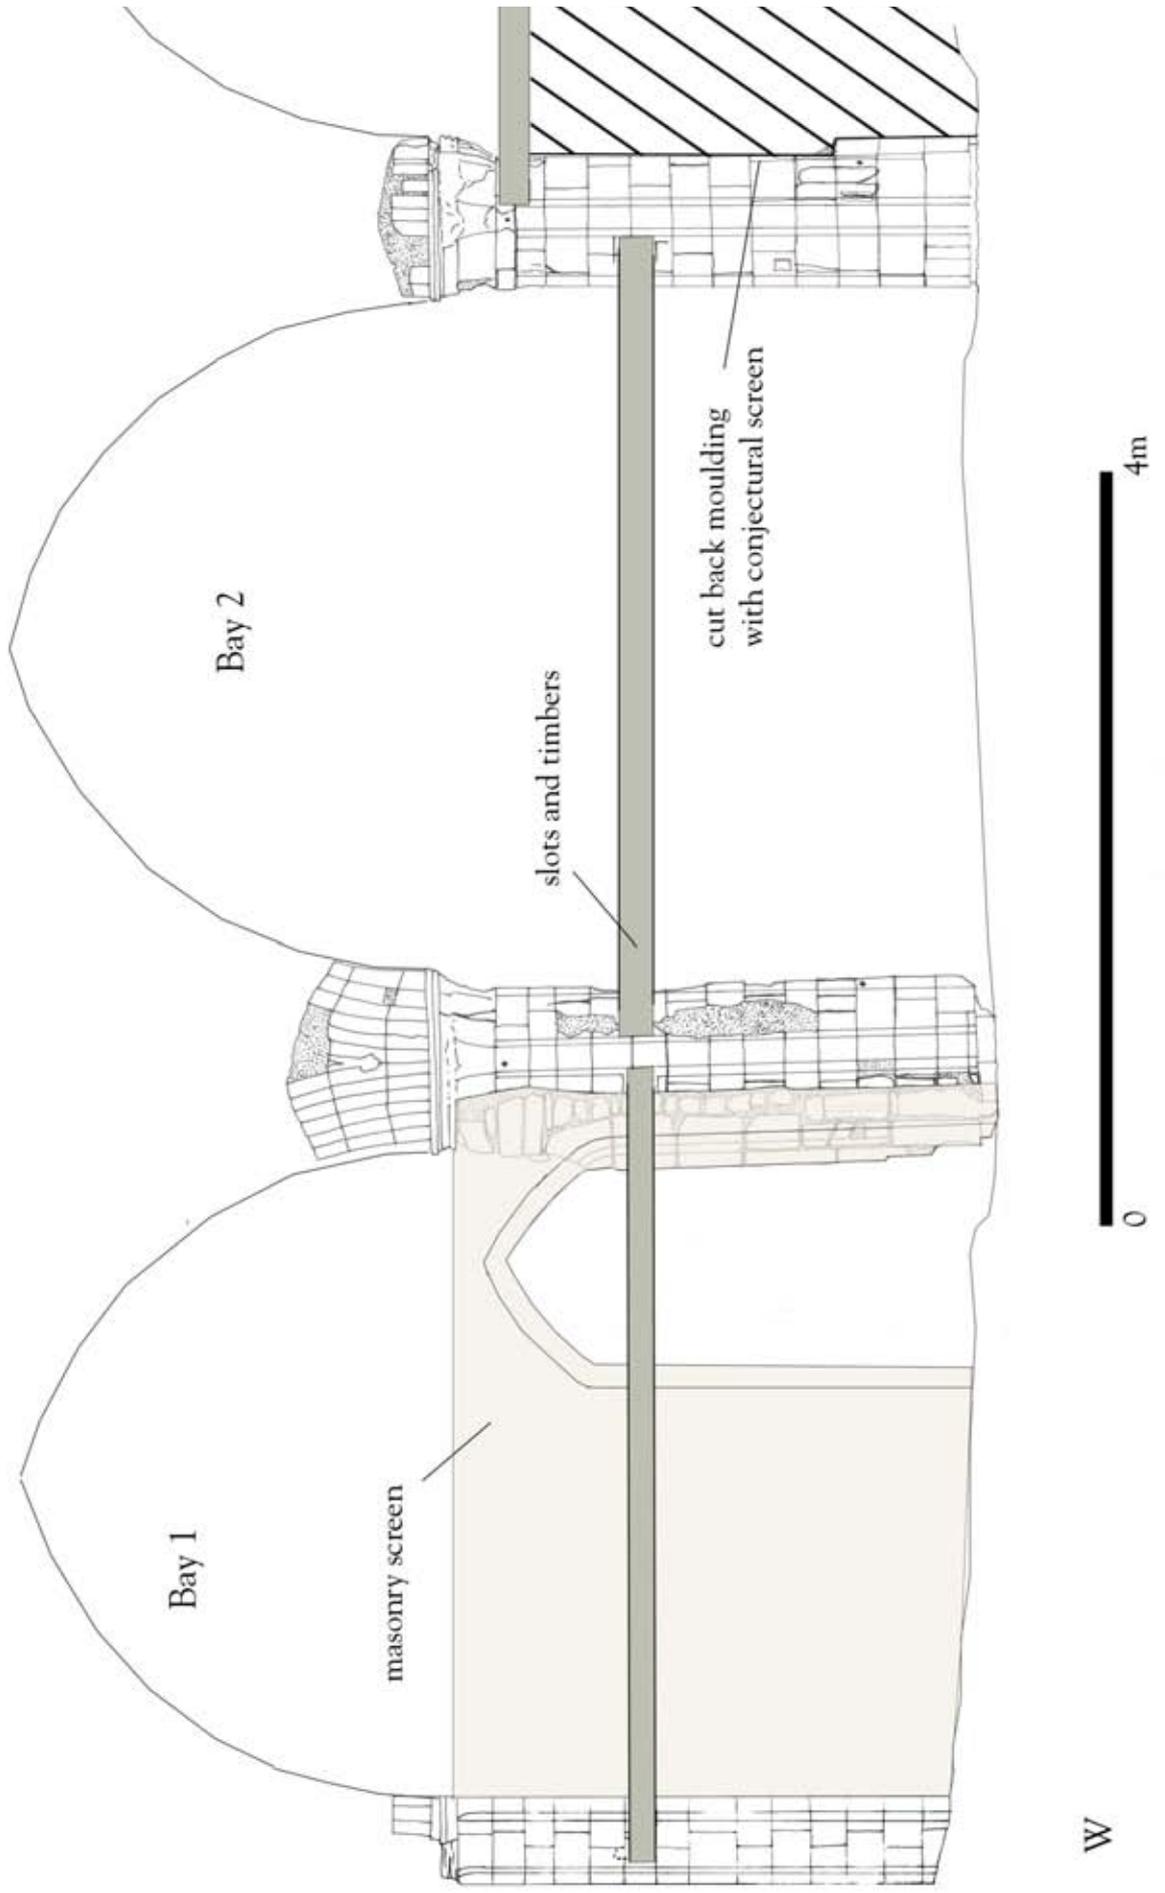
Fig. 26

North Arcade ~ reconstruction of screens
Scale 1:40

The two freestanding columns and west respond of the former north arcade show that it matched the south arcade. Slots and cut away mouldings identified on the columns and respond preserve evidence of a succession of timber, then masonry, screens partitioning the north aisle from the central aisle and dividing the bays of the north aisle. No firm dates
