From the *Transactions* of the
Bristol and Gloucestershire Archaeological Society

**A Medieval Water Tank in the Cloister Garth of Gloucester
Cathedral**

by C. M. Heighway
2000, Vol. 118, 190-201

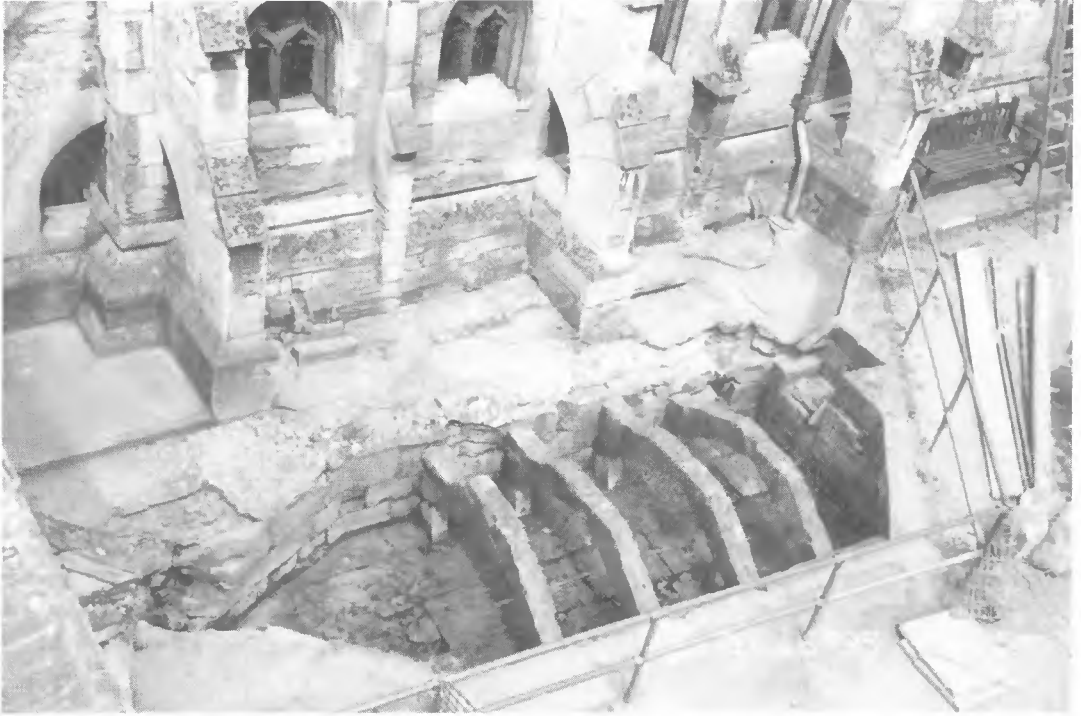
Fig. 4. General view of the tank to north-east from cloister roof.

The angle of the tank's side walls was achieved on the south by a straight joint in the masonry (Fig. 5). The equivalent effect on the north was provided by the use of deliberately angled ashlar (Fig. 4), indicating that on that side at least the funnelling of the tank was part of the original design. The sluice at the west end (Fig. 6) had been destroyed almost to the level of the base slabs, but it clearly had two paddles, one behind the other (Fig. 7).

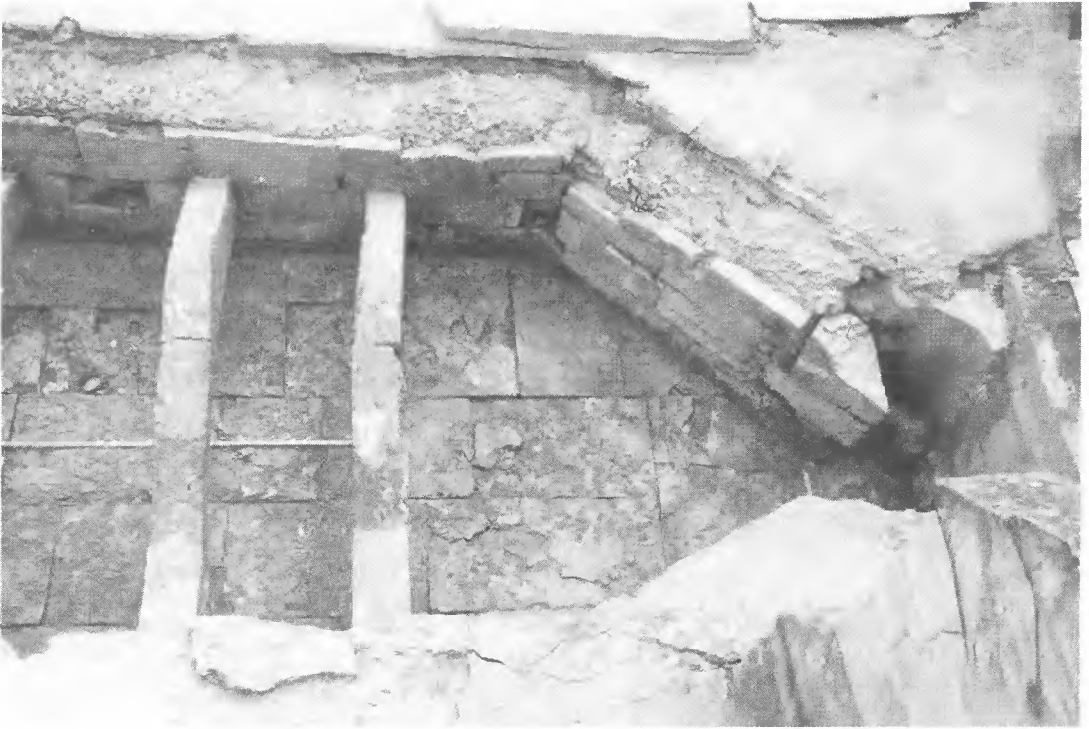
Fig. 5. View of the west end of the tank showing the funnel sluice and concrete 'shaft'.

It was apparent that extensive repairs had been made to the tank, presumably in the late 1880s. The Victorians built up the tank's sides with new ashlar to form one level and bridged its south-east corner presumably to form a safer path. Stone props were placed under the ribs along the north side and much of the stonework was pointed with concrete. The ground surface around the tank was covered with concrete, leaving the surviving medieval stone channels in place. The culvert entry at the eastern end was rebuilt with new stone, and a pre-existing blocking was repaired or the culvert was newly blocked to make a neat appearance. The western semi-circular shaft was re-formed in concrete and provided with a metal grille at the base; the grille

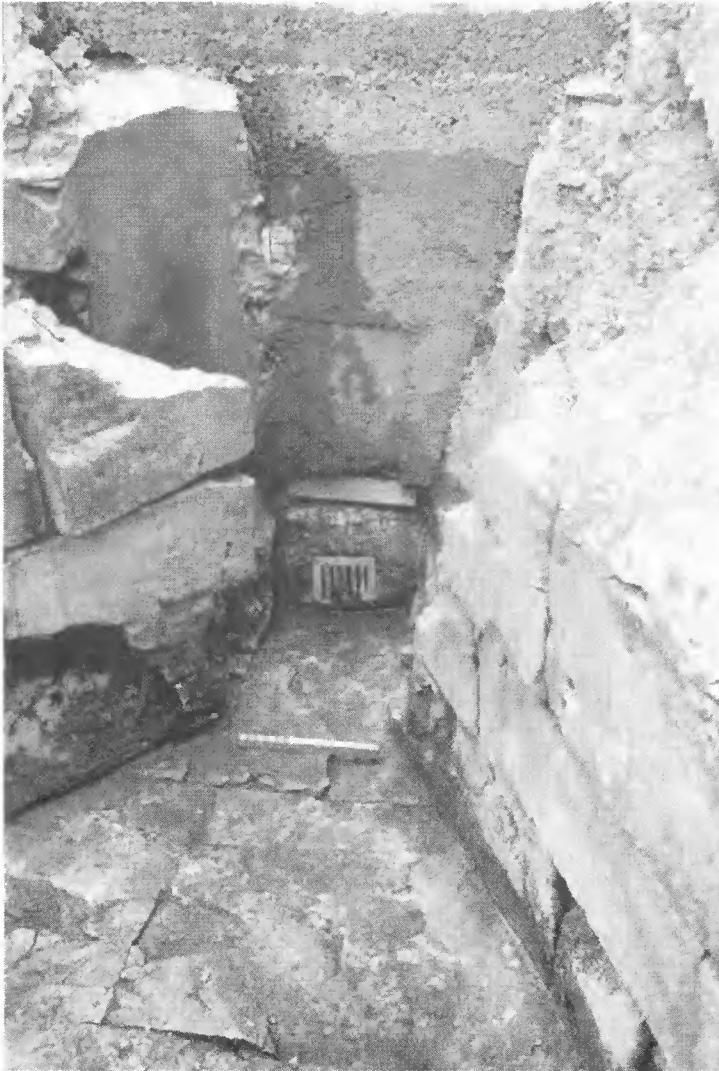
Fig. 6. View to west of the sluice with the Victorian grille beyond; the concrete manhole above the grille was the repair of 1996. The Victorian 'shaft' is left of the grille.

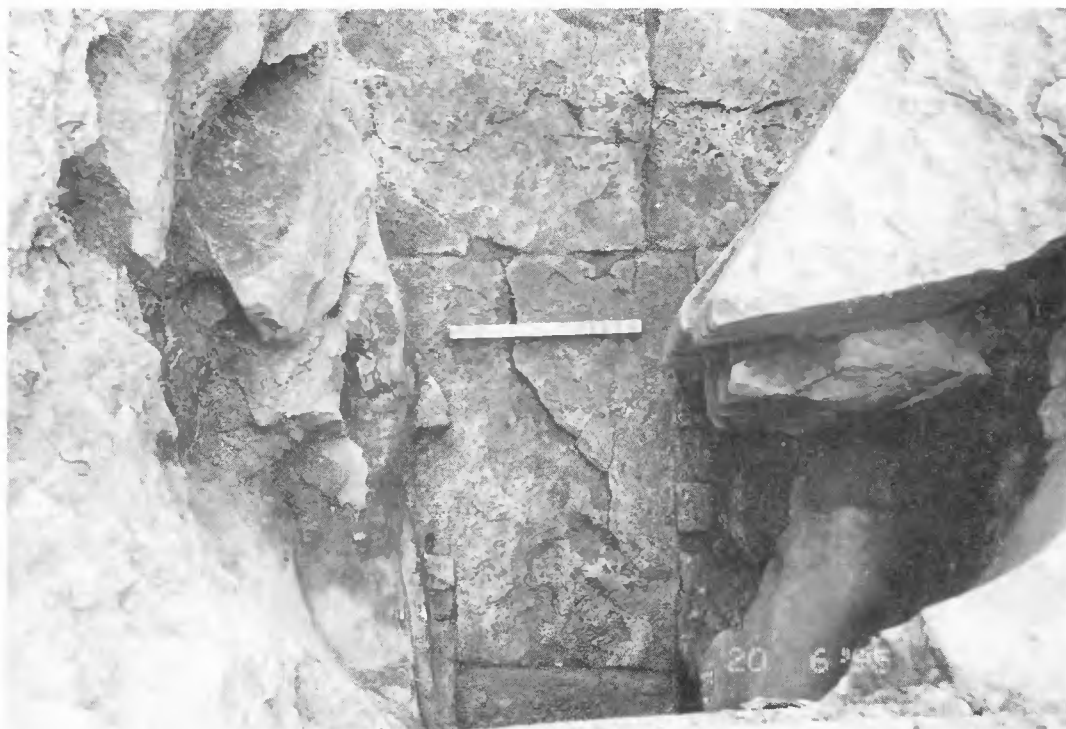
Fig. 7. View of the sluice from above, north is to left.

The tank is built of local Painswick stone, with base slabs forming the foundations for the side walls which were built of well-jointed ashlar. The tank is rectangular except at the west end where it funnels into a narrow channel 0.35 m wide, at which point was a double sluice gate (Figs. 7–9). West of the sluice the water drained into a medieval stone culvert, which runs out under the west walk of the cloister (Fig. 2). At the junction between the sluice and the drain was a shaft, roughly semi-circular in plan (Fig. 7) and accessible from ground level. The surviving facing indicates that the shaft was 1.15 m deep from the surface to the drain base. This feature must have served as a manhole to give access to the sluice, which would otherwise have been inaccessible. The shaft was entirely refaced in Victorian concrete, but it is to be presumed that the restorers imitated a feature that already existed. The base of the tank slopes from east to west and the slope was continued down into the drain under the cloister walk; the level at the west end of the tank was 13.22 above O.D. and dropped to c. 13.16 m at the point where the culvert passed under the cloister wall.

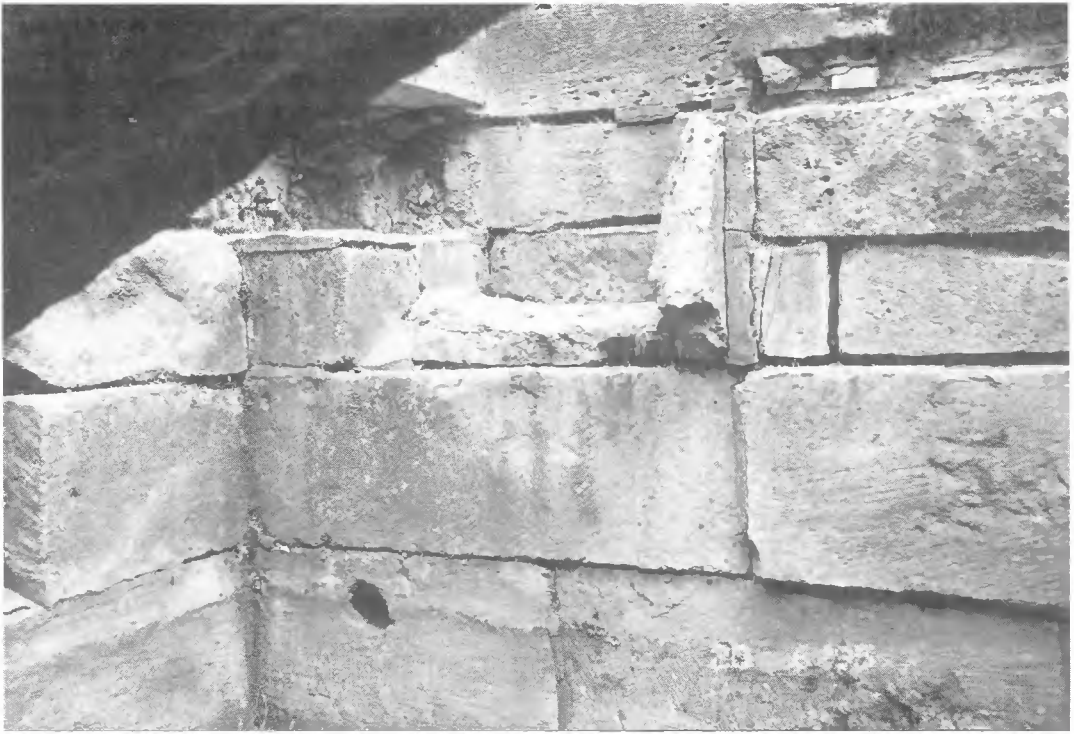
Fig. 8. View of the tank's east wall showing the culvert entrance and the hole in the lowest course.

At the east end of the tank was a culvert entrance, blocked probably during the Victorian restoration, and, in the lowest course of the east wall, a sub-circular hole which might have once provided the entry of a water pipe (Figs. 3 and 8). The whole tank is spanned by four stone ribs springing from its sides; there were sockets for two further ribs, one at each end, making a total of six. The ribs were designed to support a cover, perhaps of stone slabs, and with these in position the tank would have been invisible, taking medieval ground level to be roughly the level of the threshold of the cloister doorway.

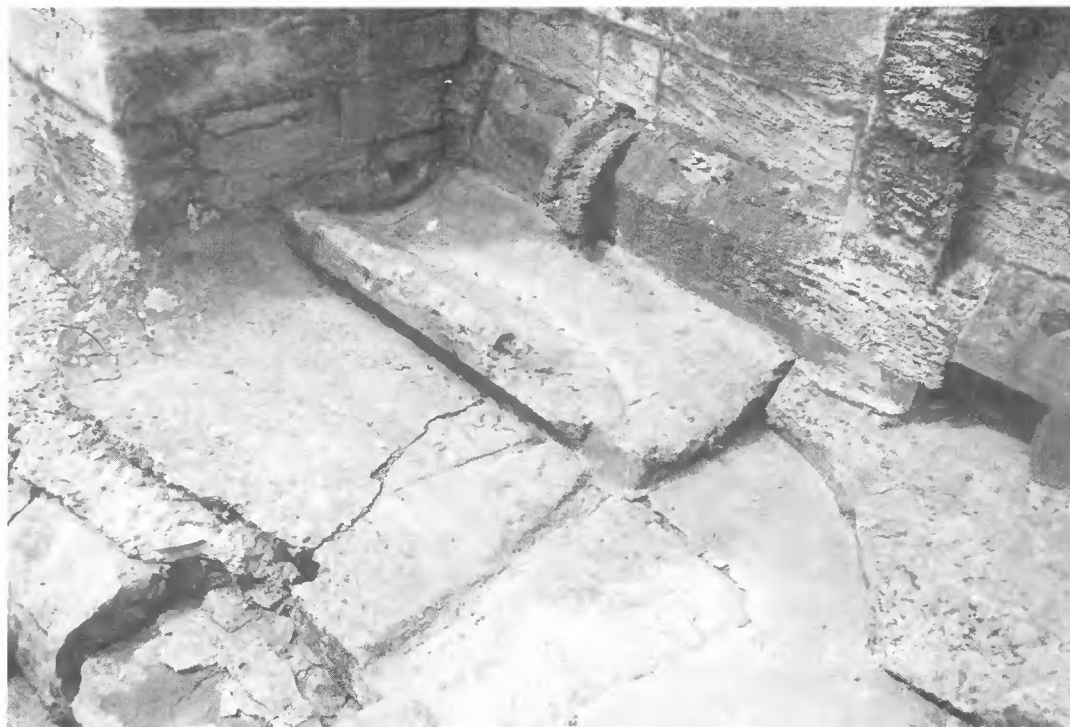
Fig. 9. View to north of the drain from the lavatorium; the re-used grave slab (WKS 207) is in the foreground.

Between the tank and the 14th-century lavatorium were the remains of drainage channels which once led waste water from the lavatorium into the tank. The drain spouts from the lavatorium emptied into stone channels along the lavatorium walls, and holes had been bored through the lavatorium buttresses so that water could pass through from one drain to the next (Fig. 3, section 101; Fig. 9). A further stone channel then took the water to the tank. Part of this channel cut through a grave slab decorated with a foliated cross (Fig. 2, WKS 207) and showing signs of having once been used as the base of a container with upright sides, perhaps a eistern.
