**Walled Gardens at Berkeley Castle, Gloucestershire' (pp. 295–
310).**

by George H. Nash
2007, Vol. 125, 295-310

Walled Gardens at Berkeley Castle, Gloucestershire

By GEORGE H. NASH

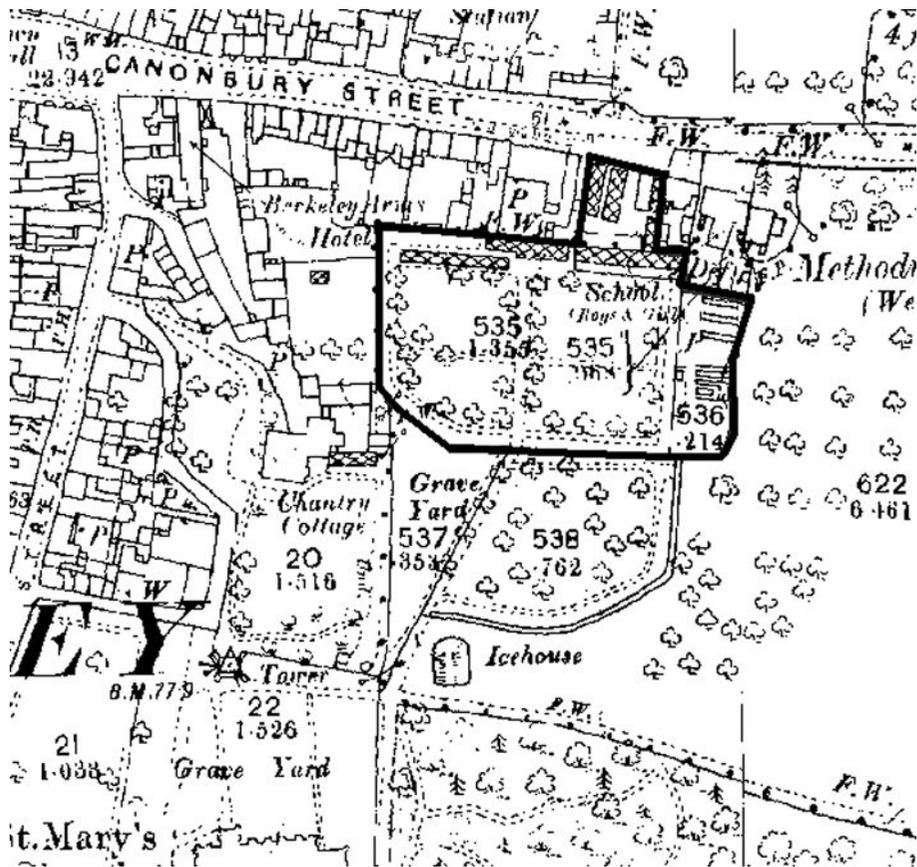
greenhouses survives. The pitch of the roof of the western building was clearly visible on the southern elevation of the wall separating the garden from Canonbury Street. Within the larger walled garden three long greenhouses oriented east–west stood on its north side and lines of trees followed the inner perimeter of the surrounding wall. Outside the garden, to the east, a series of greenhouses oriented roughly east–west has been replaced by an open timber pavilion and landscaped lawns. In the same area, facing Canonbury Street and extending 300 m to the east, was an area of formal parkland. It should be noted that the present gatehouse off Canonbury Street

Figs. 2 Changes in the gardens between 1880 (Fig. 2: above) and 1921–2 (Fig. 3: next page) as shown on Ordnance Survey maps.

Based on the cartographic evidence the buildings and structures recorded in the walled gardens in 1880 were standing in 1902. By the latter date a number of changes had taken place within the larger garden and the area to the east. In the garden there were formal paths around the perimeter and across the area, dividing it into quadrants, and on the north side, in addition to the three linear greenhouses, a small greenhouse stood close to the western wall. To the east the greenhouses outside the garden had been replaced by a narrow pavilion that abutted the eastern side of the garden wall. By 1922 the formal paths within the larger walled garden had been replaced by a single north–south route bisecting the garden and there may have been some landscaping in the area to the east. The landscape feature, a large bank, was not recorded on the earlier maps. By 1922 a number of trees in the park had been felled.

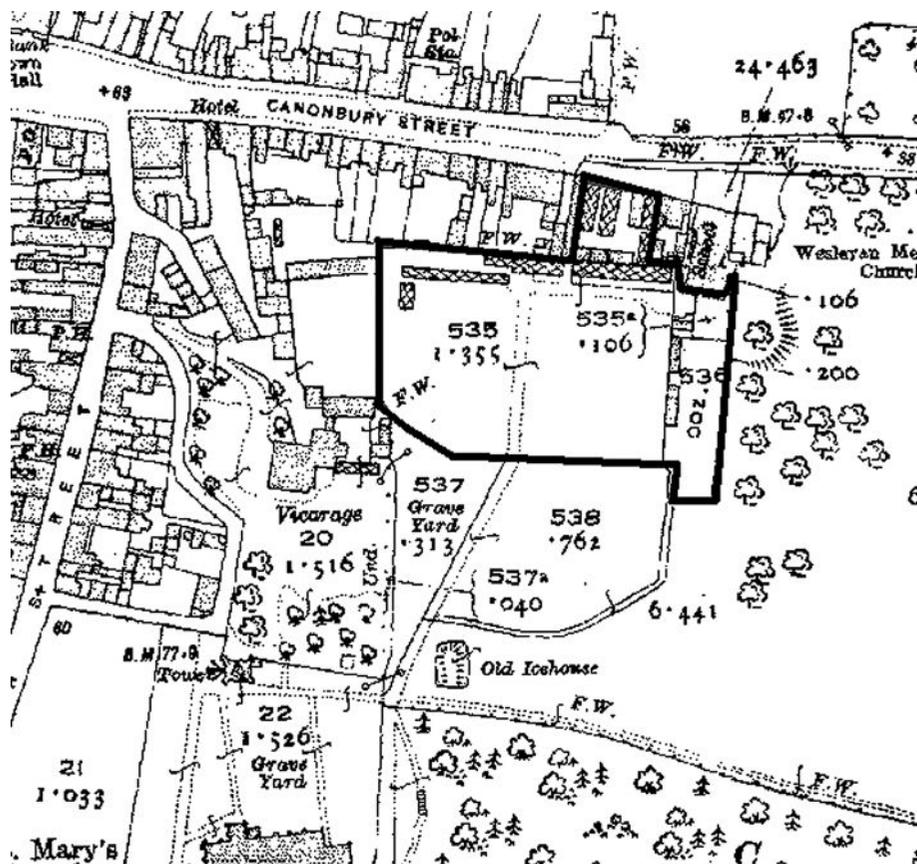
was constructed some time after 1921–2 (Fig. 3). To the north and east of the walled gardens were a school and a Wesleyan Methodist chapel, buildings that now form a hotel. South of the larger walled garden was the graveyard of St Mary's church.

Figs. 3. Changes in the gardens between 1880 (Fig. 2: previous page) and 1921–2 (Fig. 3: above) as shown on Ordnance Survey maps.

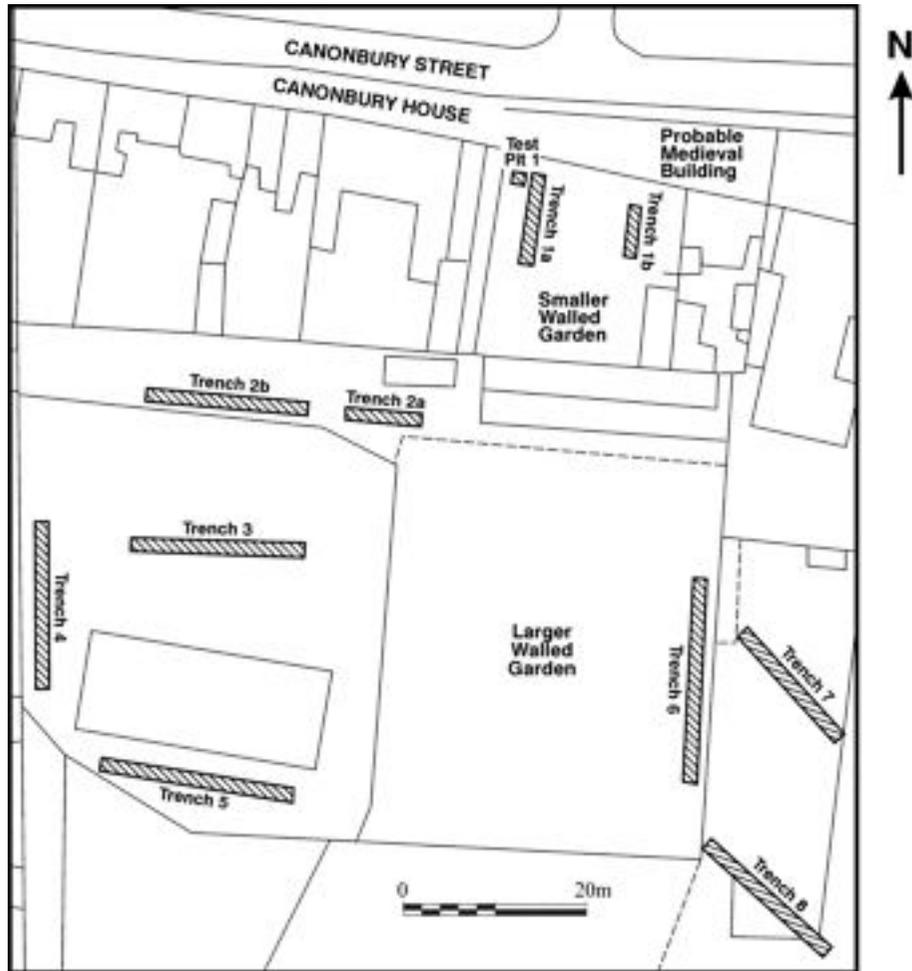
Ten trenches and one test pit were strategically located within areas likely to be impacted by the development (Fig. 4). Although trench size varied, their depths were roughly similar – complying with the terms set out within the archaeological brief. Only Trench 2b exceeded to

Fig. 4. Location of the trenching.

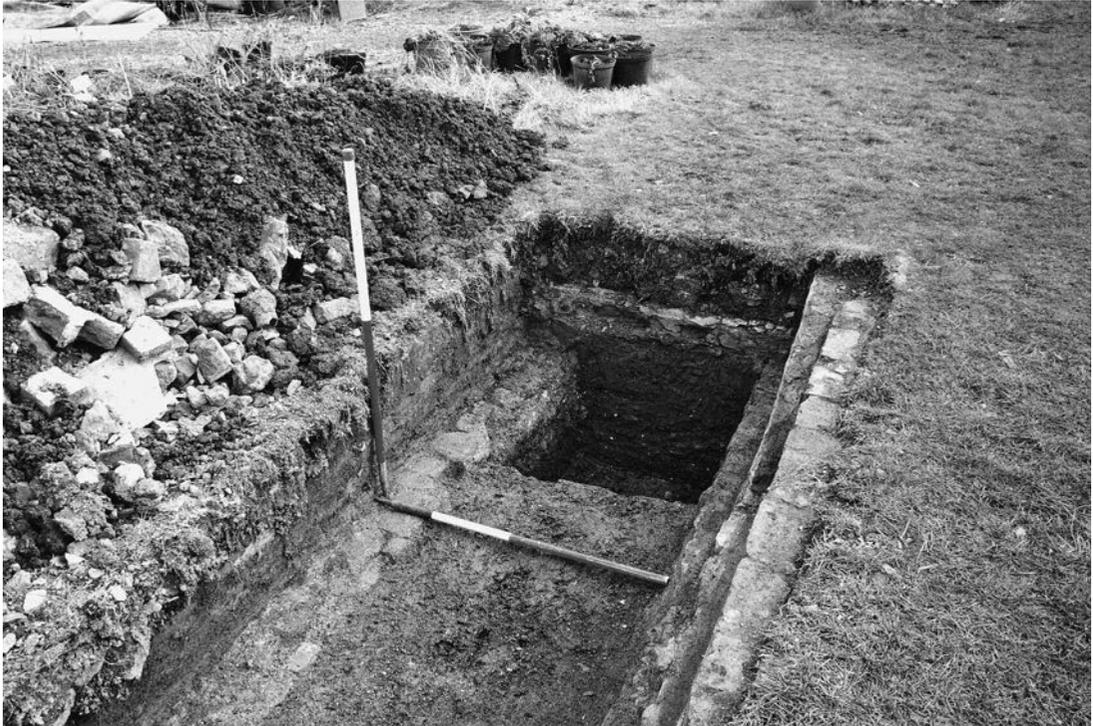
Trench 1a, within the smaller walled garden, was located close to Canonbury Street over the site of the westernmost Victorian greenhouse oriented north–south (Fig. 5). Four contexts were recorded. The foundation and base of the greenhouse with a series of brick walls (laid in the stretcher bond style) were uncovered. At the northern end of the trench a small square sondage measuring $0.75 \times 0.75\text{m}$ was excavated. Underneath the foundation material within this sondage was a small assemblage of medieval and Post-medieval pottery. The pottery was recovered from a deposit at a similar depth to pottery found within Test Pit 1.

Fig. 5. Trench 1a, oriented N-S, looking north.

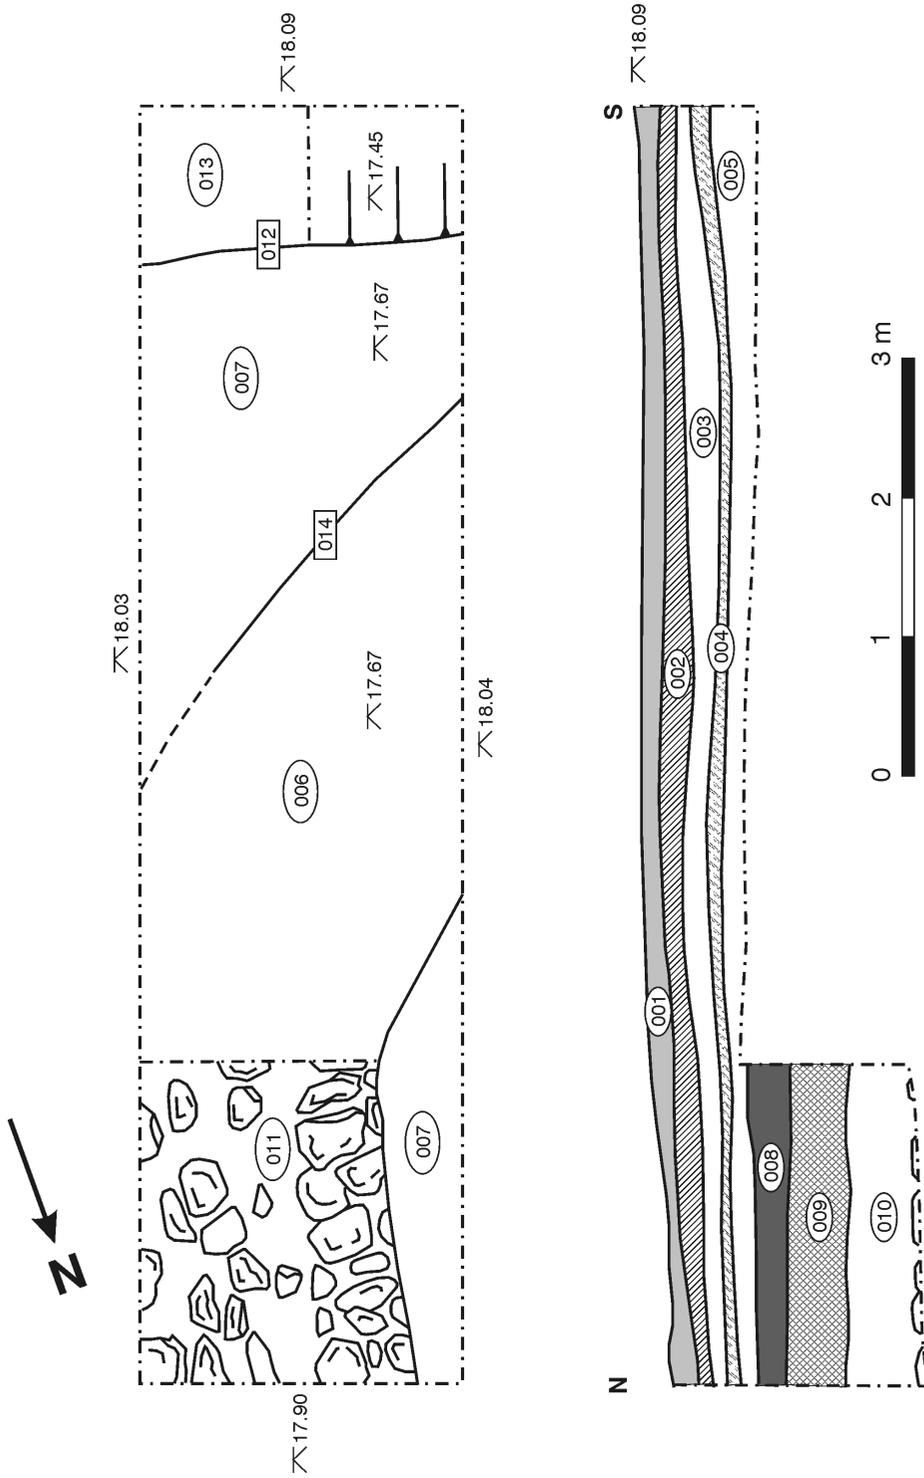
Trench 1b was placed east of Trench 1a and close to Canonbury Street. Fourteen contexts were identified (Fig. 6). Underlying the topsoil deposit [10YR3/3] (001), and extending across the trench, was a levelling deposit (002), possibly resulting from demolition of the greenhouses. The deposit consisted of tightly compacted, orange to red coarse rubble infill measuring 0.05 m in thickness and containing small red brick fragments. Underneath was a moderately compacted grey to brown coarse sandy soil (003) [10YR5/3] that was 0.05 m thick and contained frequent limestone fragments. It probably formed the sub-base of a recent pathway between Canonbury Street and the garden. It overlay other recent sub-base material comprising a tightly compacted, dark grey coarse sandy lens containing occasional red-brick and limestone fragments (004).

Underlying context (004) was a tightly compacted brown to red coarse sandy soil (005) [5Y4/4] sealing features [012] and [014]. The deposit contained moderate quantities of angular stone fragments (aggregate) and measured 0.10 m in thickness. It was interpreted as a probable path sub-base, of late 19th/early 20th-century date, as was (007), a tightly compacted brown to red coarse sandy deposit [7.5YR5/6] with frequent limestone fragments located within the northern section of the trench underneath (005). This deposit, 0.15 m in thickness, was cut by [012] and [014] and overlay a sondage measuring 1 × 1 m.

Within the sondage, and extending across this section of the trench, was a tightly compacted grey to brown clayey sand deposit (009) [7.5YR5/2] with frequent quantities of wall plaster. The

Fig. 6. Plan and section of Trench 1b.

material, probably renovation (or demolition) deposits associated with a building that once occupied this part of the site, measured 0.15 m in thickness. Underlying context (009), and within the upper section of the sondage, was a tightly compacted, dark brown coarse sandy deposit (010) [10YR3/2] with occasional charcoal flecking and several galena glazed sherds of a late medieval Laverstock-type pottery (see Appendix). This deposit may have been an occupation layer associated with later use (011), a surface of roughly-hewn limestone blocks underlying (010) and within the base of the sondage. This surface extended into all sondage sections and may represent a rear courtyard associated with a building fronting Canonbury Street.

Located within the southern section of the trench and cut into context (007) was a linear cut oriented east–west [012]. The cut, possibly associated with Post-medieval garden drainage, was 0.45 m wide and 0.22 m deep. The length was unknown. Filling the cut was a moderately compacted, dark brown coarse clayey sand (013) [10YR4/4] with occasional charcoal flecking. The fill was sealed by (005). Within the central-northern section of the trench was a curvilinear cut oriented NE–SW [014]. This feature cut (007) and was 1.10 m wide and *c.*0.20 m deep. The fill of this feature, which was associated with Post-medieval garden activity, consisted of a tightly compacted, dark brown coarse clayey sand (006) [10YR4/3] with frequent charcoal flecking and occasional moulded plaster fragments. Also found was a cartwheel penny dating to 1797 and occasional glazed 19th-century ‘willow-pattern’ sherds (see Appendix).

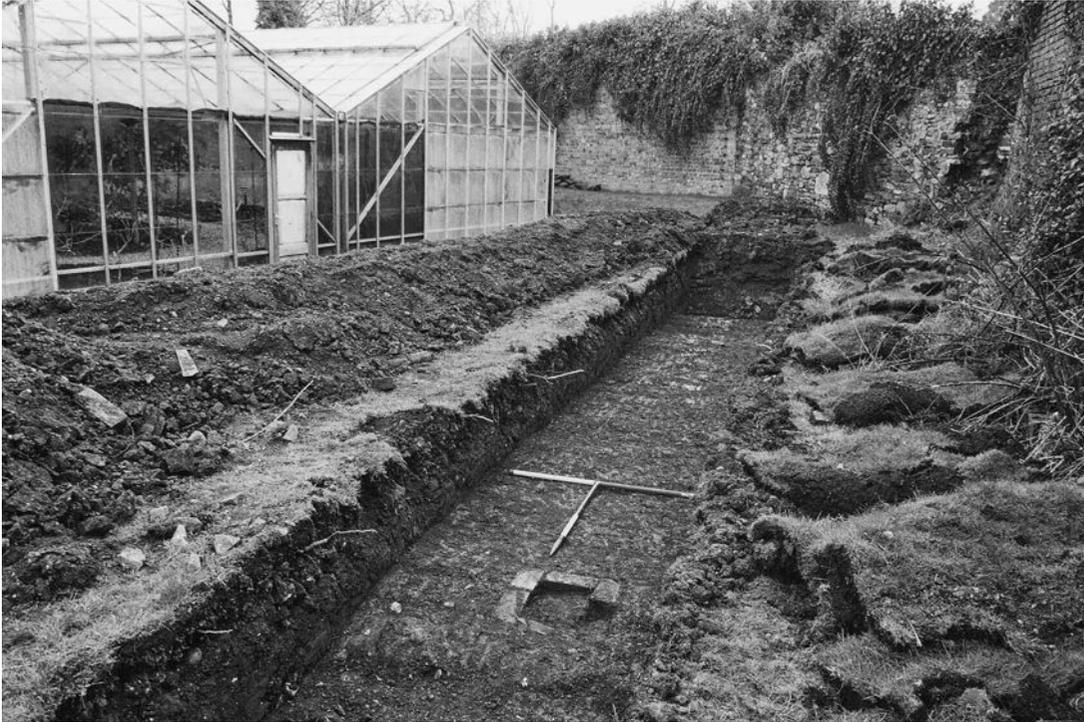
Fig. 7. Trench 4 running parallel with the western garden wall, looking south.

Trench 4 was dug parallel to the western wall of the larger garden (Fig. 7). A total of 13 contexts were recorded. Underlying the garden earth (401) was a Post-medieval accumulated garden soil with evidence of building activity (402) [10YR3/3].

The northern part of the trench revealed several features. Firstly, a linear cut [403] within natural deposits was oriented north–south. The cut, probably of 19th/20th-century date and related in some way to a formal garden bed, measured 4.00×0.40 m and extended into the south-facing section. Secondly, the cut [405] of a linear sandstone-lined and possibly ornamental garden feature (406) extended into the west-facing section. The cut, within natural deposits, measured 1.00×0.10 m and was oriented NW–SE. Oriented north–south and extending into the central balk was another linear cut [407]. This feature, a probable flower bed, measured $c.3.0 \times 0.6$ m and lay 0.40 m below existing ground level within natural deposits.

Within the central section of the trench was a probable late 19th- or early 20th-century drain housing (410) comprising mortared unfrogged red brick and measuring 0.45×0.45 m. The feature was cut into natural deposits.

In the southern area of the trench, and oriented north–south, was a linear cut [411] measuring 4.90×0.40 m. This feature was cut into natural deposits and formed part of a 20th-century drainage soakaway system that extended to the north-facing section.

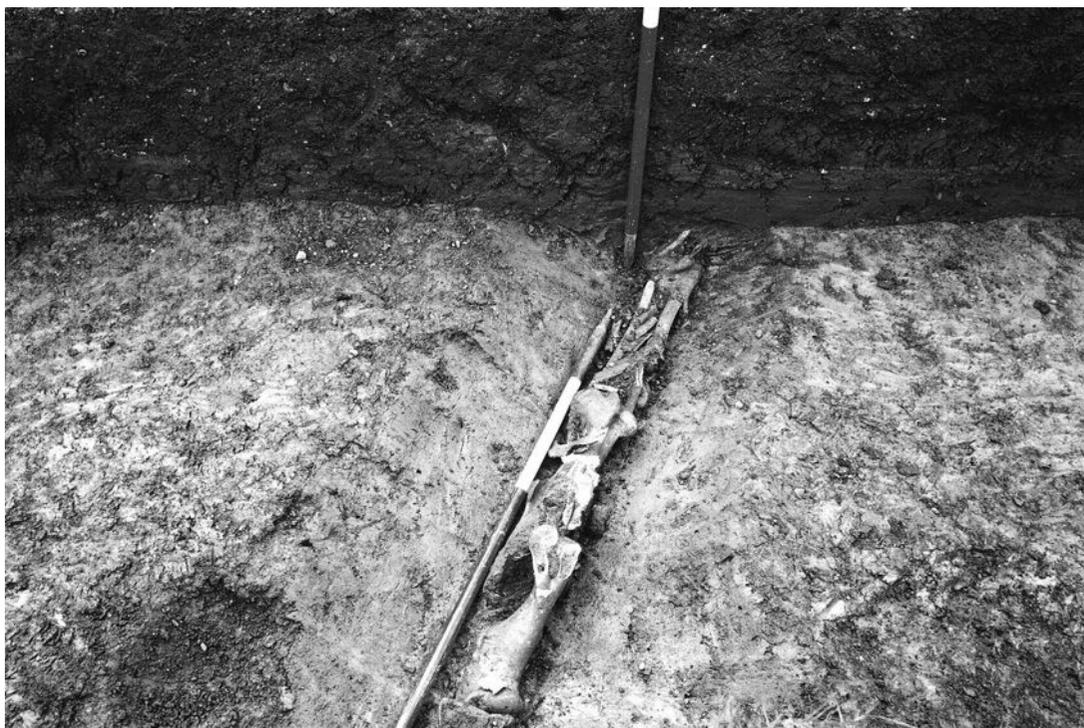
In the eastern part of the trench and extending into the north-facing section was the terminus of a probable garden bed [506]. It measured 0.7 m in length and was cut into natural deposits. In the central part and extending into the north and south sections was a linear drainage cut [508] oriented NE–SW. It measured 0.5 m in width and 0.25 m in depth. Within the cut was a bone assemblage that included cattle [*Bos taurus* dom.] and sheep [*Ovis aries*] bone (509) (Fig. 8). The assemblage consisted mainly of long bone and rib fragments and formed a bone (land) drain. The drain cut into natural deposits which consisted of a tightly compacted orange clay (510).

Fig. 8. Bone drain located within the central section of Trench 5, looking south.

19th century/early 20th-century drainage. In the same trench were the base sections of a stone garden ornament, residual in context. Unusually, in Trench 5 was a bone-lined garden drain. This feature, oriented north–south, consisted of a series of domesticated animal bones, including those of cattle and pig.

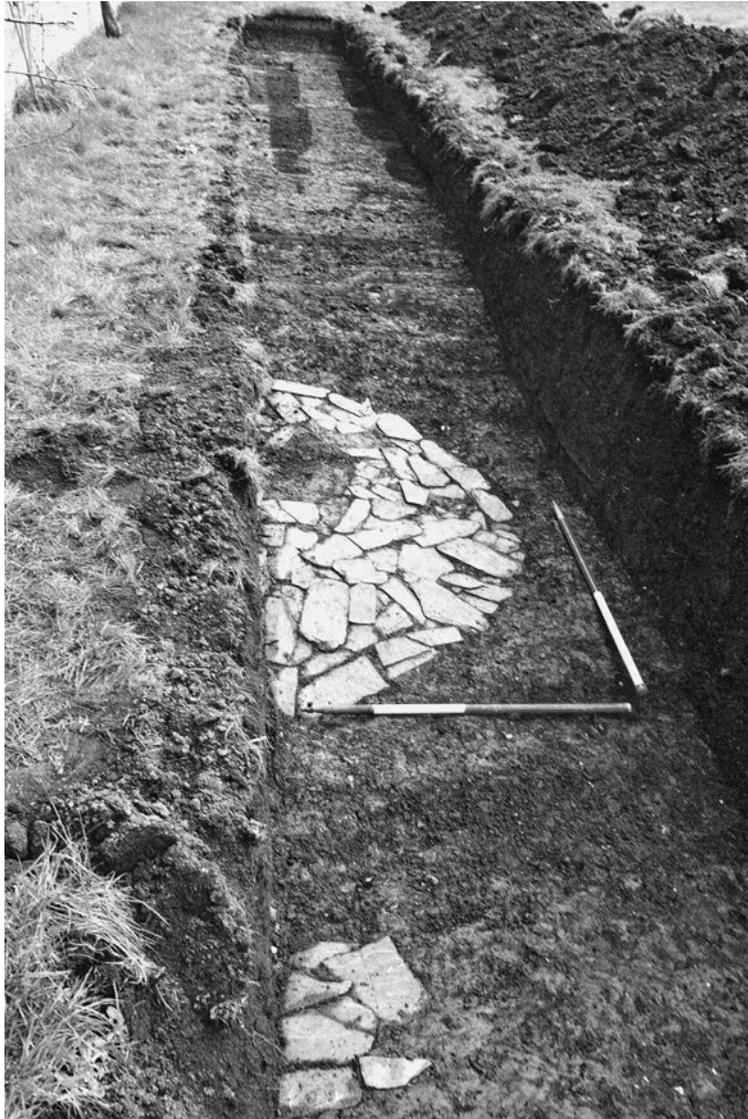
In the northern part of the trench, and extending into the west-facing section at a depth of 0.88 m below existing ground level, was a late 18th- or early 19th-century semi-circular cut [605]. The feature, which probably continued beyond the eastern section to form a circle, was 4.0 m in diameter and was cut into the natural deposits (616). It formed the foundation of a garden feature that was part of a formal garden plan with features [607], [608] and [609] in symmetry. Constructed of slate fragments, [605] probably predates the walled garden (Fig. 9), a suggestion based on the depth of the feature in relation to the hypothetical depth of the wall foundations. Within [605], and underlying the slate surface, was a moderately compacted, mid brown clayey soil (606) with occasional charcoal and mortar flecking.

Semi-circular feature [607] in the northern part of the trench overlay natural deposits (616) and extended beyond the west-facing section. It comprised a series of laid grey slate that appeared to have been deliberately cut and shaped. An identical feature was identified within the southern part of the trench. Overlying (616), it extended into the west-facing section and comprised laid grey

slate that appeared to have been deliberately cut and shaped. The central part of the trench revealed remnants of another circular formal garden feature [608] extending into the west-facing section and comprising approximately six fragments of grey slate. These presumably circular features probably form part of 18th- or 19th-century formal gardens that predated the creation of the walled gardens. Williamson (1993; 1995; 1999) has suggested that rudimentary features such as those revealed in Trench 6 are not uncommon during that period. At that time it became fashionable to create series of inorganic features symmetrically placed in order to break up a vista and provide formal views that established a contradiction between culture and nature. A similar concept is evident at the same time – but on a much larger scale – in the formal and informal layout of parkland. Other formal garden features may exist to the west of this trench.

Fig. 9. Part of a semicircular feature in Trench 6 probably predating the mid 19th-century walled garden looking south.

On the eastern side of the garden a number of formal garden features identified in Trench 6 possibly predate the 19th-century walled garden. Running through the centre of the trench was a drainage system contemporary with the walled garden and apparently aligned so that the pipe ran beneath a door opening within the eastern wall. Either side of the drain were two large semicircular features constructed of slate. Their arrangement was symmetrical and they evidently extended beyond the line of the garden's eastern wall. They may date to the late 18th or early 19th century.

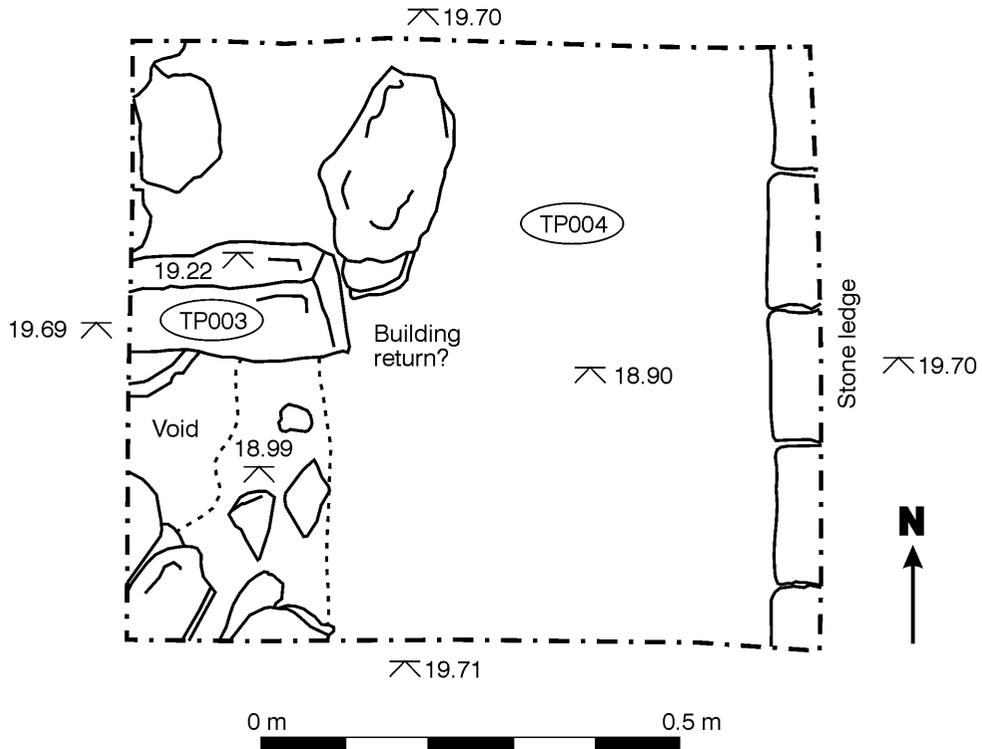
Following consultation with Gloucestershire County Council Archaeological Service it was decided to excavate further within the vicinity of Trench 1a. As the results from the trench were inconclusive a test pit (Fig. 10) was located to the west of it in order to clarify the extent of medieval activity in the area of the garden fronting Canonbury Street. The lower deposits revealed there within a sondage in Trench 1b had appeared to date to the medieval period.

Five contexts were recorded within the test pit. The top soil (0001) [10YR3/3] contained occasional 19th-century unfroged brick, charcoal and late Post-medieval pottery. Underlying context (0001) was an accumulated Post-medieval garden soil (0002). It was a moderately compacted, dark red to brown silty clayey soil and it contained moderate quantities of charcoal and mortar. Also found within the deposit were occasional CBM fragments and a single sherd of medieval Laverstock ware.

Underlying context (0002) was the possible return of a wall belonging to a medieval building (0003). This sandstone structure, extending into the northern and western sections of the pit, measured 0.46 × 0.40 m and stood 0.80 m in height. Underlying (0002) and abutting (0003) was an accumulated medieval soil. The deposit was a brown to orange sandy soil containing frequent charcoal and mortar flecking. Three medieval galena glazed Laverstock-type sherds were recovered from it.

Extending from the eastern, northern and southern sections of the pit was a mortared sandstone wall (0004) oriented north–south. The wall, possibly the lower courses of a medieval building, may be associated with wall return (0003). It was abutted by context (0004).

Fig. 10. Plan of Test Pit 1.
