**Reading the Stones: archaeological recording at Gloucester  
cathedral.**

by Carolyn Heighway  
2008, Vol. 126, 11-30

## Reading the Stones: archaeological recording at Gloucester cathedral

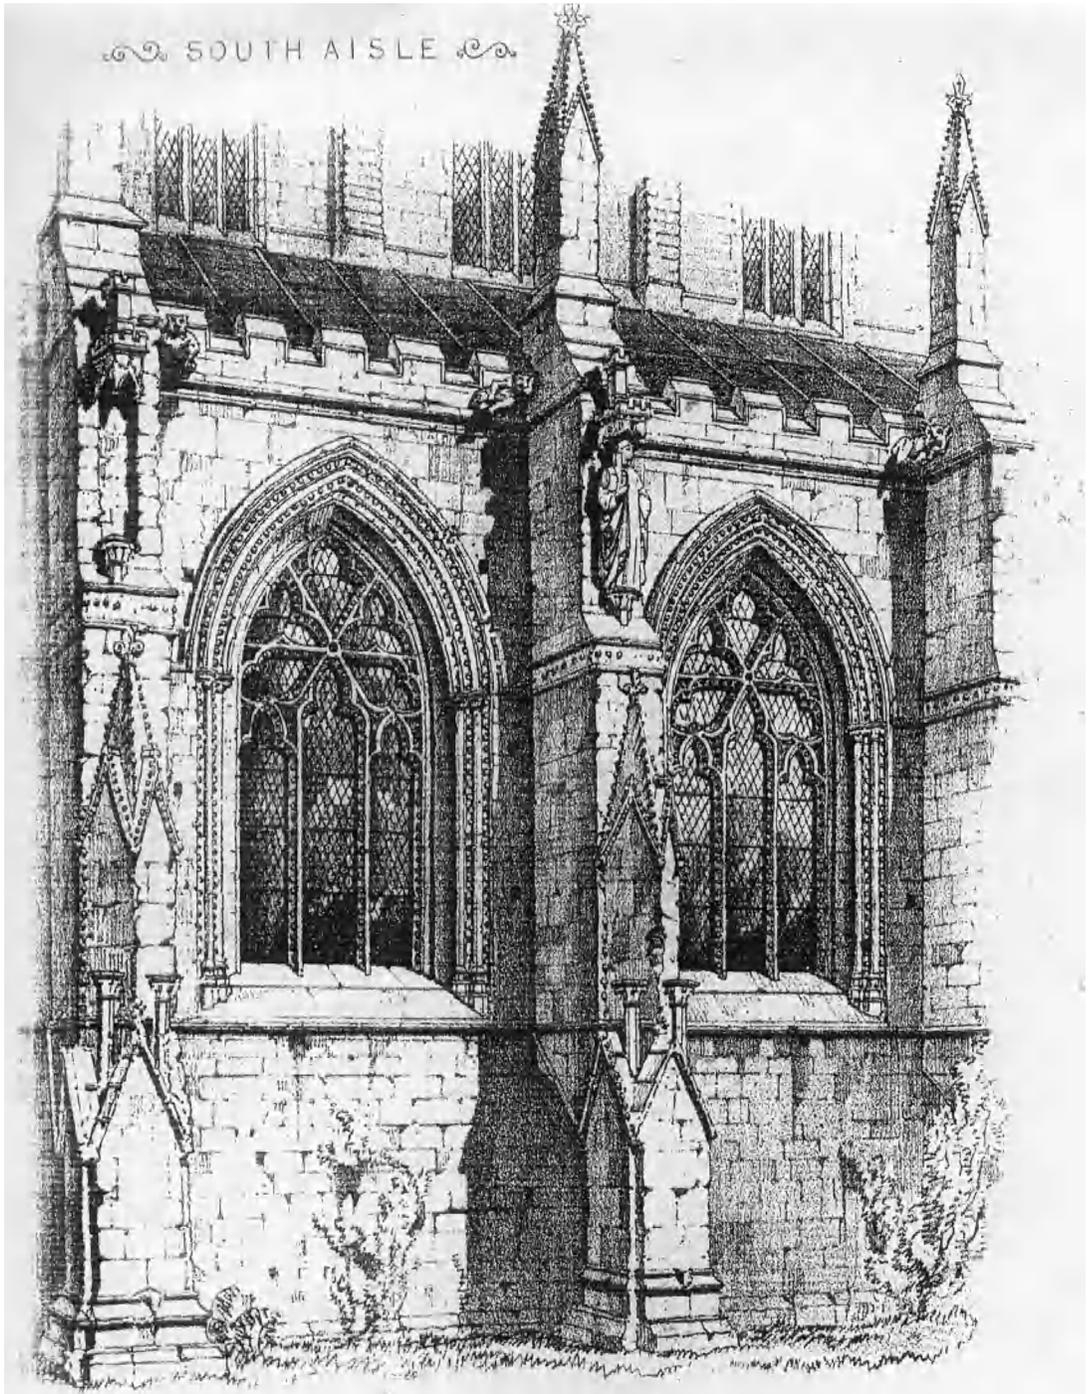
Fig. 1. Drawing of two bays of the south aisle by F.S. Waller, published as illustration 19 in his *General Architectural Description of the Cathedral Church formerly the Abbey Church of St Peter at Gloucester* (1856).

The transformation of the church to a Gothic structure could be said to begin in 1318 with the construction of the south aisle (Fig. 1).<sup>18</sup> The new façade had large windows and flying buttresses decorated in the latest local fashion of ballflower ornament.<sup>19</sup>

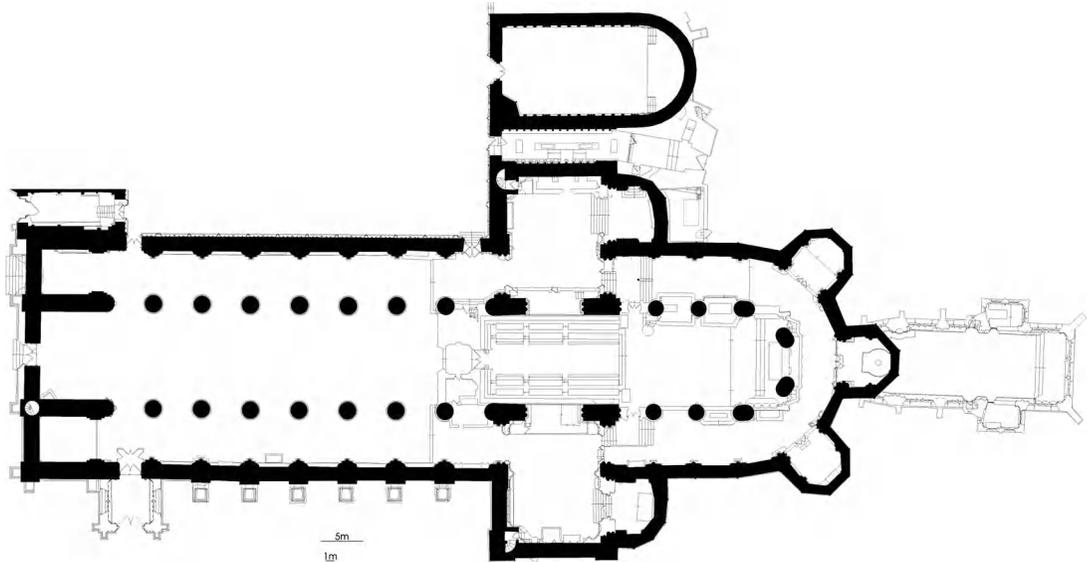
Fig. 2. A plan of Serlo's church by Gemma Bryant based on a survey by Cartographical Surveys Ltd of Worcester.

Serlo’s church, shown here in a new plan and draft 3D model (Figs. 2 and 3) was of characteristic Romanesque thick wall construction (up to 1.5 metres – i.e. 5 feet – thick). The crypt remains much as it was built soon after 1089; though due to subsidence it had to be strengthened a decade

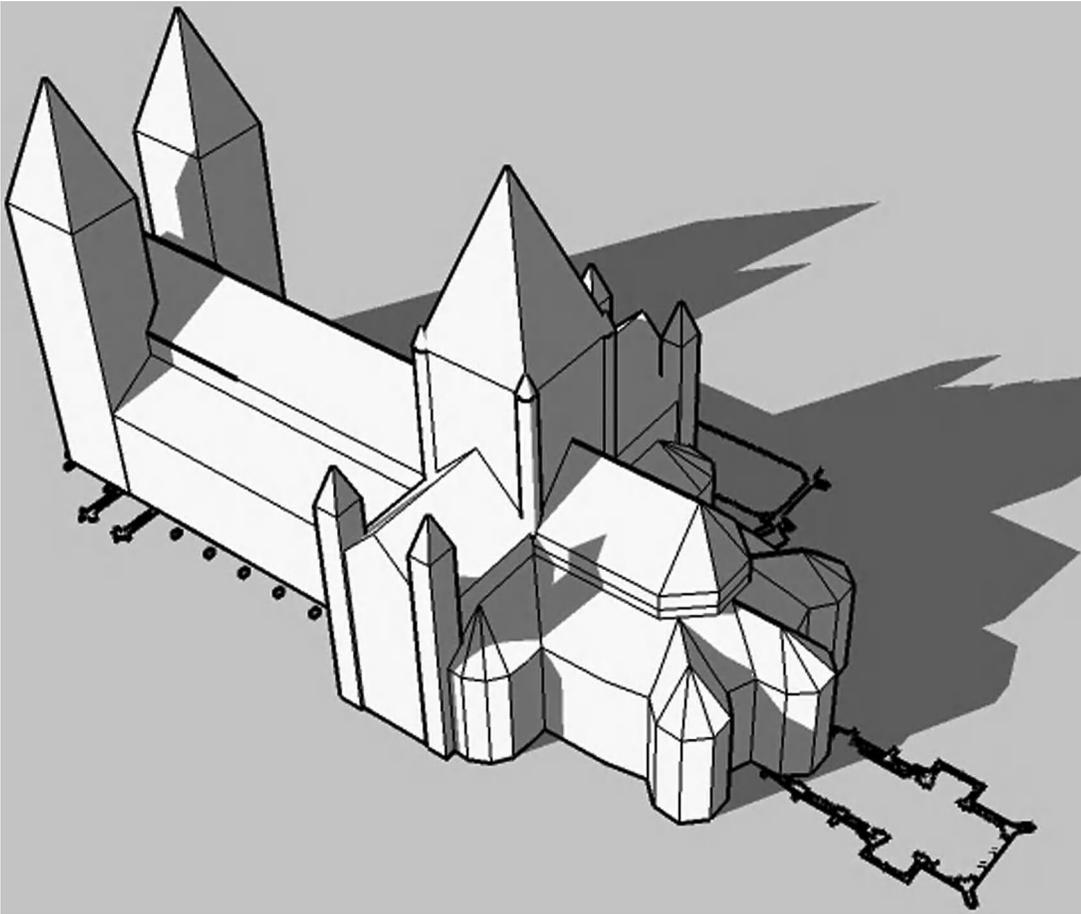
Fig. 3. Model of Serlo's church constructed in Sketchup by Gemma Bryant using dimensions from new surveys. A reconstruction by C. Wilson is reproduced in D. Welander, *History, Art and Architecture of Gloucester Cathedral* (1991), 75.

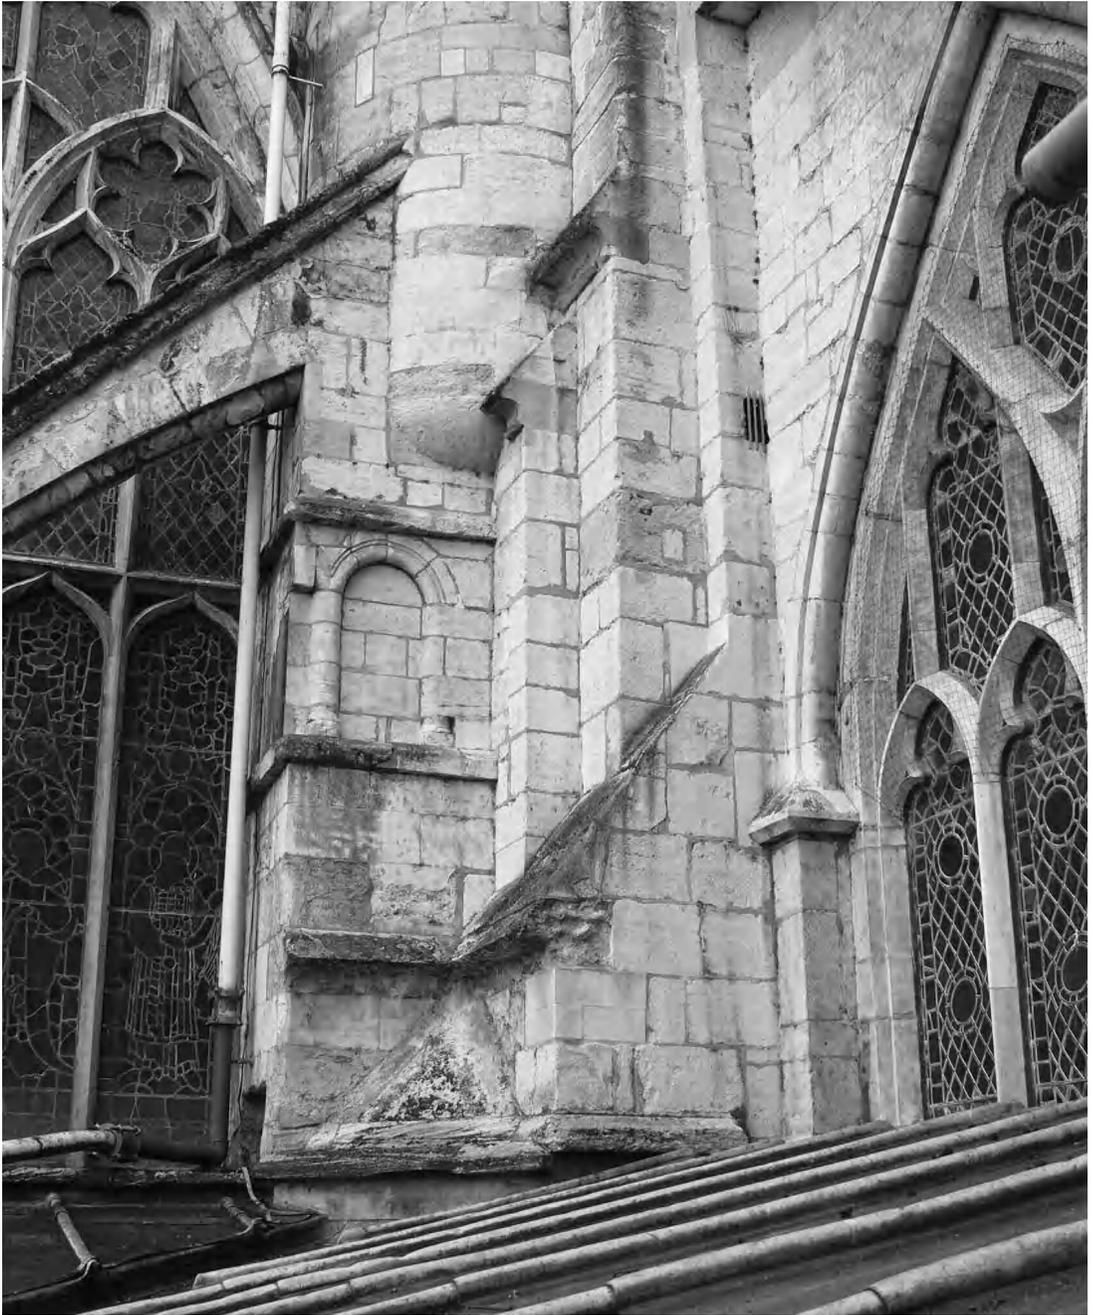
Fig. 4. The remains of a bay of blind arcading, and the lower part of the Romanesque turret, on the north side of the choir (photograph by C. Heighway).

The crossing tower had a round turret at each corner.<sup>30</sup> The base of one of these can still be seen (Fig. 4) and the remains of two more are visible in the nave roof space (Fig. 5). The tower may have been decorated with blind arcading, like that at Tewkesbury.<sup>31</sup>

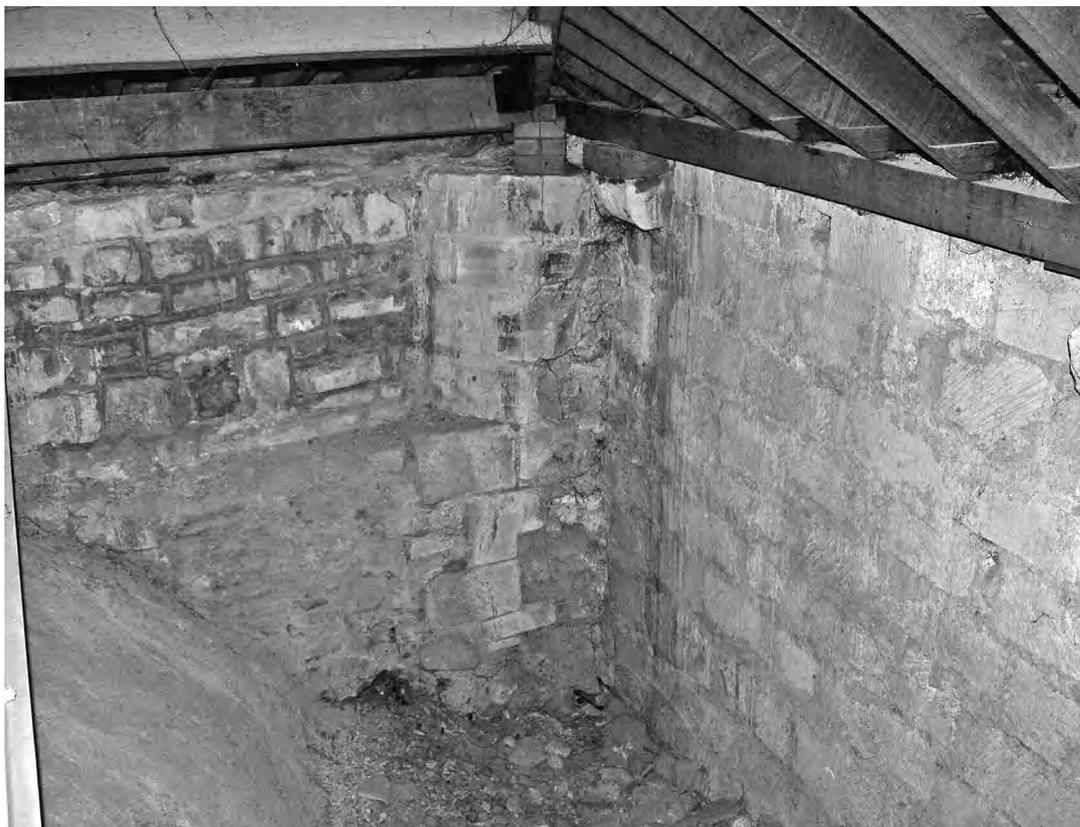
Fig. 5. The remains of one of the Romanesque turrets in the nave roof space at the east end (photograph by C. Heighway).

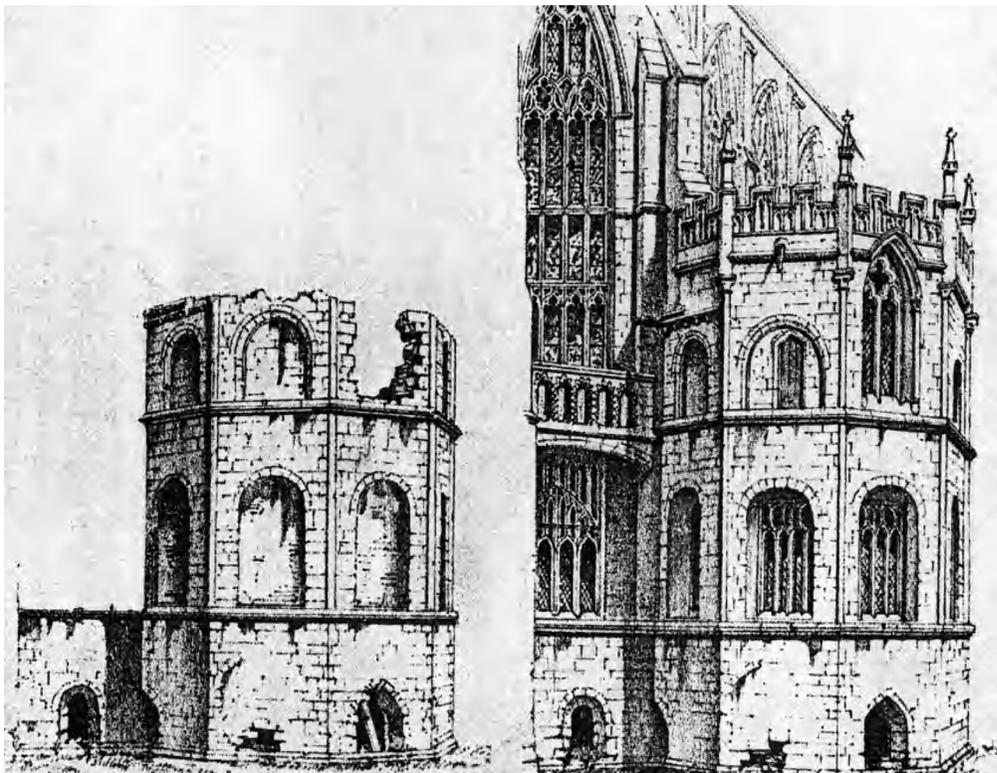
Fig. 6. Drawing of the north-eastern chapel by F.S. Waller, published as illustration 13 in his *General Architectural Description of the Cathedral Church...at Gloucester* (1856).

The south ambulatory was repaired in 2000 giving the usual opportunities for record. F.S. Waller's drawing of the corresponding north-eastern chapel shows how the 14th-century adaptations were made (Fig. 6) and Bagshaw's analysis of the ambulatory adds detail,<sup>34</sup> the south-eastern chapel being adapted in the same way. The walls of the chapels and ambulatories were raised and the roof lowered (to give more room for clerestory windows); the windows were enlarged and new tracery inserted.

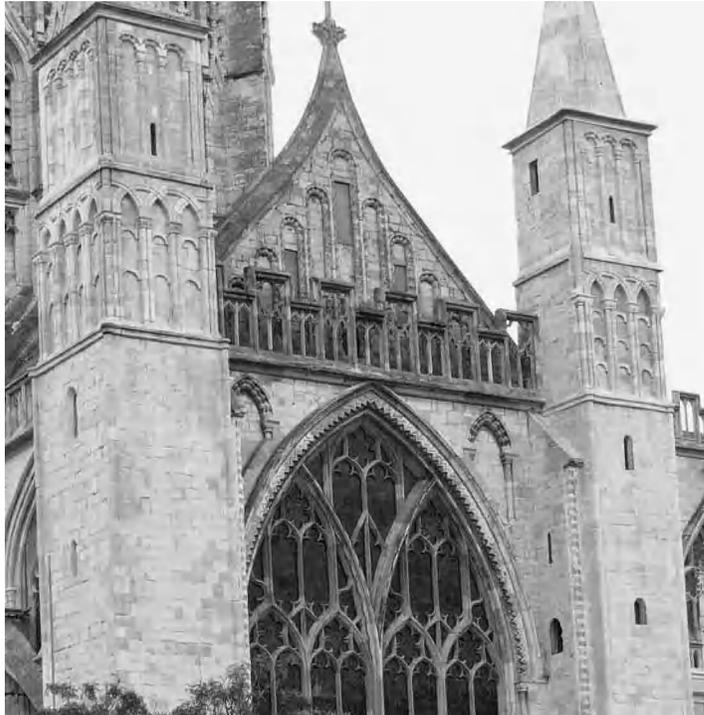
Fig. 7. The south transept (photograph by C. Heighway).

Repairs to the south transept in 2002 revealed that the two upper stages of its turrets (Fig. 7) are additions of the 12th century.<sup>37</sup> Not only do they use different stone sizes and mortar, they also have chevron decoration re-used in plain walling. These 12th-century upper stages originally had string courses of dark green sandstone. The sandstone was replaced in the 19th century with Bath stone, which in turn had to be replaced in the 1990s.<sup>38</sup>

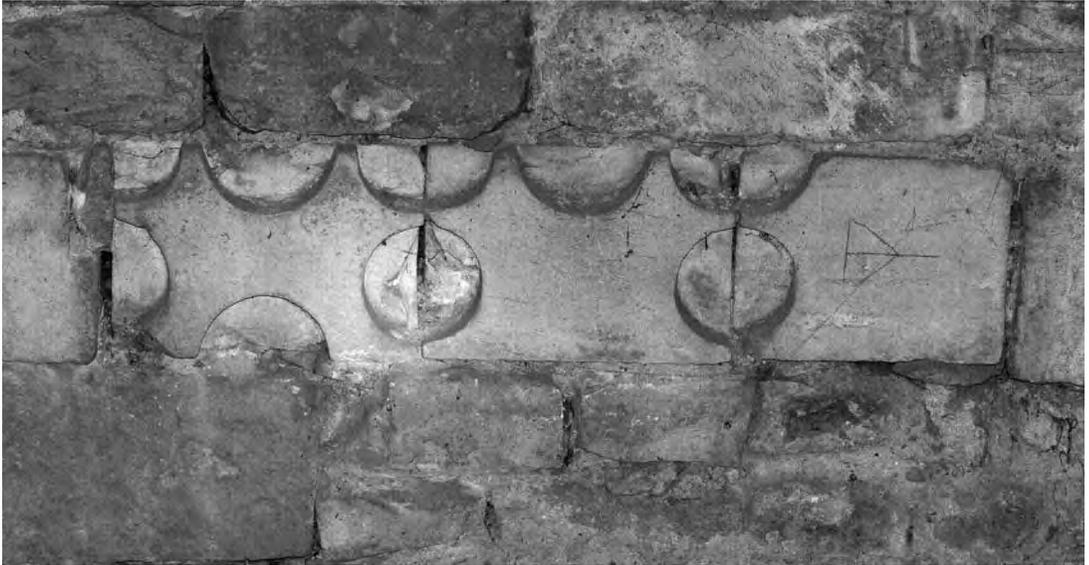
Fig. 8. Recessed circles, with Romanesque mason's mark, on a stone re-used in the raising of the nave walls (photograph by C. Heighway).

Work on the clerestory produced a different example of the ‘contrasting stones’ phenomenon. Bagshaw noticed, built into the nave walls which were heightened in the 14th century, a number of stones cut with a pattern of recessed circles and displaying Romanesque masons’ marks and tooling (Fig. 8).<sup>39</sup> The pattern can be arranged to fill a gable end. This sort of decoration can be seen on Romanesque churches elsewhere; the circles were originally filled with contrasting stone. It is unclear where the circle patterns were originally positioned, perhaps the west end. Their unweathered nature hints that they were rapidly superseded.

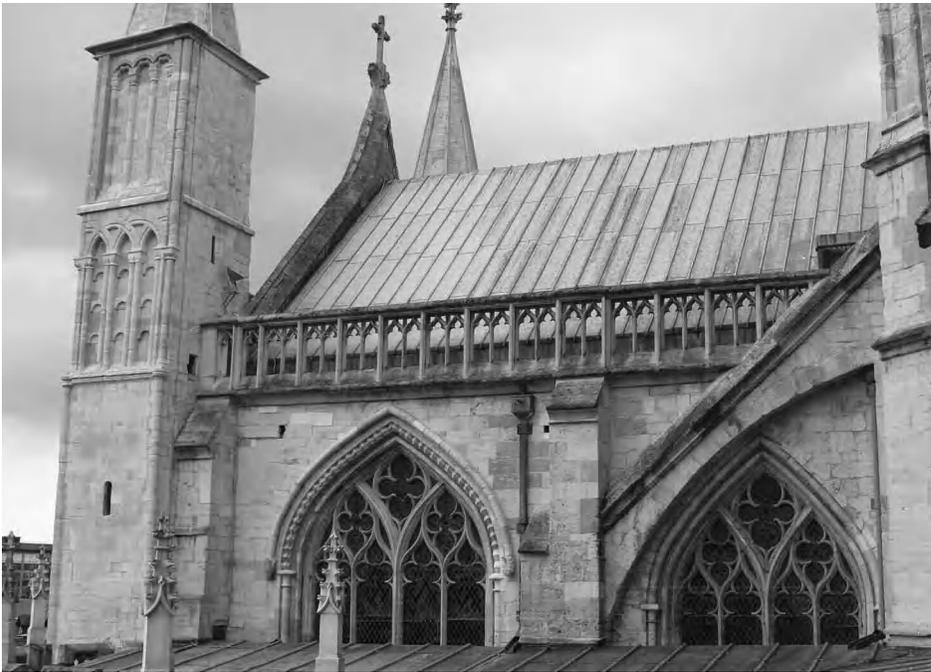
Fig. 9. The east side of the south transept, showing re-used Romanesque decoration (photograph by C. Heighway).

and capitals were re-used as window jambs.<sup>41</sup> The east elevation (Fig. 9) uses Romanesque chevron and roll-mouldings on the new 14th-century window arch, combined with 14th-century polygonal capitals and a re-used Romanesque beast-head label stop.<sup>42</sup> Some of these imitations of 12th-century work have in turn been recreated by today's masons.

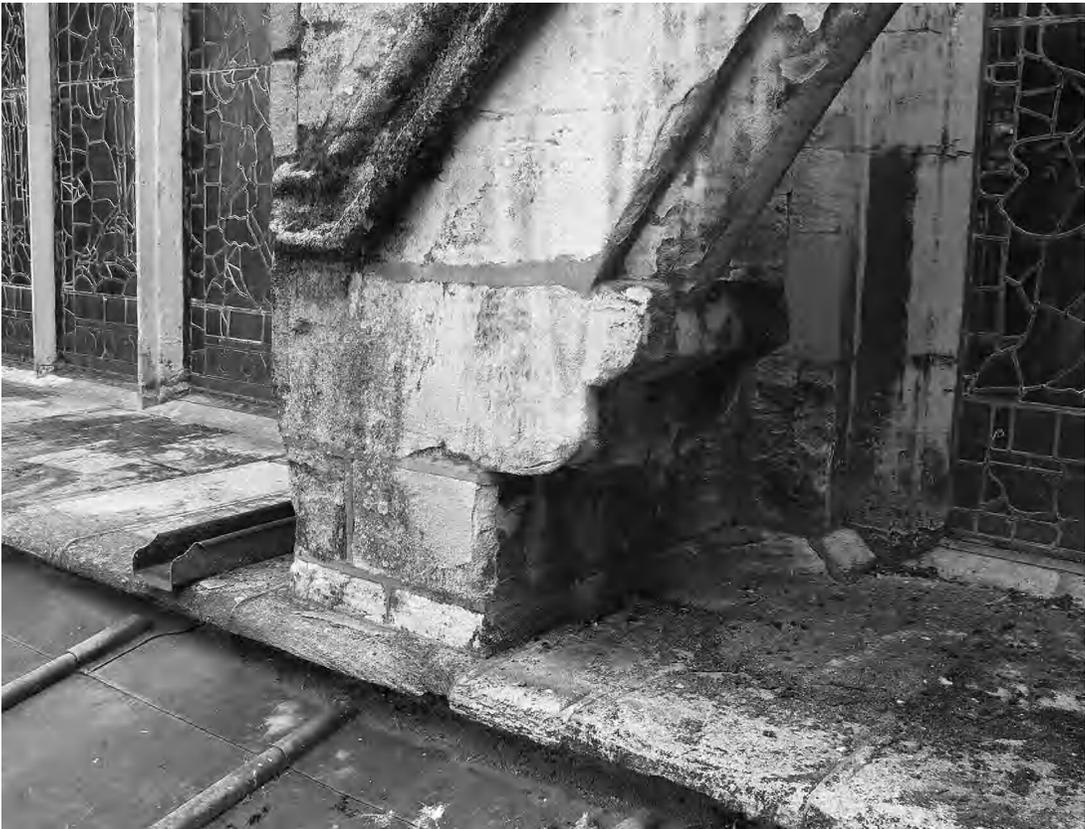
Fig. 10. Flying buttress formed out of Romanesque soffit rolls, and a re-used Romanesque capital, on the north side of the choir (photograph by C. Heighway).

The south choir elevation appears from a distance to be new 14th-century work, but the window jambs are lengths of Romanesque shaft joined together with Romanesque capitals and bases used interchangeably.<sup>43</sup> Even some of the roof-space windows have Romanesque jambs with a window-head new-made to match in the 14th century.<sup>44</sup> And of course plenty of Romanesque detail was made use of as recycled stone. The flying buttresses against the tower are made of soffit rolls from a Romanesque arch and one buttress springs from a massive capital (Fig. 10): these are probably from the Romanesque choir apse.

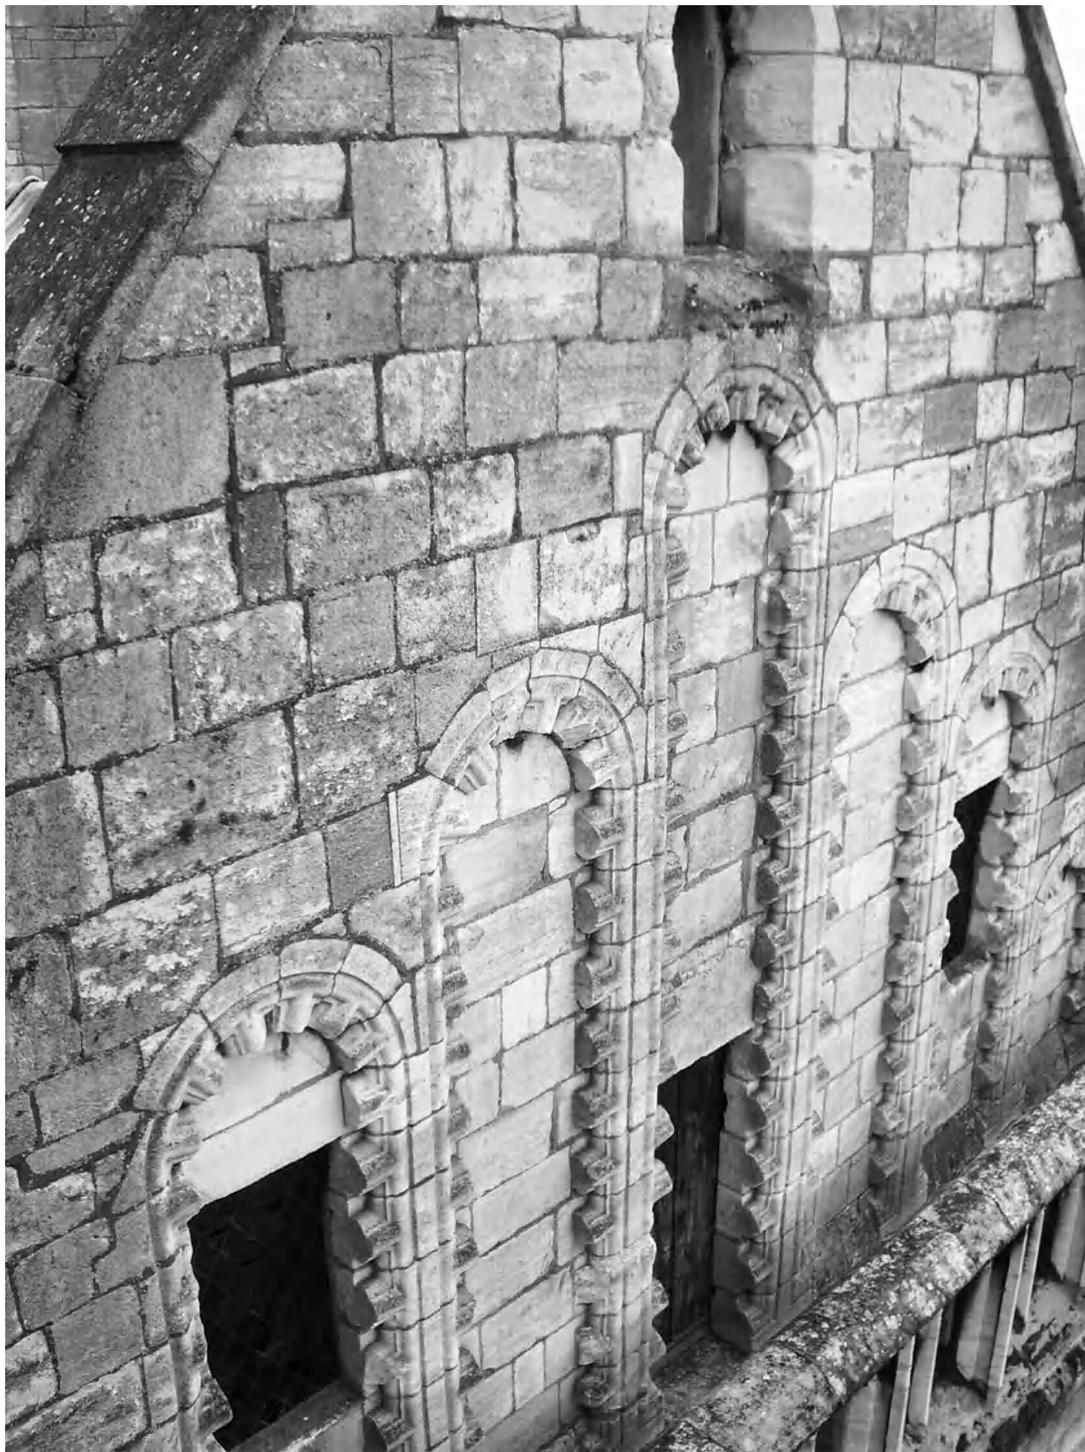
Fig. 11. The north gable of the north transept before restoration in 2007 (photograph by Rita Dawe).

The north transept gable<sup>45</sup> was, like that on the south, rebuilt re-using the Romanesque arcading (Fig. 11); this is executed in an unusual style which the cathedral masons call ‘T-moulding’. The detailed record by the master mason shows how the gable was remade: the arcading is re-used architecture, most ashlar were re-used from the previous gable, and a few stones were cut new. At the top of the gable is a charming lion which may also be re-used Romanesque (Fig. 12).

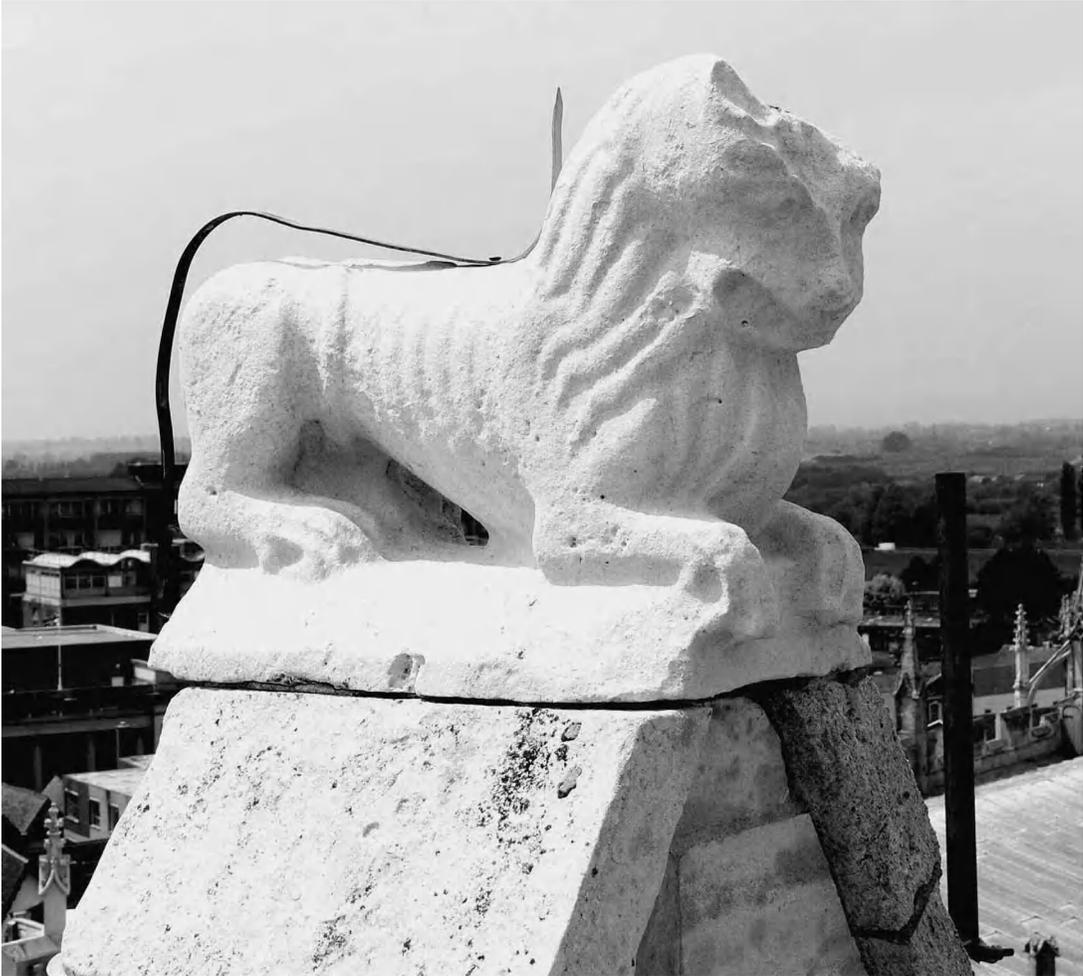
Fig. 12. Lion sculpture at the apex of the north transept gable (photograph by Richard Bryant).

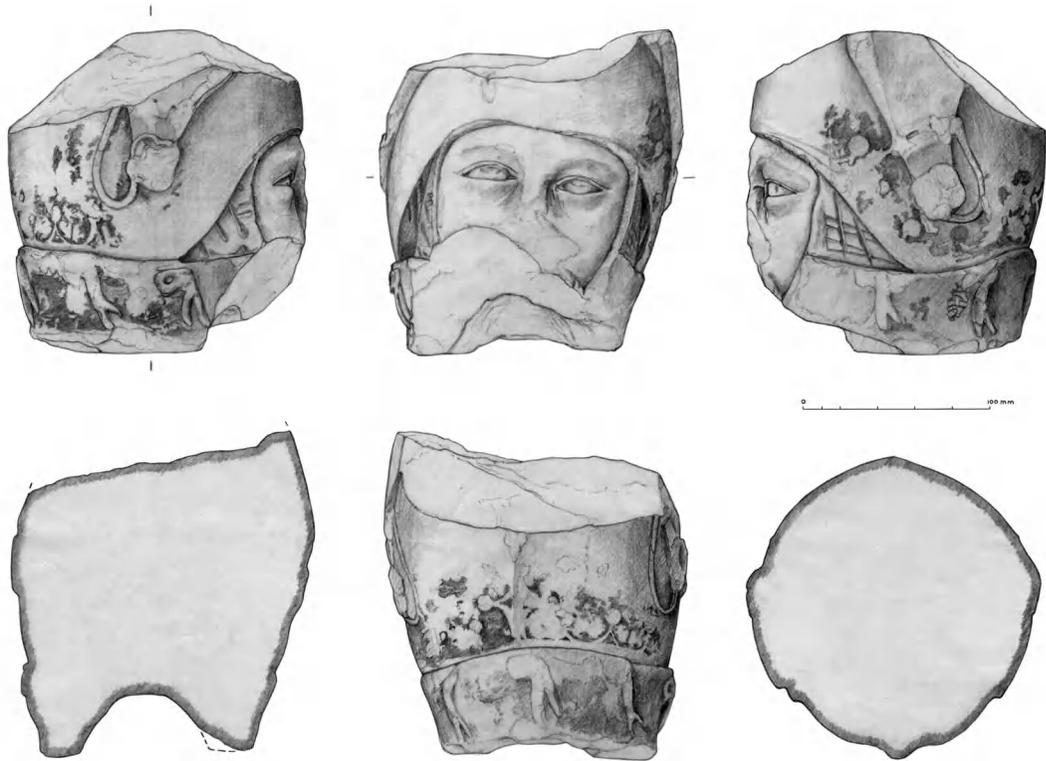
Fig. 13. Mid 15th-century sculpture of a knight's head (drawing by Richard Bryant).

Survivals of medieval sculpture at Gloucester cathedral are minimal: the few remaining pieces are exceedingly battered. So it was exciting to find, during alterations to the cloister garth in 1996, the mid 15th-century stone head of a knight, wearing armour of the time with every detail beautifully portrayed (Fig. 13).<sup>50</sup> The figure would have been about half life-size and was painted

using gold and silver leaf, vermilion lead white, charcoal black, yellow earth, and red lake. It could have been a flanking figure from a tomb or reredos.
