Archaeological Investigations at the Parish Church of St John Baptist, Cirencester, 2008 and 2009

By PETER DAVENPORT

INTRODUCTION by Mark Collard and Peter Davenport

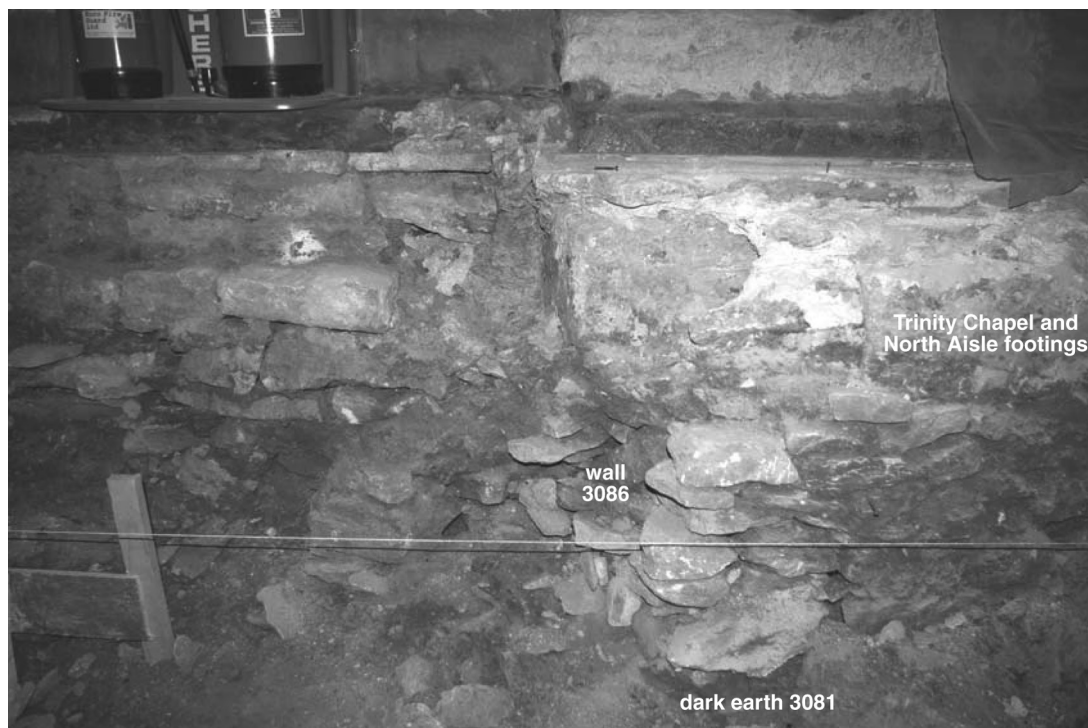
Fig. 4. The 'dark earth' 3081 and stub of early footing 3086 under the Trinity Chapel.

walling running north/south (3086), incorporated in the later east/west footings, but without any obvious footings (Figs. 2 and 4).

The wall under the north arcade was less visible, but was still noted under most of the piers (Fig. 2). It projected a maximum of almost 1 m north of the central pier base, giving an offset (if this is typical) of *c.*0.50 m to the north from the present arcade. However, this particular projection (3059) is almost opposite the projecting north/south stub in the north aisle north wall footing, 3086, and may just represent the junction with that wall. Wall 3086 was only *c.*0.95 m wide and had relatively shallow footings (Fig. 4).

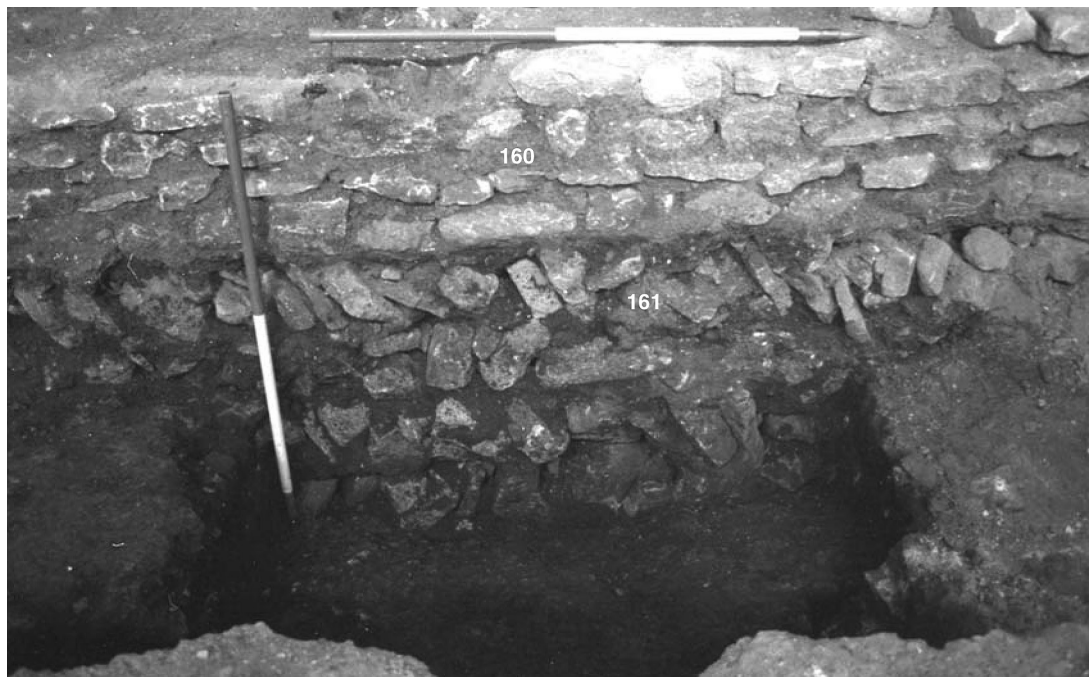
Fig. 5. The wall 160, and footings 161, under the south aisle wall.

Wall 160 projected *c.*0.80 m from the inner face of the 15th-century wall above it, and about 0.5 m from the west wall. A service trench had been dug through the doorway from the south aisle into the south porch at some time in the past, presumably when the 19th-century works were carried out. It was bridged by grave ledger stones, forming a low tunnel under the porch floor. This trench had cut through wall 160, showing that it was up to 2.64 m (8' 8") wide (Fig. 2, 160). Where it was traced under the nave arcades the wall was more like 1.9 m wide (6' 2¾"), though often truncated by sleeper walls of the 1867 floor. Its centre line was generally 0.7 m to the south of the present south arcade's centre line. That this was likely to be the original width and alignment was shown by the survival of both wall faces at the east end of the south arcade and under one or two of the nave arcade piers, the 1867 sleeper walls having been set against the face (Fig. 10). The footing was originally continuous, only missing where later disturbance cut across it leaving gaps of as little as 0.30–0.40 m (although often considerably more). In the centre of the south arcade a contemporary channel in the north-west corner of the footing (380) suggests a drainage arrangement, which may have been for a font or a water stoup (Fig. 2). Its further route was removed by later disturbance.

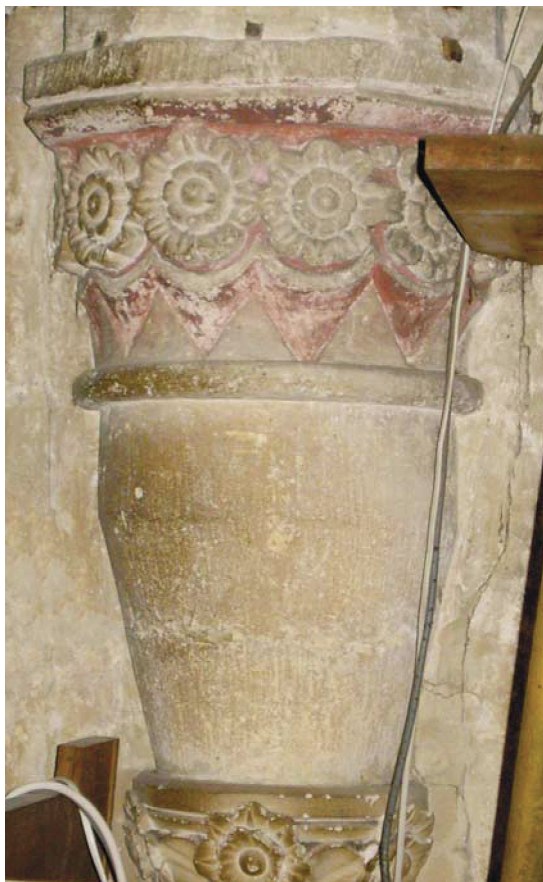
Fig. 6. The Romanesque capital and cut-back shaft of the western respond of the south chancel arcade.

In most places the Period 3 wall and footings was seen to be quite distinct from the yellow-brown-mortared footings and walling of the present church built directly off it. In other places, however, it could be seen to be integral with the existing above-ground fabric. At the east end of the south aisle, for example, the wall to which respond 2 is attached (Fig. 2) was of one build with the Period 3 footings. It has been much altered, but contains a fragment of round-arched recess on its western side (Rodwell 1997, 32). On its eastern side a flat respond has had its corners bevelled and a shaft removed from it at some time in the past. The temporary removal of the organ loft revealed the upper part of this shaft and its late Romanesque capital forming the western respond to the south chancel arcade (Fig. 6). A date of 1170–90 would be appropriate stylistically.

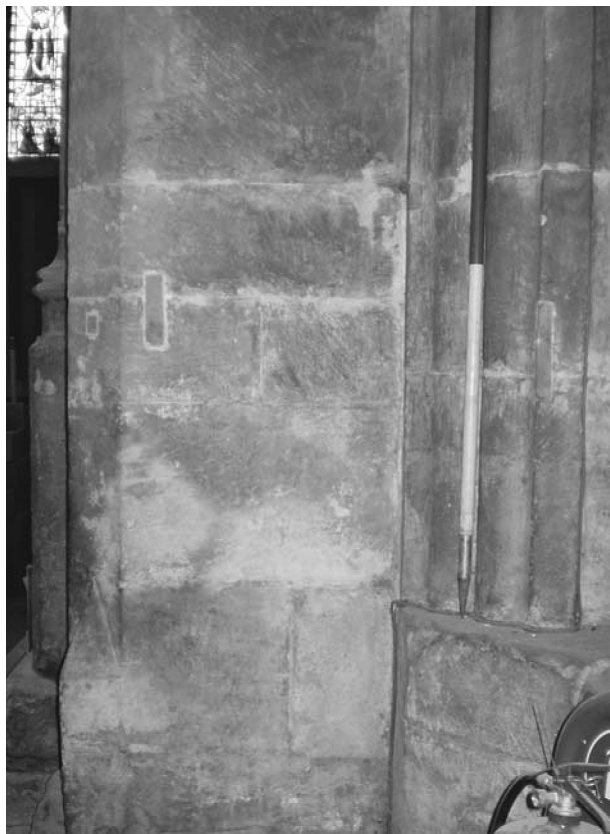
Fig. 7. The base of the southern tower arch jamb, showing junction of early and later work (to left and right, respectively), and broach stop to chamfer.

The distinctive Period 3 footing was also seen under the tower/nave junction. Again, parts of the above-ground fabric were integral with it. The jambs of the outer order of the tower arch were set directly on two courses of large, square-cut slabs of limestone about 0.25 m thick, which in turn were set on the older reddish-brown mortar footings (140 and 375) of the west end (Fig. 3, Section AA) and were bonded in the same mortar. The lowest part of these tower-arch jambs are also stratigraphically older than the main structure of the tower (Fig. 7). This lower masonry has different coursing and a different plinth design (a simple hollow over a half round) from the rest of the tower masonry. It has also been cut back for the jamb mouldings of the tower arch on the south side and dogged into on the north, suggesting that as much as the lower 1.5 m might be older masonry. The chamfer on this masonry has a broach stop, which was certainly in use in the 13th

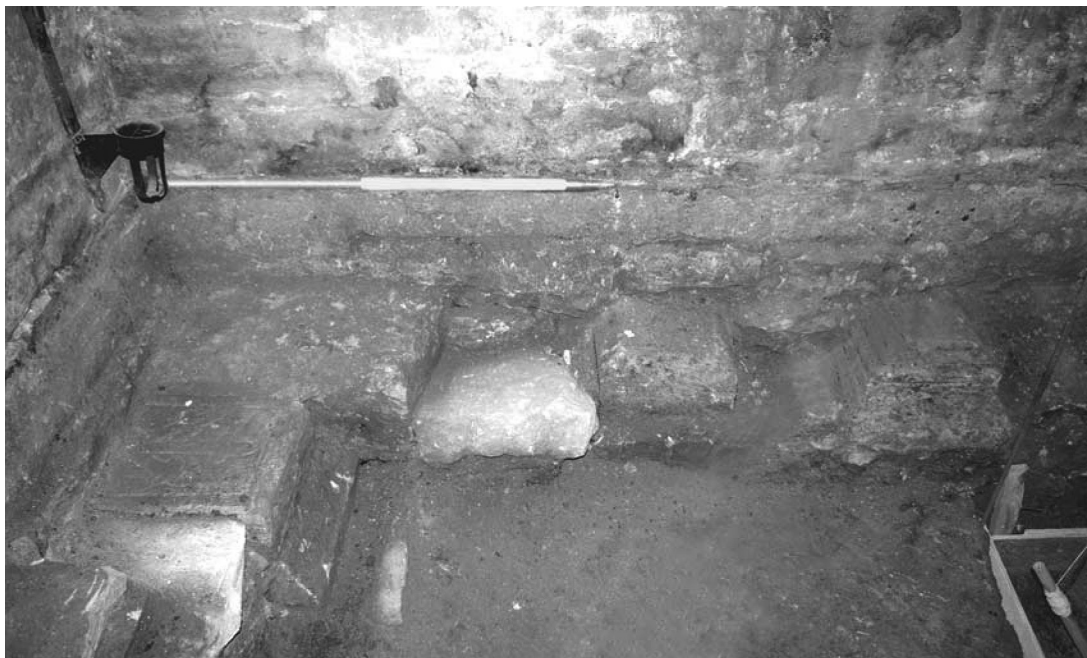
Fig. 9. Medieval grave covers used in the north aisle footings.

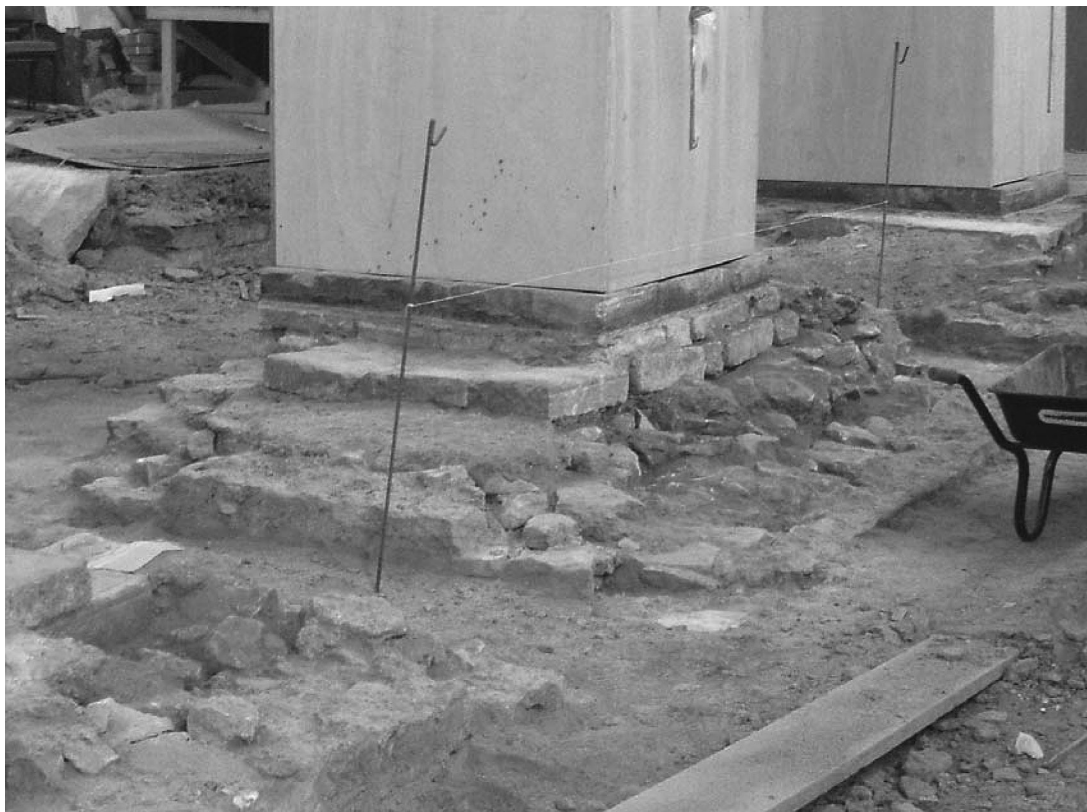
Fig. 10. The multi-period base of the central pier in the south nave arcade.

The nave was rebuilt within the existing aisles between 1514 and c.1530 (Verey and Brooks 1999, 250–1). Shallow stone platforms, c.1.2–1.5 m square, were built on the earlier Period 2 footings in limestone set in yellow-brown mortar at each pier position (Figs. 8 and 10). There were smaller platforms for the east and west responds. The platforms were levelled with reused medieval grave slabs, which were set just below floor level, and finished with ashlar plinths at floor level. The pier bases were separate and not linked into one foundation wall.

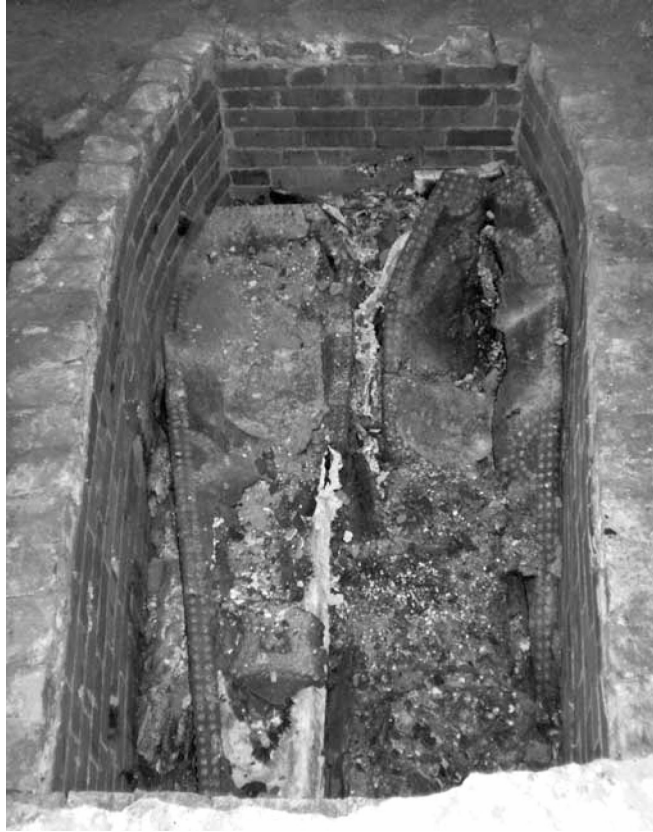
Fig. 11. The double Clutterbuck and Cripps vault after removal of the cover slabs.
