THE SOUTH TRANSEPT OF
GLOUCESTER CATHEDRAL, 2002-3:
ARCHAEOLOGICAL RECORDING

Steve Bagshaw

Gloucester Cathedral
Archaeological Report 2002/C
Cathedral project no 1900-5071

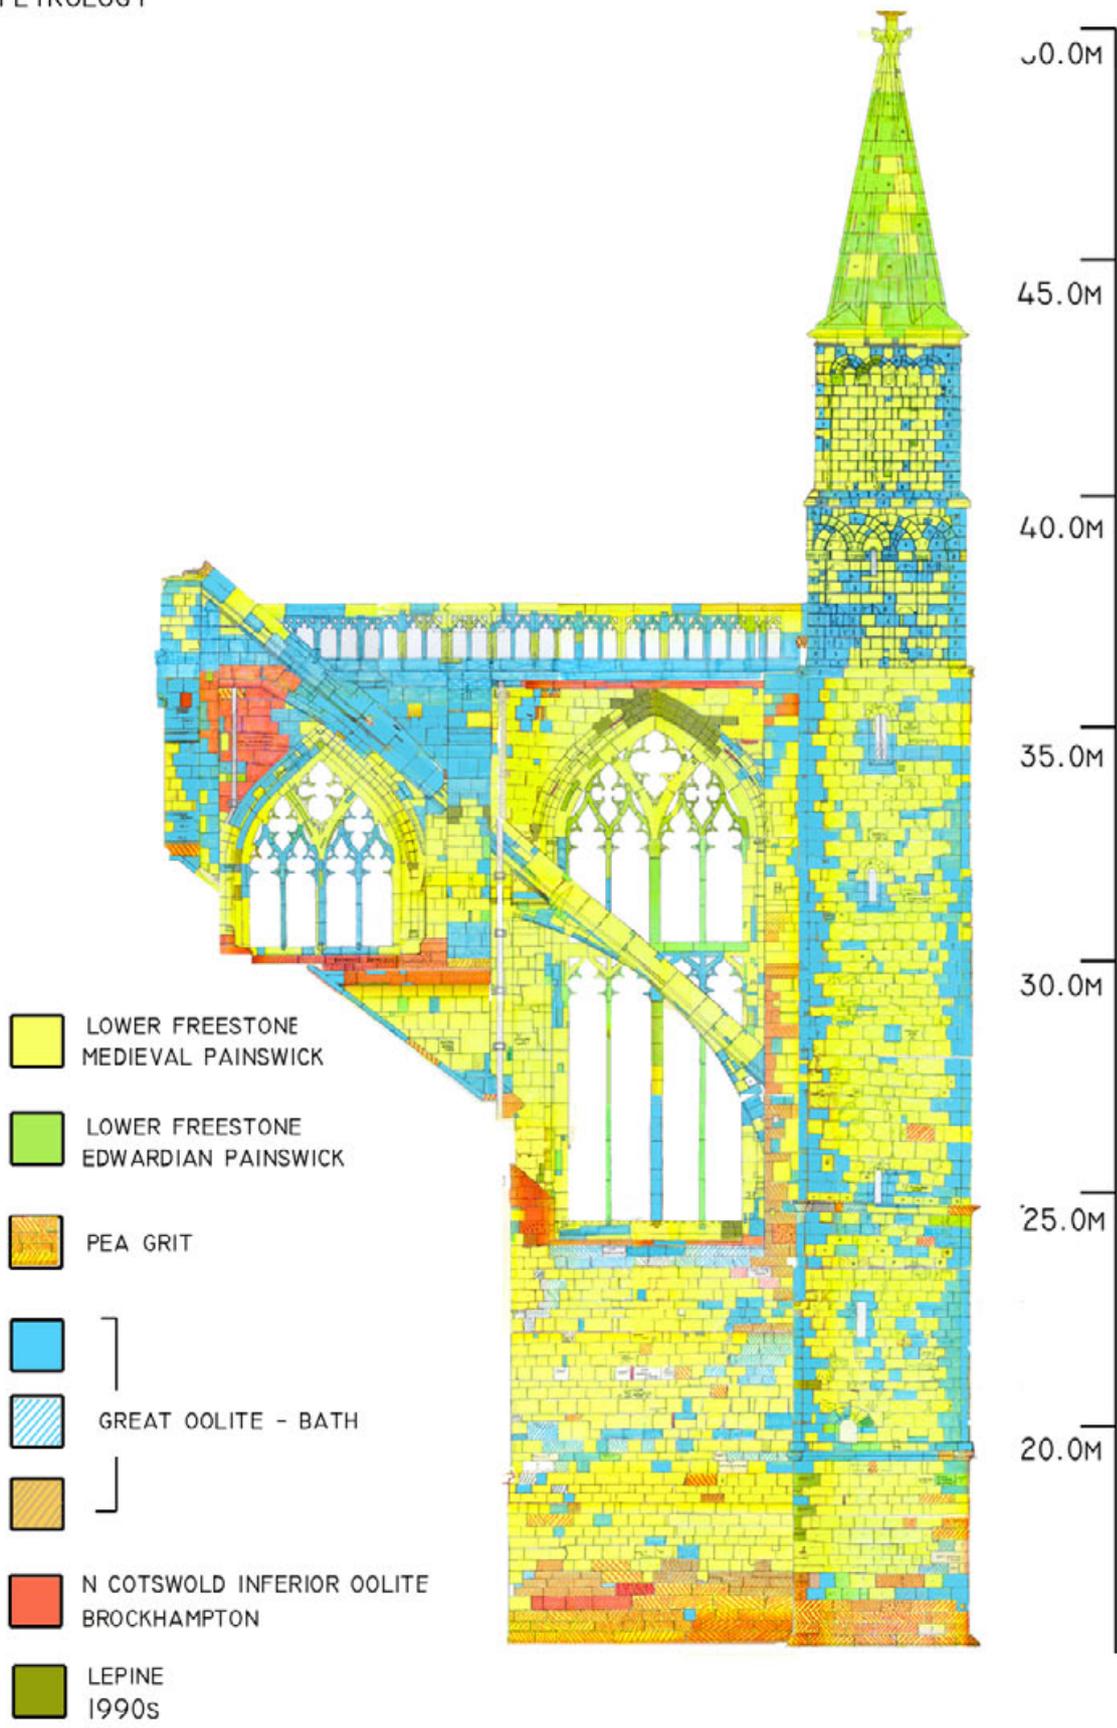
FIG. 2 GLOUCESTER CATHEDRAL ~ SOUTH TRANSEPT, WEST ELEVATION

PETROLOGY

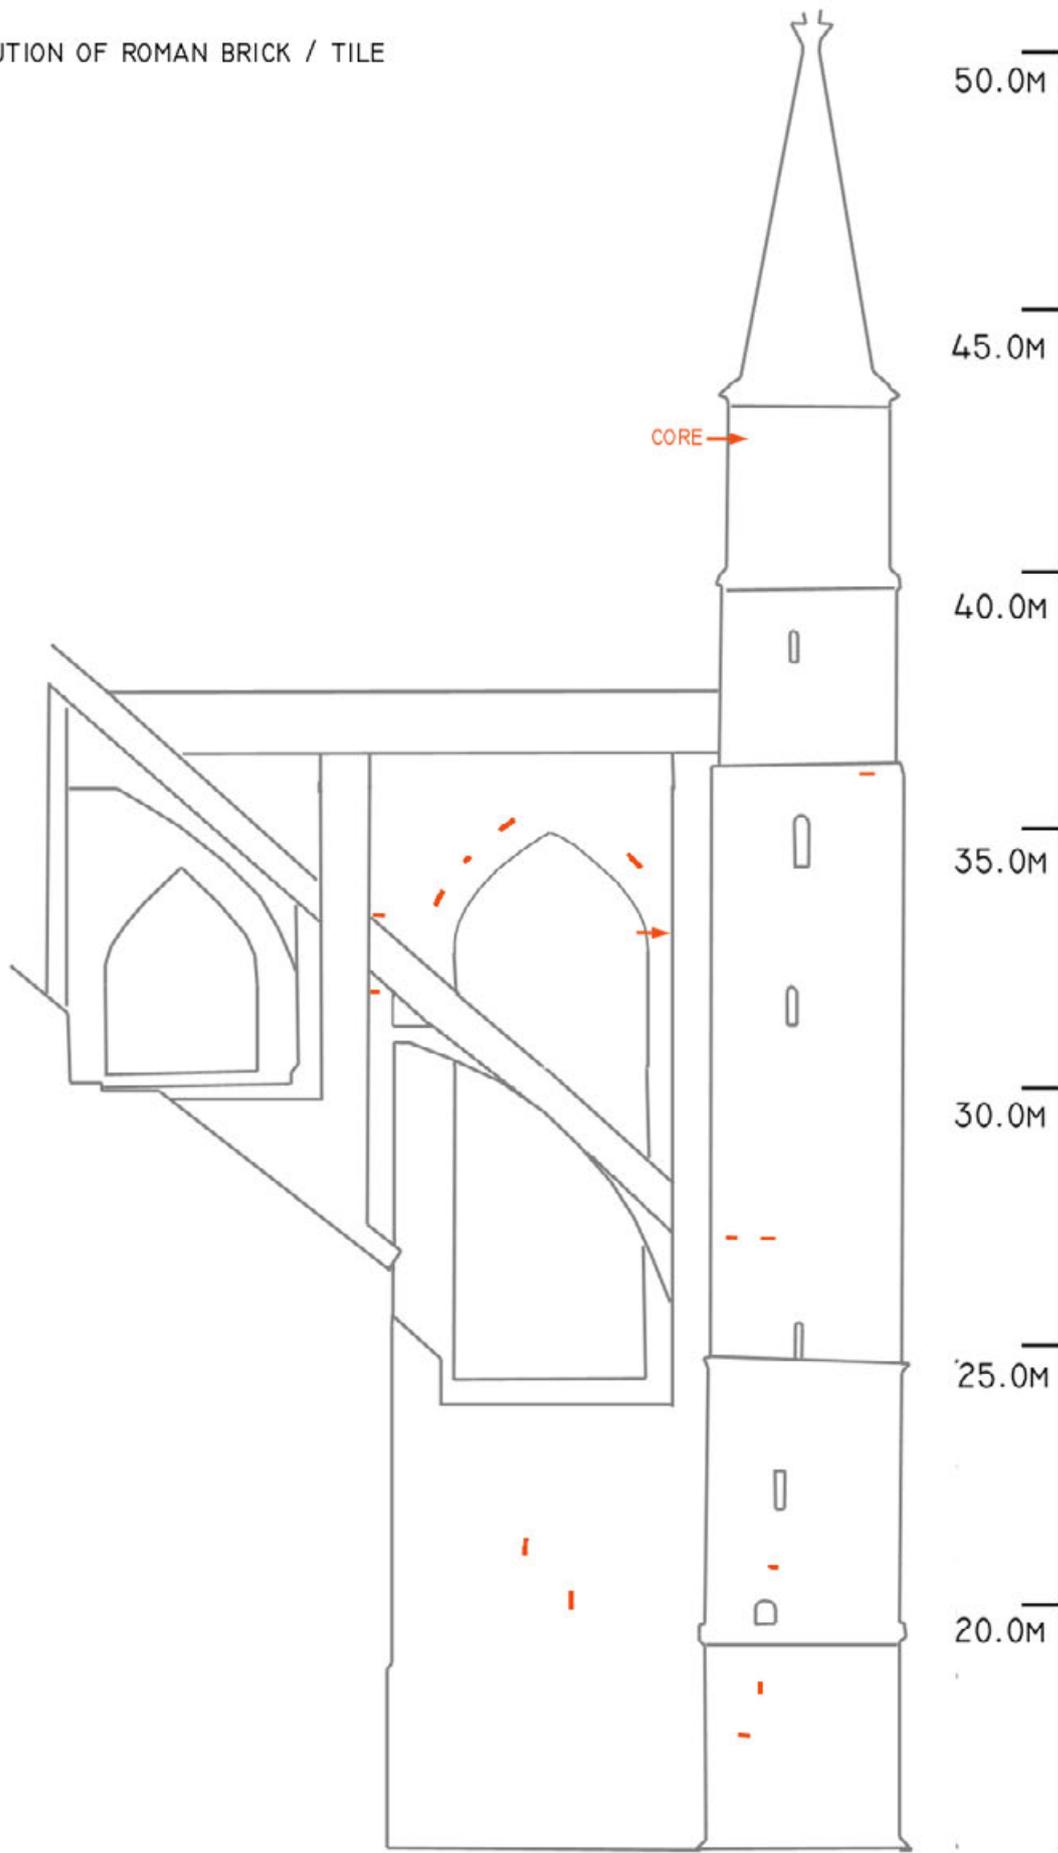
FIG. 4 GLOUCESTER CATHEDRAL ~ SOUTH TRANSEPT, WEST ELEVATION

DISTRIBUTION OF ROMAN BRICK / TILE

After the joints had been raked out it was possible to see thin pieces of stone or ceramic tile deep in the joints and placed so as to compensate for small variations in the dimensions of the ashlar. These slithers of stone were pieces Blue Lias Limestone, Stonesfield Slate and Old Red Sandstone, as well as Roman brick/tile (Fig. 4).

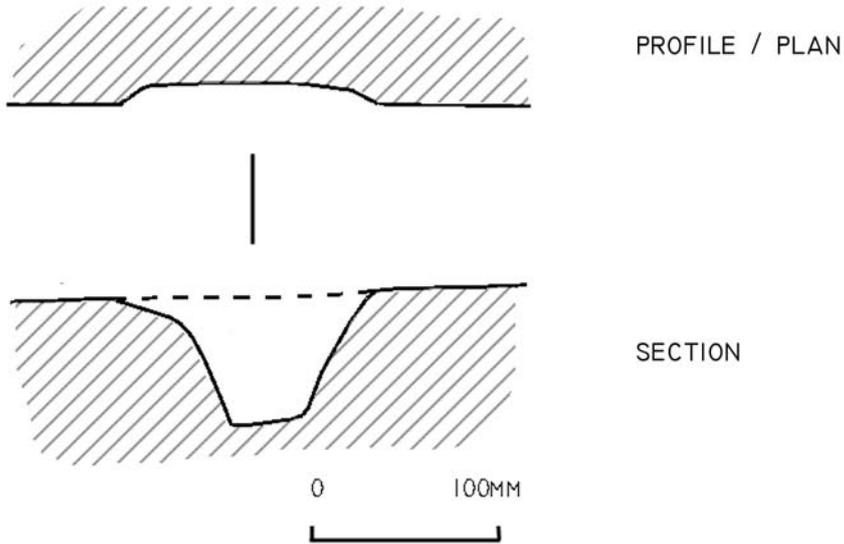
I. WEDGE MARK 1:4

FIG.8 GLOUCESTER CATHEDRAL ~ SOUTH TRANSEPT, WEST ELEVATION
WEDGE MARKS

Wedge shaped slots were identified at eighteen places in the 11th-century masonry, the distribution of the slots is shown on Fig. 7. The slots are present in section and in profile on the faces of the ashlars (Fig. 8). The width of the slots varies from 80-130mm, the depths between 60-80mm. These are the remains of slots cut for wedges, which were used to split the blocks. The blocks would require dressing after they had been split and the removal of some of the surface of the stone may have removed part of the slot making it appear smaller, or with a shallower profile, than would have been the case when the wedge was in use. The size of the slots suggests that they were cut to split the blocks into roughly their present dimensions, by the abbey's masons, rather than for breaking stone on a larger scale such as may have been the case in a quarry.

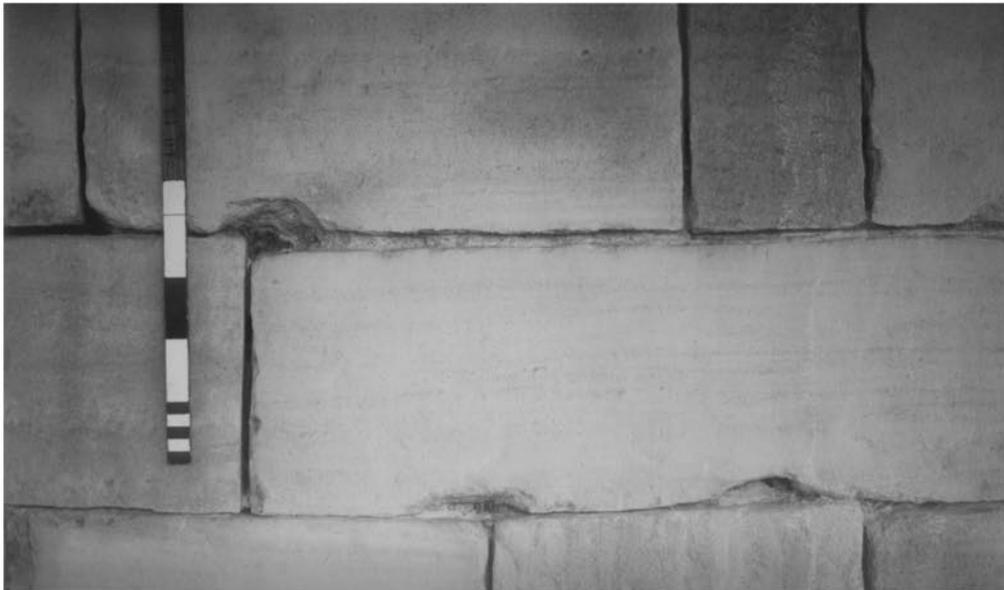
II. PHOTOGRAPH OF THREE WEDGE MARKS IN PROFILE

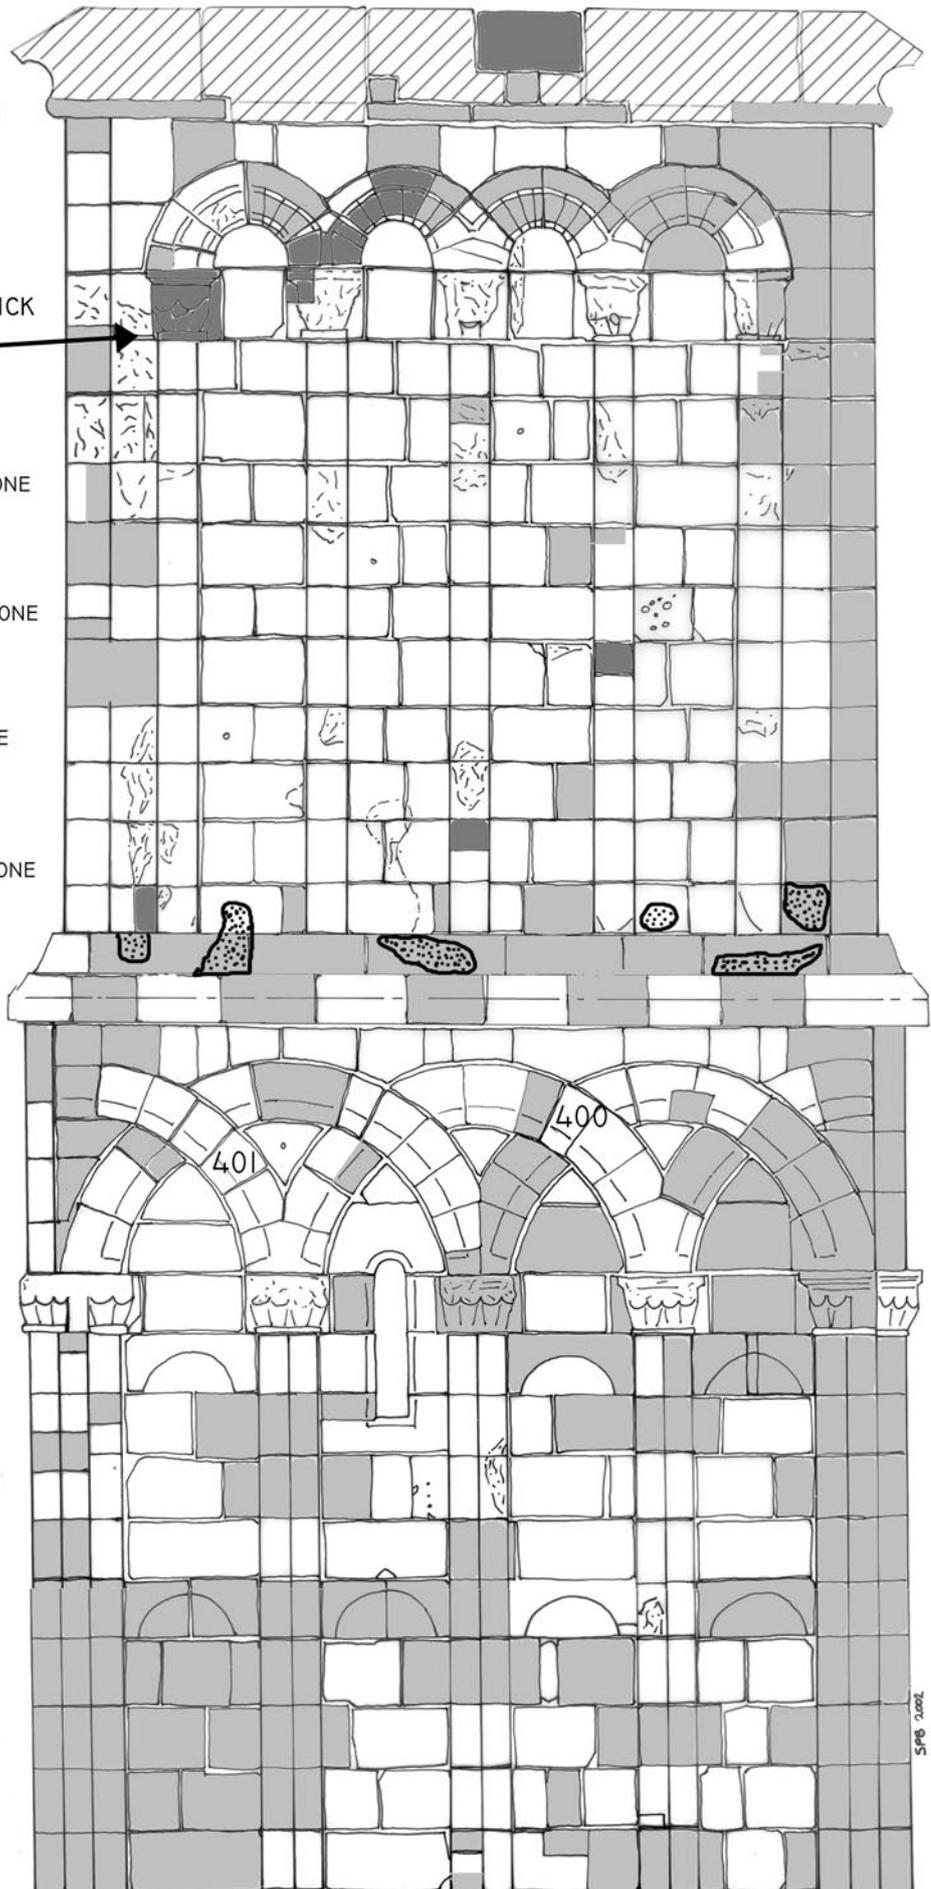
FIG. 12

BUILDING MATERIALS

GREEN SANDSTONE IN
CORE
- 401
RE-CUT CHEVRON

ROMAN BRICK
IN CORE

Masonry belonging to four periods has been identified in the fabric of the top stages of the turret. The petrology of the 12th-century ashlar is Lower Freestone (Painswick stone) as is the 14th-century cornice; Great Oolite from Bath was used for the repairs of 1868 whereas Lower Freestone was again used for the small number of early 20th century replacement stones. Fig.13 shows the 19th and 20th century repairs to the decorative arcading in the top stage of the turret. In places it was possible to trace differing mortars in the joints around such repairs, Fig.14 illustrates such an example showing the joint between the cornice moulding and the course below.

A number of badly weathered stones were removed from the intersecting arcading for replacement, two of these were found to have the remains of chevron decoration on the back. The positions of the stones (Worked Stone 400 and 401) are marked on Fig. 12.

Worked stone 400 is 250x200x190mm in size and has part of the chevron moulding profile found on 401 with the exception that there is a billet between the dags. The bottom of the block, i.e. that below and at 90 degrees to the chevron, is flat showing that 400 was not originally a voussoir. It could have been a jamb stone to the arch of 401.

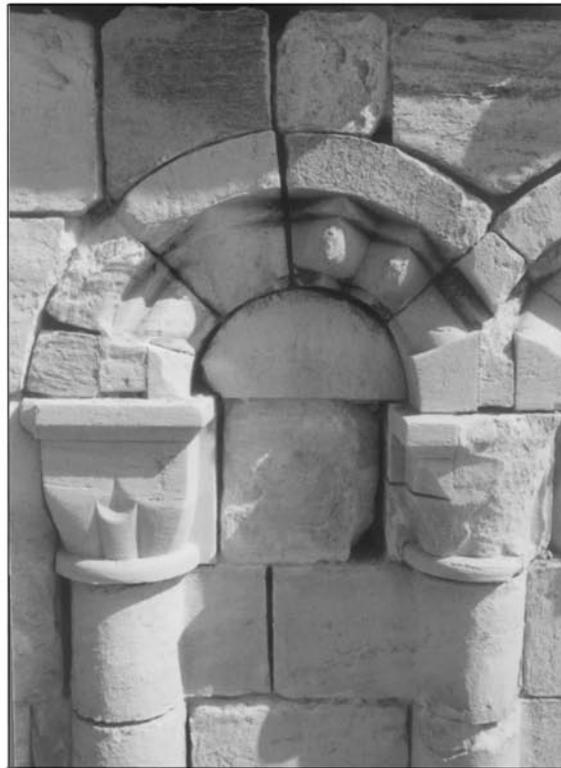
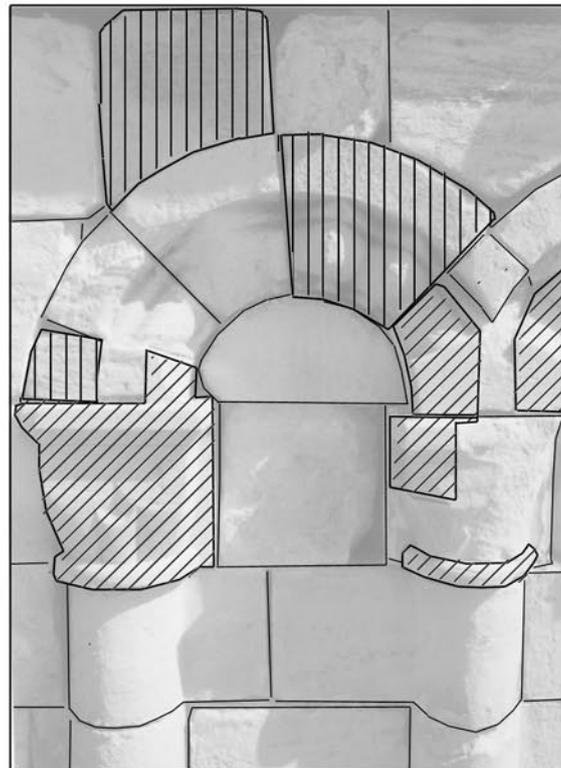
FIG.13 GLOUCESTER CATHEDRAL ~ SOUTH TRANSEPT, WEST ELEVATION

DETAIL OF REPAIRS TO DECORATIVE ARCADING, UPPER STAGE, TURRET

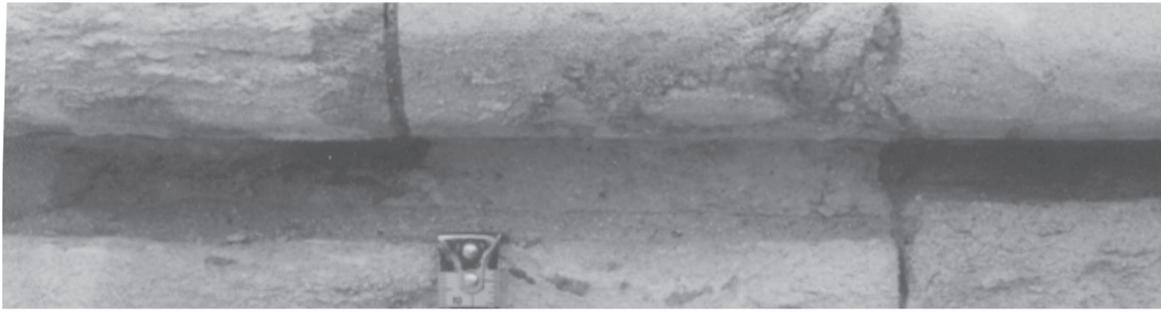
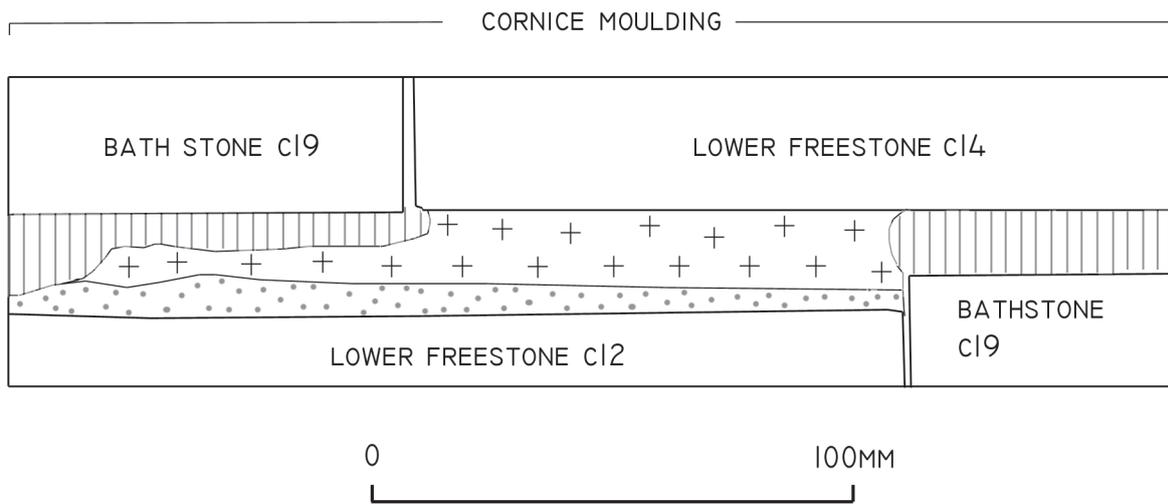
FIG.14 GLOUCESTER CATHEDRAL SOUTH TRANSEPT ~ WEST ELEVATION
 DETAILS OF BUILDING MORTARS IN THE CORNICE JOINT OF THE TURRET

12TH CENTURY MORTAR

19TH CENTURY MORTAR

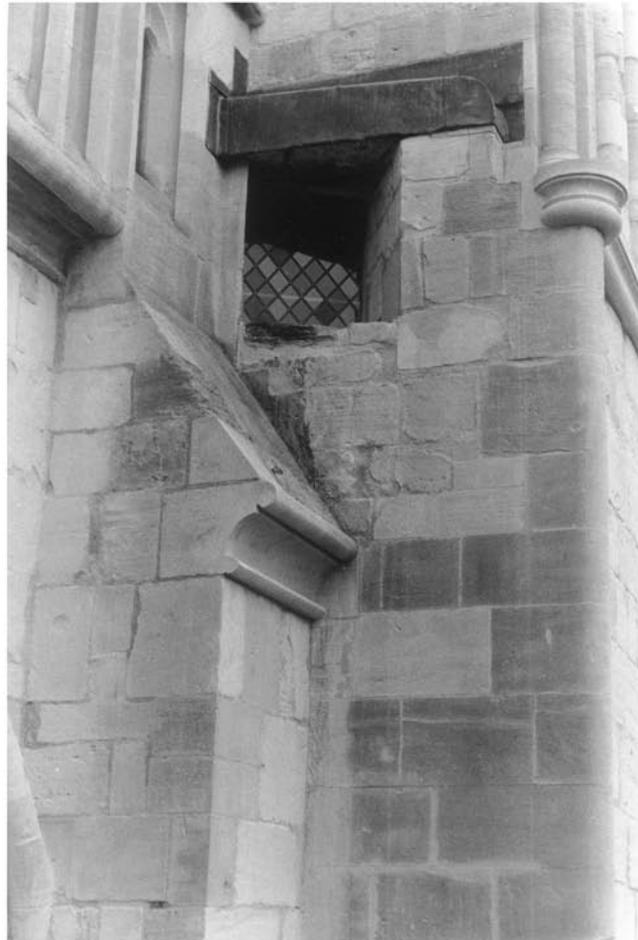
II. N ELEVATION OF TURRET AT 35M AOD

The partially blocked remains of a doorway are located on the north elevation of the south west turret at 35.50m AOD (Fig.18, ii). The opening was formerly 1.6 x 0.5m in size with undecorated reveals; the lower part is blocked leaving an opening (700x500mm) that lights the stair vice and which is now glazed. At the top is a rough lintel of Pea Grit which is set across the angle formed by the turret and parapet. This opening is what remains of an 11th-century doorway giving access to the roof leads from the then top of the turret. It was partially blocked and adapted to function as a window during the 14th century.

Any evidence of passageways across the west elevation of the transept would have been removed from the exterior in the 14th century, when the narrow strip of masonry forming the north elevation of the turret between 30.0m AOD, was re-faced as a result of the reduction in thickness of the main elevations of the transept. Additionally, most of the stonework in the narrow north elevation of the turret was replaced in the 19th century (Fig.18, ii).

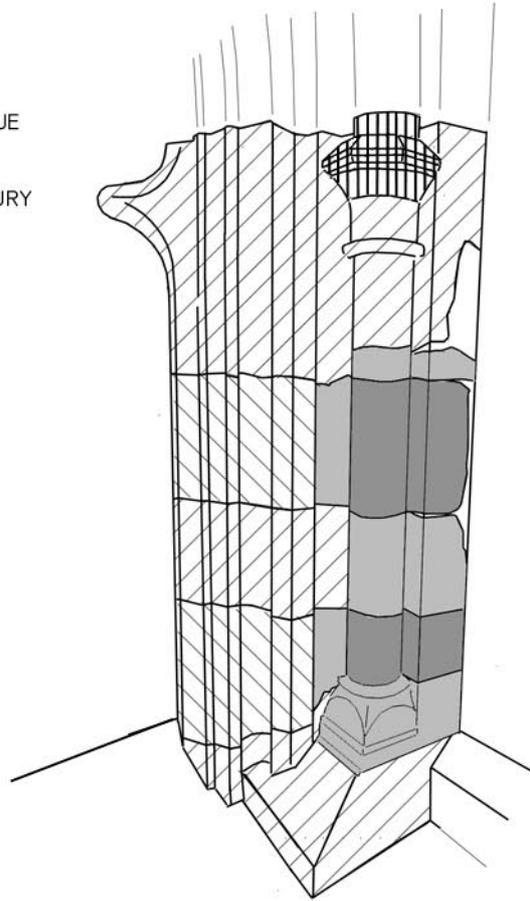
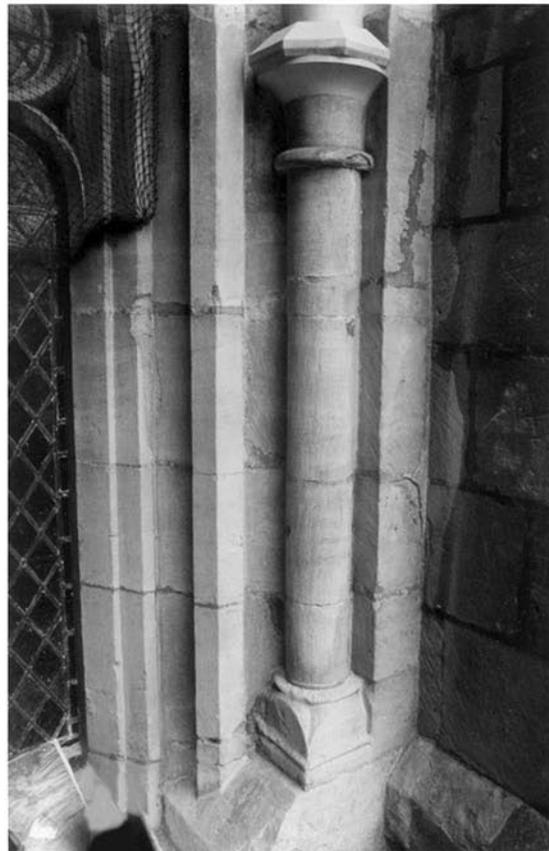
FIG.19 GLOUCESTER CATHEDRAL ~ SOUTH TRANSEPT, WEST ELEVATION

NORTH WINDOW ~ SOUTH JAMB, DETAILS OF CONSTRUCTION

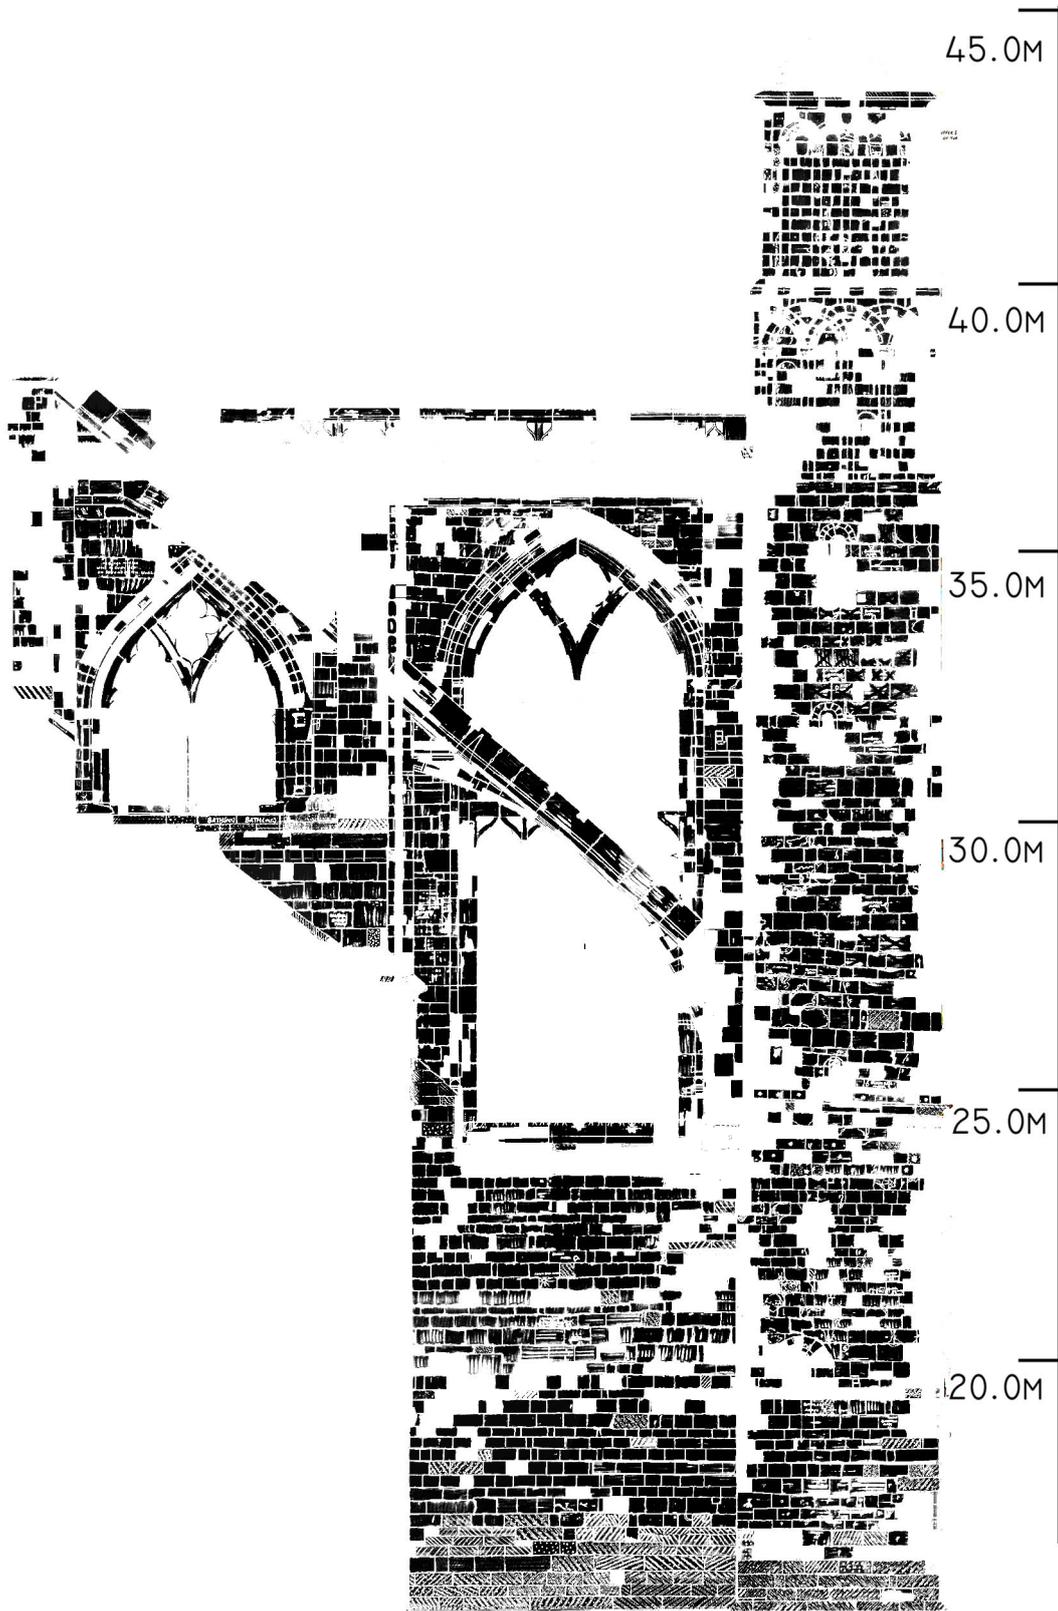
FIG.22 GLOUCESTER CATHEDRAL SOUTH TRANSEPT ~ WEST ELEVATION

MEDIEVAL STONES

The extent of the 19th- and early 20th-century repairs are illustrated in Fig. 22 where the elevation is shown with this work subtracted.

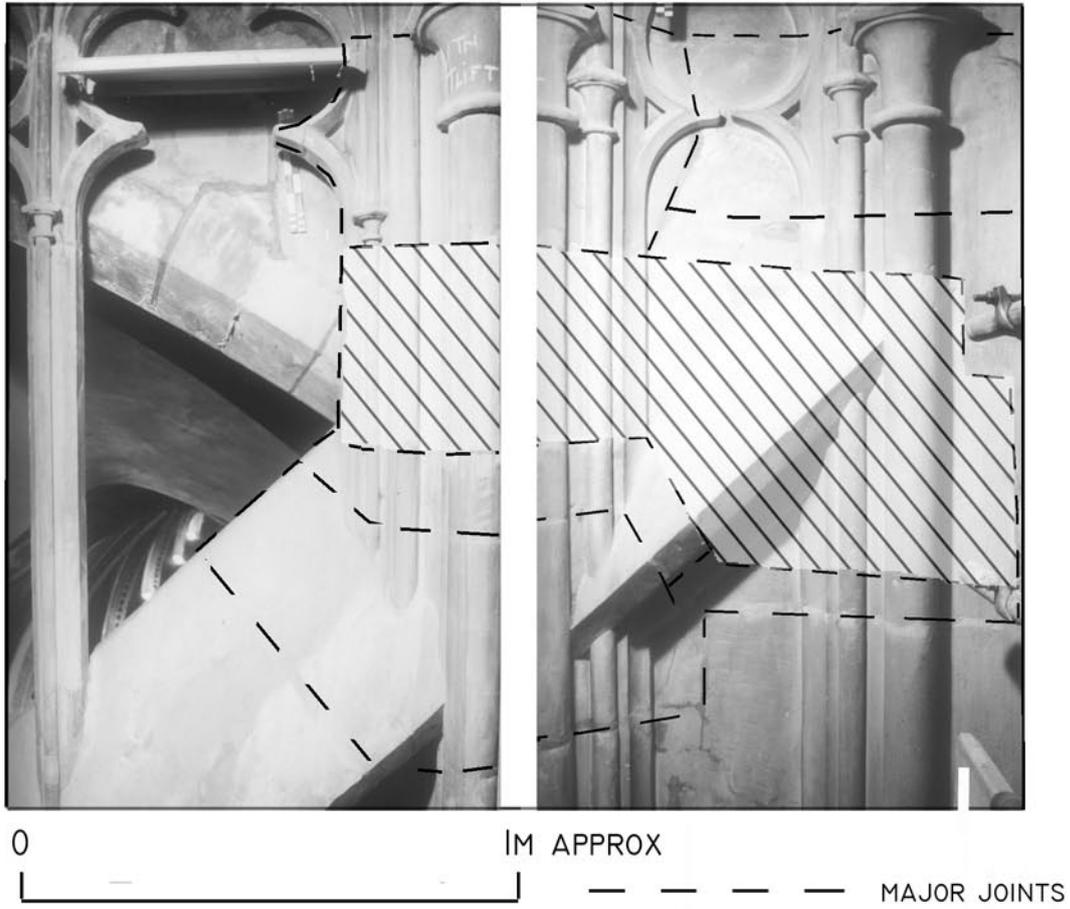
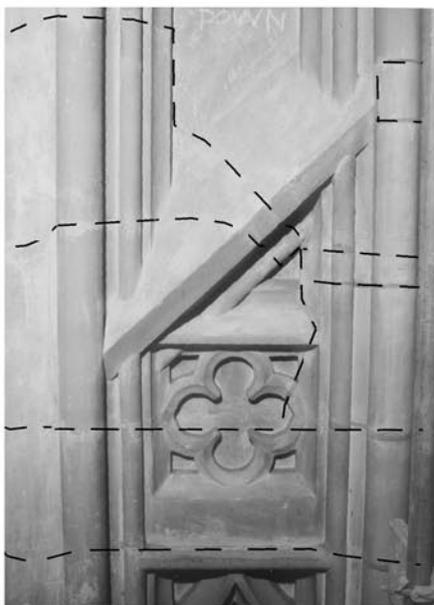
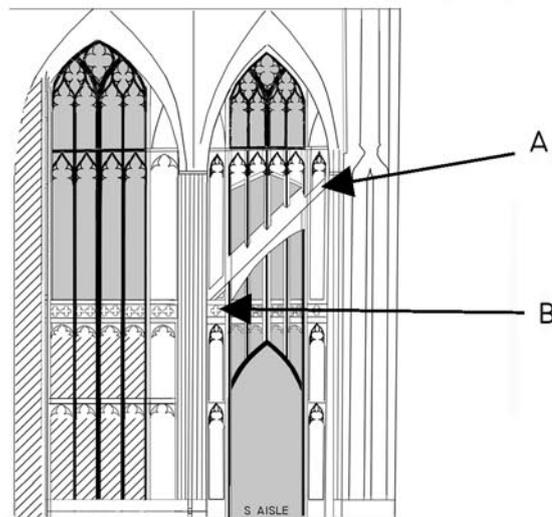
FIG. 3 GLOUCESTER CATHEDRAL SOUTH TRANSEPT ~ WEST ELEVATION, INTERIOR

SINGLE STONE WITH WALLSHAFT
BUTTRESS AND PANEL MOULDINGS
