GLOUCESTER CATHEDRAL NORTH AISLE ROOF

Gloucester Cathedral Archaeological Reports 97/B

Report on architectural recording during repairs

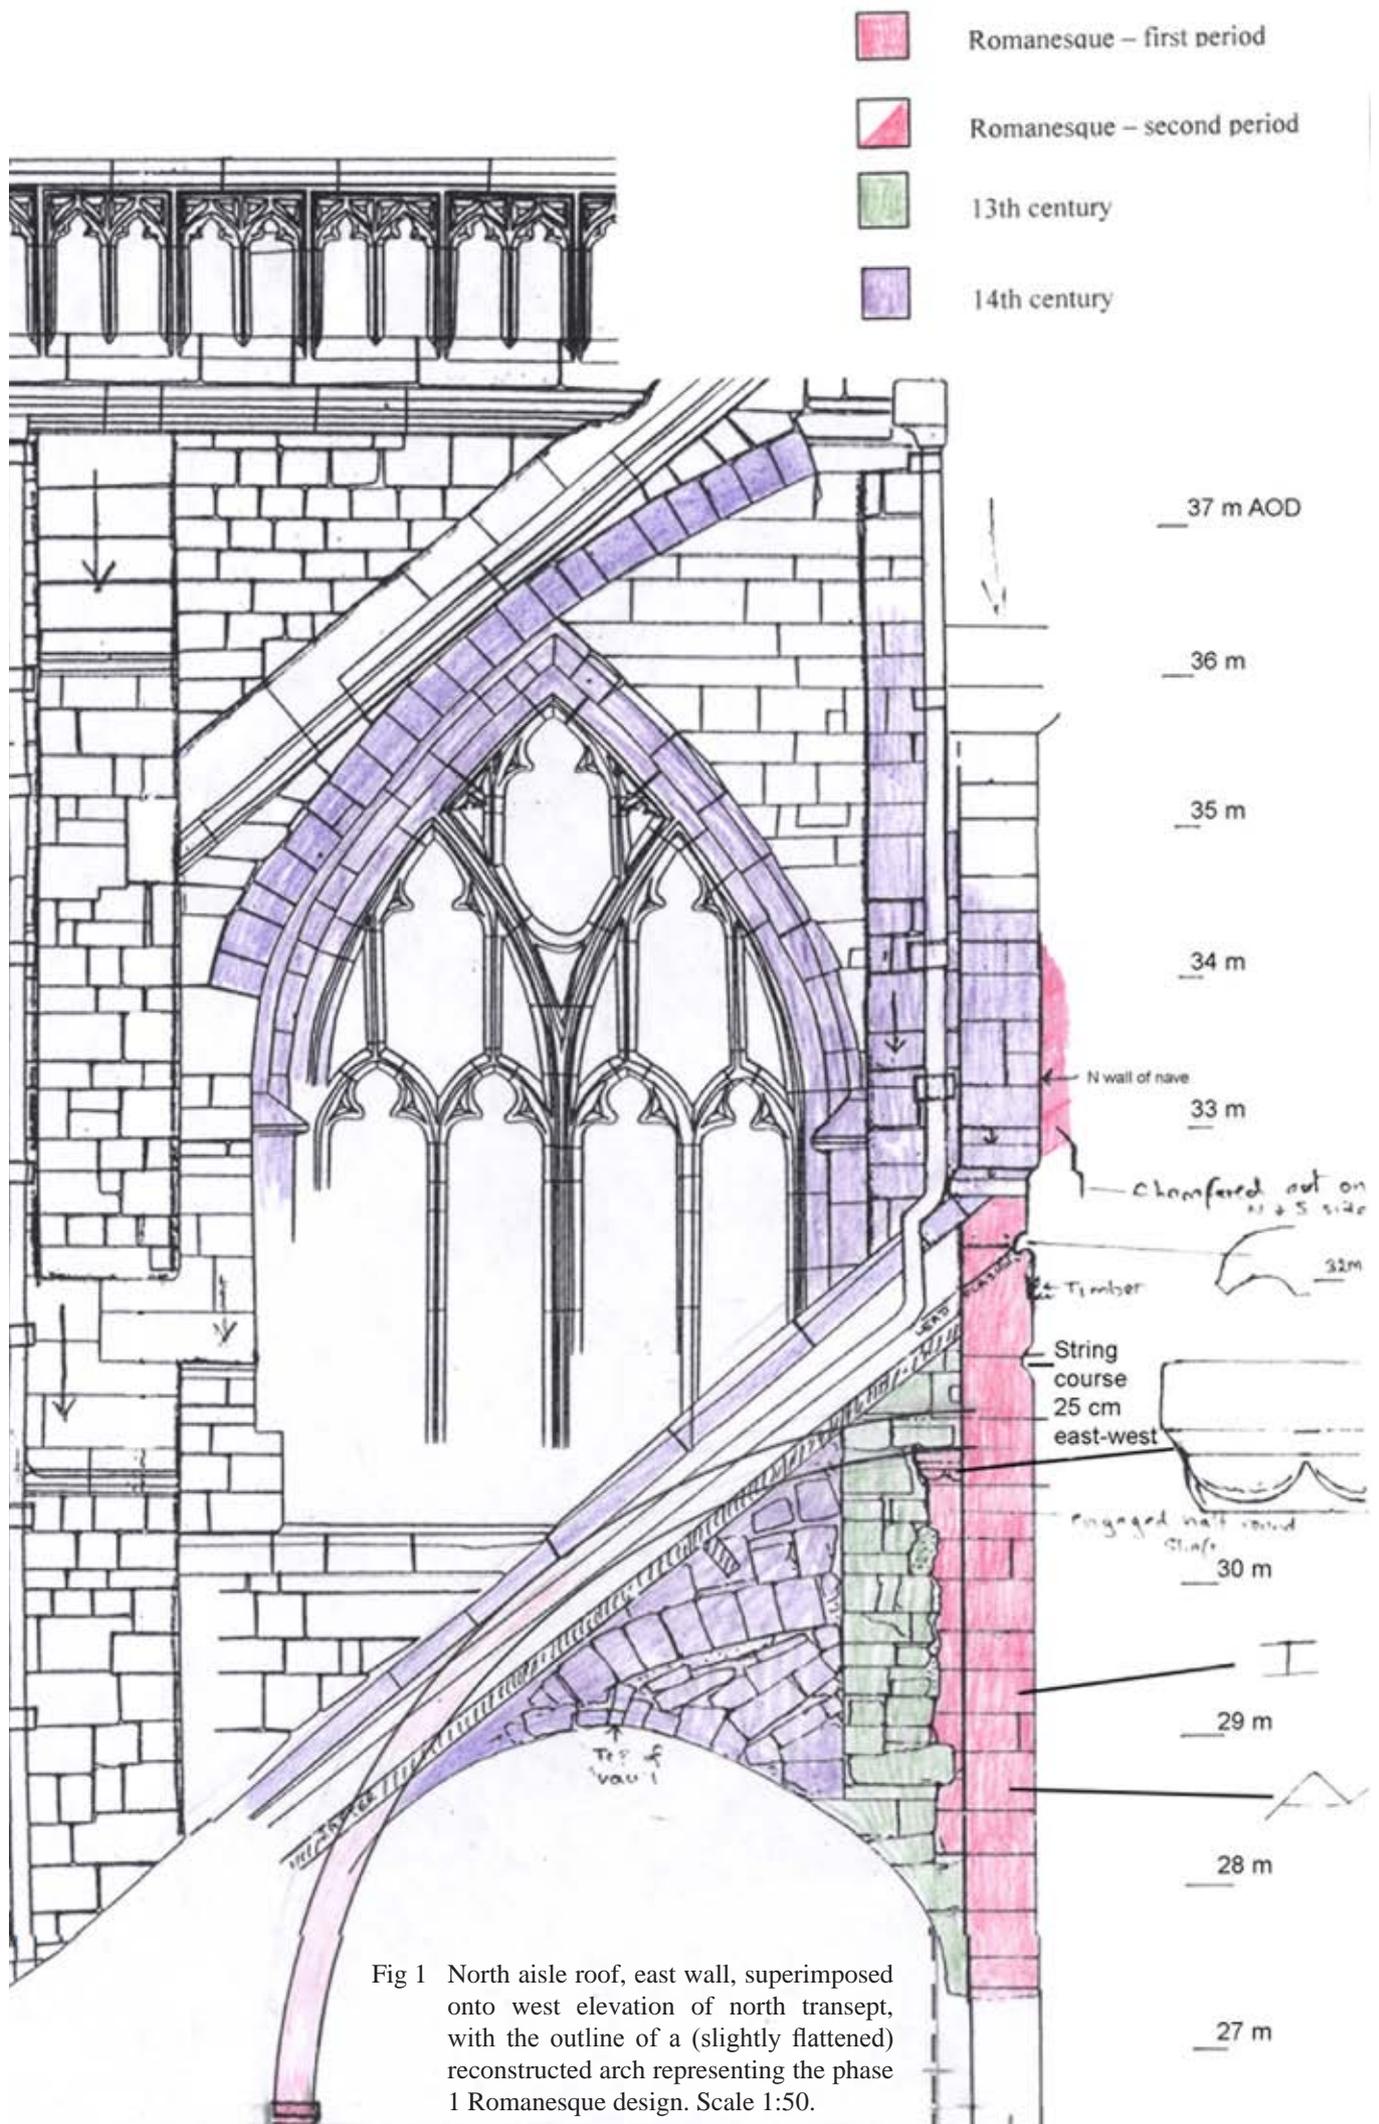
Fig 1 North aisle roof, east wall, superimposed onto west elevation of north transept, with the outline of a (slightly flattened) reconstructed arch representing the phase 1 Romanesque design. Scale 1:50.

Other buttressing was added later at the west end of the north aisle, encasing the phase 1 evidence almost completely: One buttress has been tentatively assigned to the 13th century (when the nave roof was rebuilt), and the build of the rest of the east wall (Fig 1) is related to the insertion of the arch to the north transept in 1368-73.

Dr Wilson's theory, which places a quadrant arch on the capital in the north-east corner of the north aisle, is reconstructed on Fig. 1. It is also reconstructed on an enlargement of Ansted's drawing in Fig. 3. As Wilson says, 'it is obvious that a quadrant, even of the shallowest curvature, could never have fitted in between capital and roof' (Wilson 1985, 73). The Ansted cross-section (Fig. 3) shows this even more clearly (in Fig. 3 the arch has been drawn as a quadrant). A slightly flattened arch will not fit under the present roof but could fit under a slightly higher roof line (Fig 1). Although Wilson claims to see trace of an earlier roof line on the west face of the north transept, I cannot discern evidence of

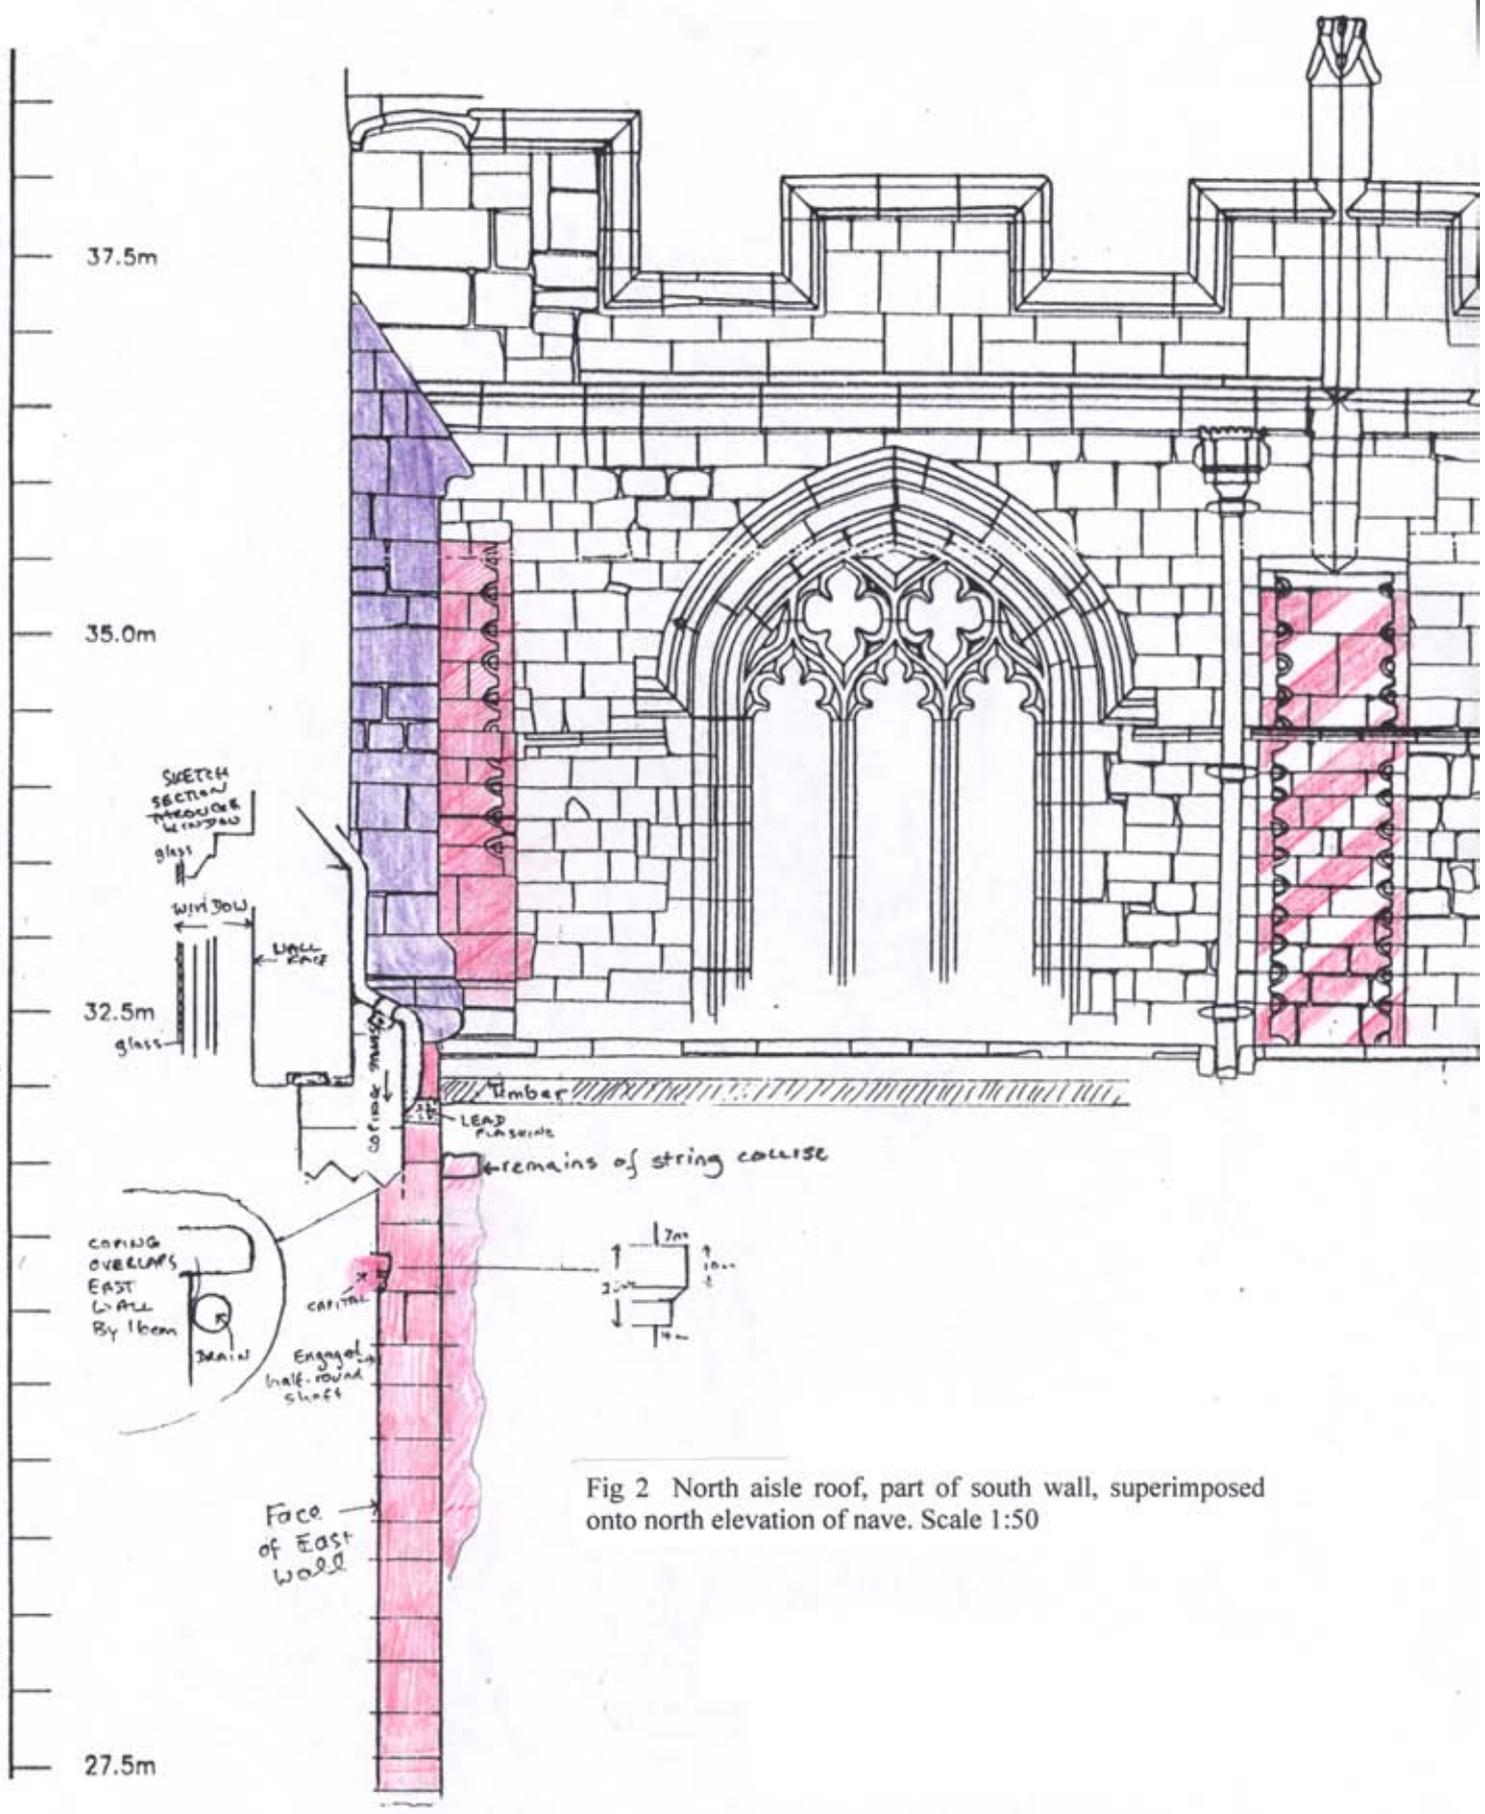
Fig 2 North aisle roof, part of south wall, superimposed onto north elevation of nave. Scale 1:50

On the outside, the first strip-buttress near the north transept is the only one to have its lower portion without decoration: Wilson suggested that this was phase 1 work, and that the plain lower portion was to take the higher roof-line of the phase 1 north aisle roof. Presumably the remaining strip buttresses in the clearstorey level of the north nave wall are phase 2 work (see Fig 2).

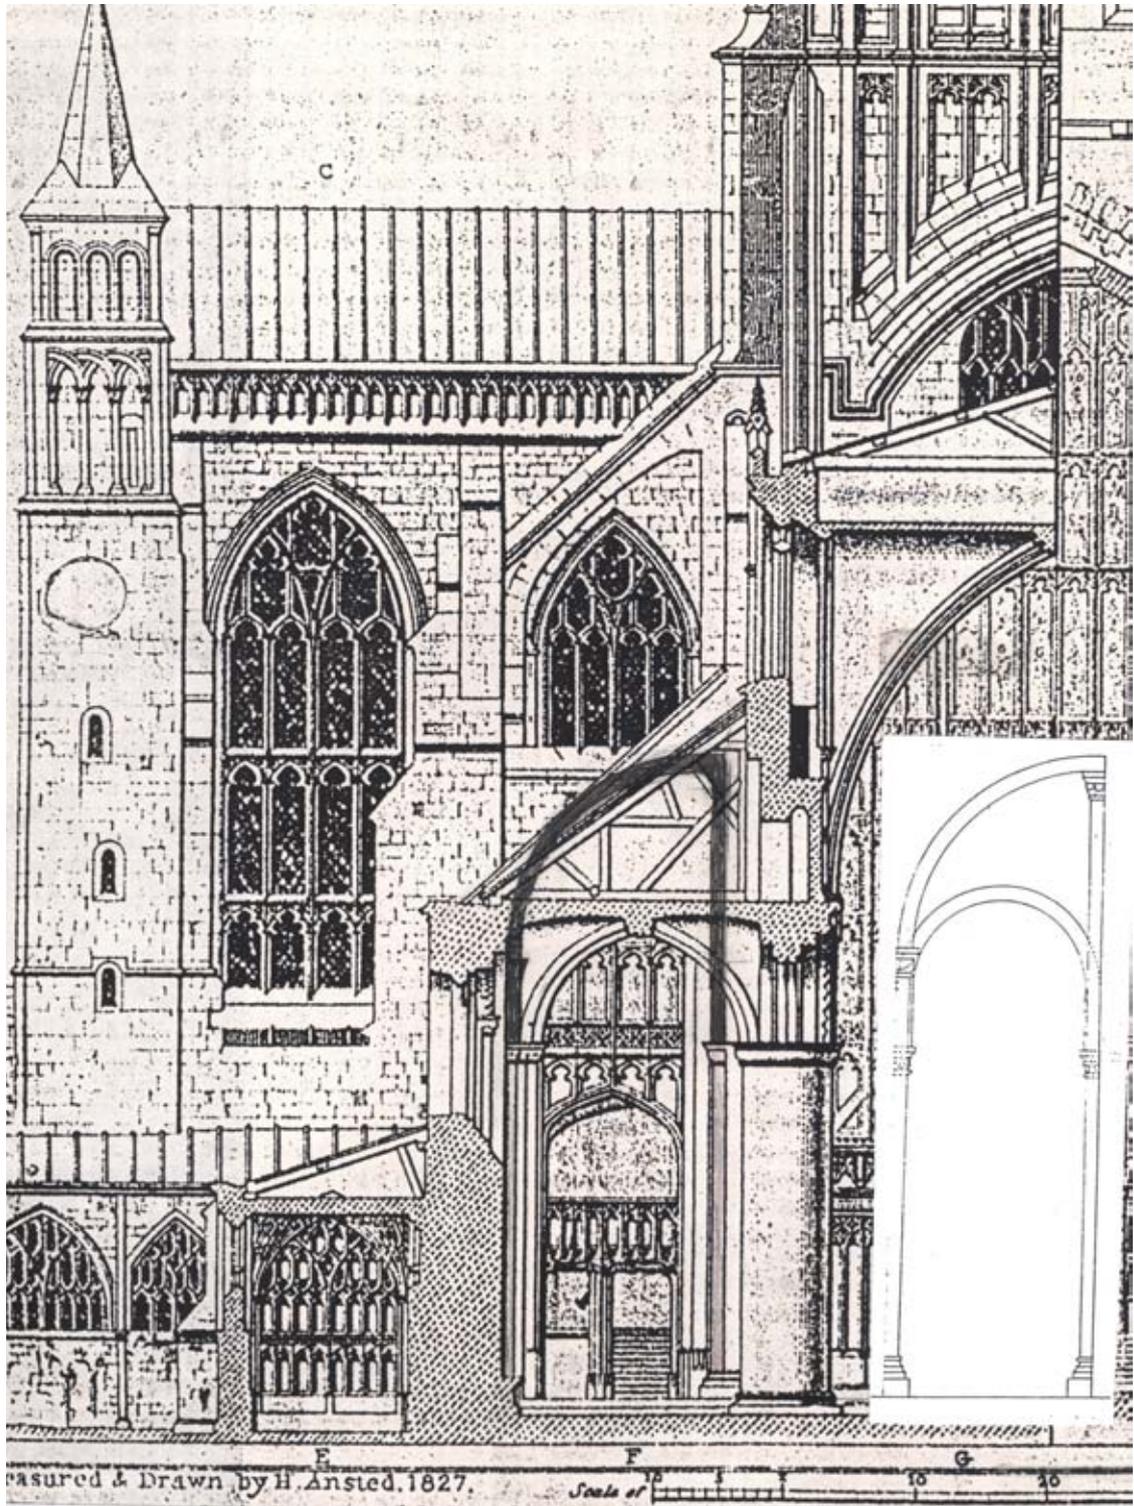
Fig 3 Copy of Ansted's elevation /cross section of the north aisle and north transept, from Britten 1829. Inset: Wilson's reconstruction of the phase 1 north aisle at about the same scale.

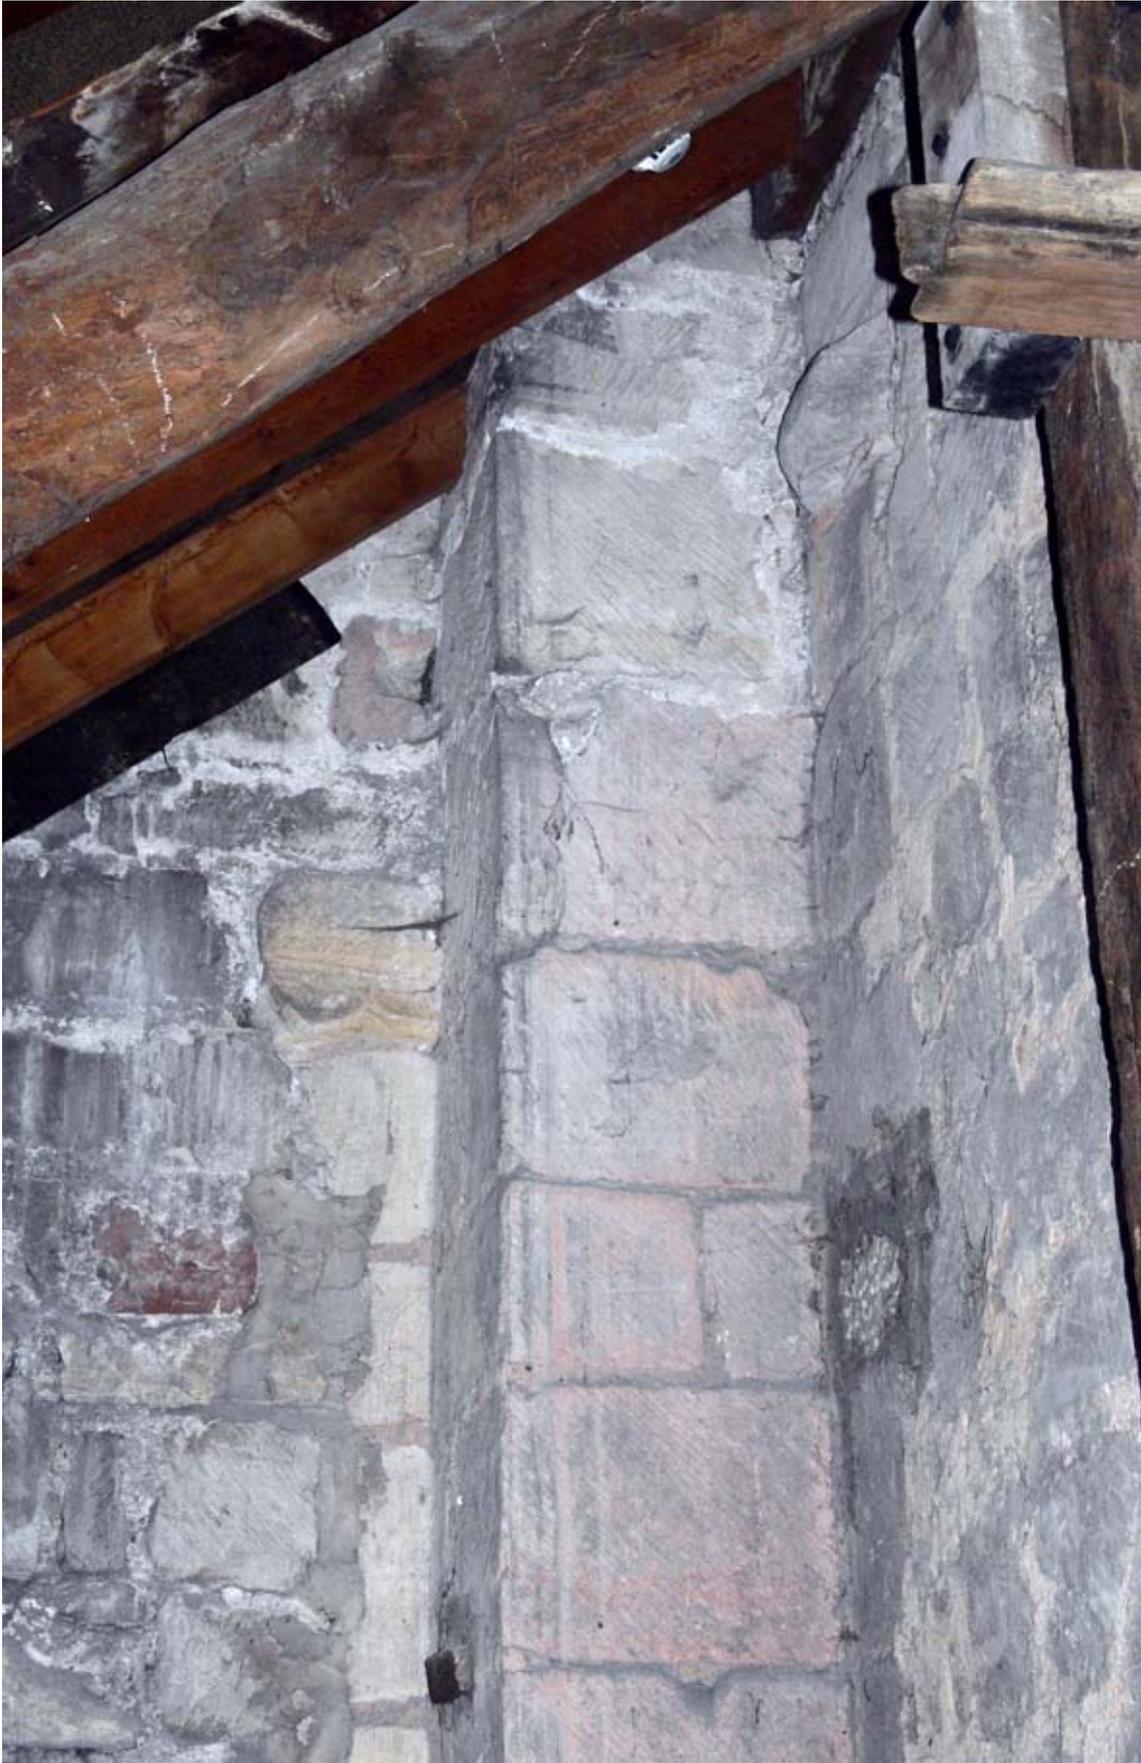
Fig 4 North aisle roof, photograph (P1010818) of capital and shaft on east wall, remains of string-course high up on nave wall on the right, and vertical masonry break between phases 1 and 2.

The evidence for the previous intention is to be seen in the north aisle roof space on the east wall. Here there is a wall shaft with a cushion capital which emerges from the 14th-century roof vault and which can be seen in the nave. This shaft was intended to take a quadrant vault, and compatibility with the quadrant vaults over the choir galleries was clearly intended (Wilson 1985, p 73). The shaft is in bond with the pier just to the west of it and also with the first stones of the north aisle wall at this level (Figs 1 and 2). Remains of a string course survive in the nave wall at 31.5 AOD. West of this there is a vertical break in courses and the character of the stonework changes; the rest of the nave wall face is fairly uniform (not drawn in Figs 1 and 2, but visible on photographs). Presumably this break is the junction between phases 1 and 2 of the Romanesque work.
