# Gloucester Cathedral South Transept and South Choir Elevations 1999

Gloucester Cathedral Archaeological Reports 99/A and 99/B

GLOUCESTER CATHEDRAL  
SOUTH TRANSEPT AND SOUTH CHOIR  
CLERESTORY ELEVATIONS 1999

## THE SOUTH TRANSEPT, EAST ELEVATION

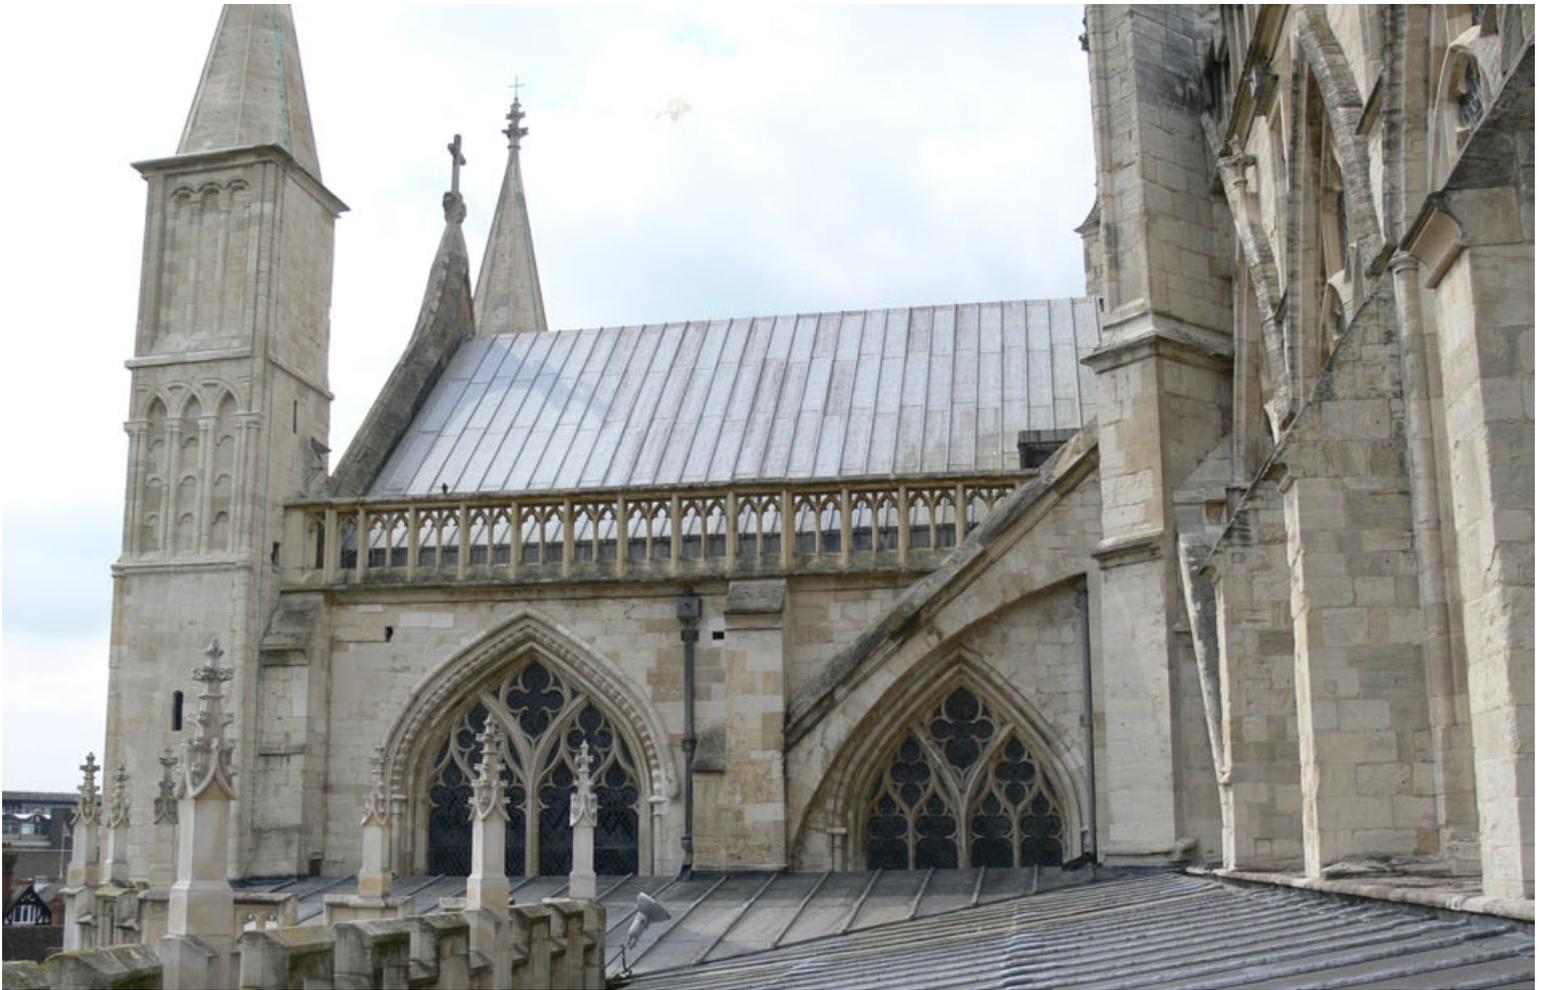
Plate 1 East side of south transept in 1999, after repairs. The remains of the Romanesque passage at clerestory level can be seen at the base of the buttress. Photo: Alan Norton.

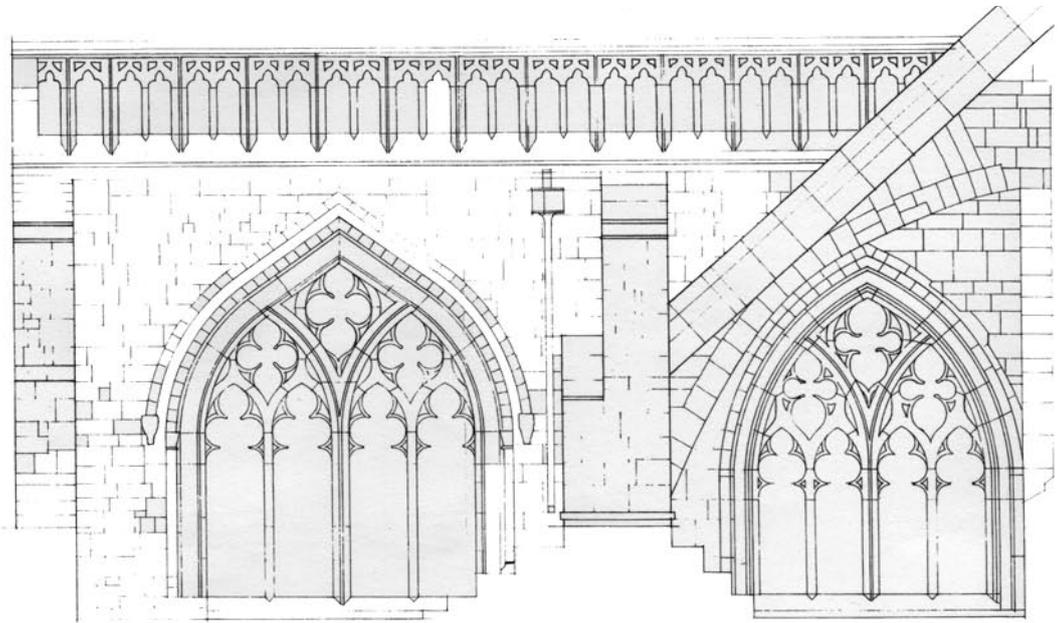
1a The east side of the south transept: drawing by Stainburn Taylor. Scale: 1:100

The south transept retains 12th-century turrets, but the windows were entirely rebuilt and the interior altered in the 14th century. Buttresses were also added for the support of the tower (Fig 1). These may have been added in the 15th century, although major interior buttressing is integral with the 14th-century work and must reflect concern about the stability of the Norman tower (Wilson 1980, 133-4).

Figure 1 shows the suggested dates of the different parts of the structure. The northern window is smaller than the southern one, and this reflects the whole design of this façade in the 12th century, which emphasises the arches to the eastern chapels at the expense of the entrance to the ambulatory (Wilson 1985, 72).

The upper coursing above and south of the east side southern window slopes slightly (though the drawing shows it as level courses). This is ultimately the result of the tilting south of the 12th-century turret.

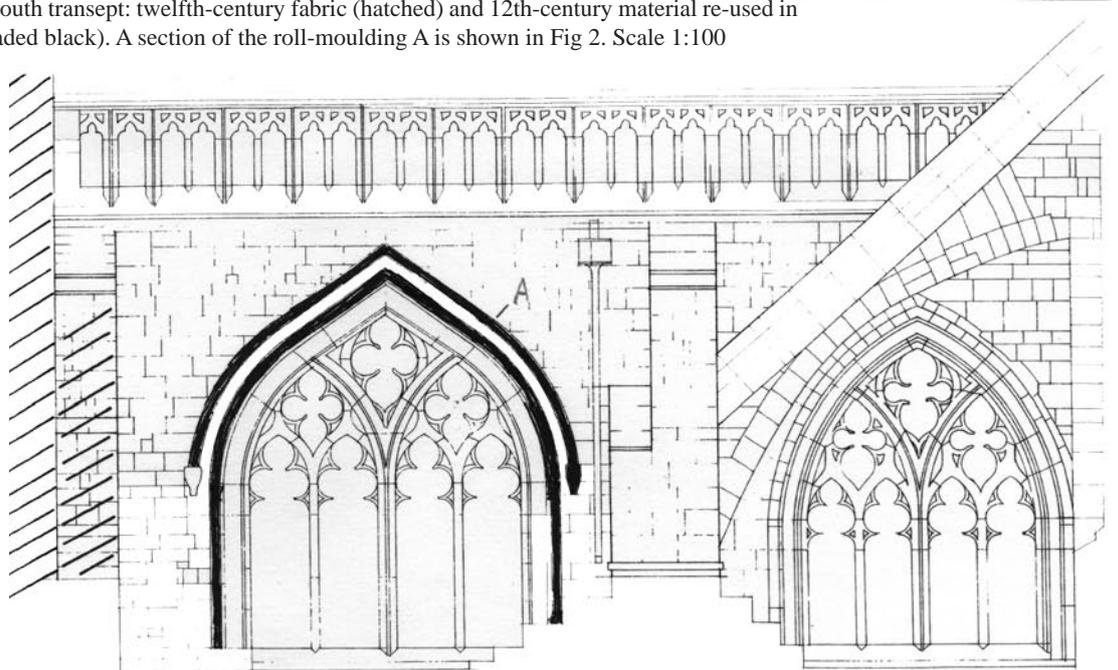
1b East side of the south transept: twelfth-century fabric (hatched) and 12th-century material re-used in the 14th century (shaded black). A section of the roll-moulding A is shown in Fig 2. Scale 1:100

The southern window on the east side is made up of re-used Romanesque material, in the same way as the south window of the south transept (Ashwell 1985). Above the window is a band of chevron, and above this a hood-mould constructed of re-used rolls (Figs 1b and 2; plate 1). The

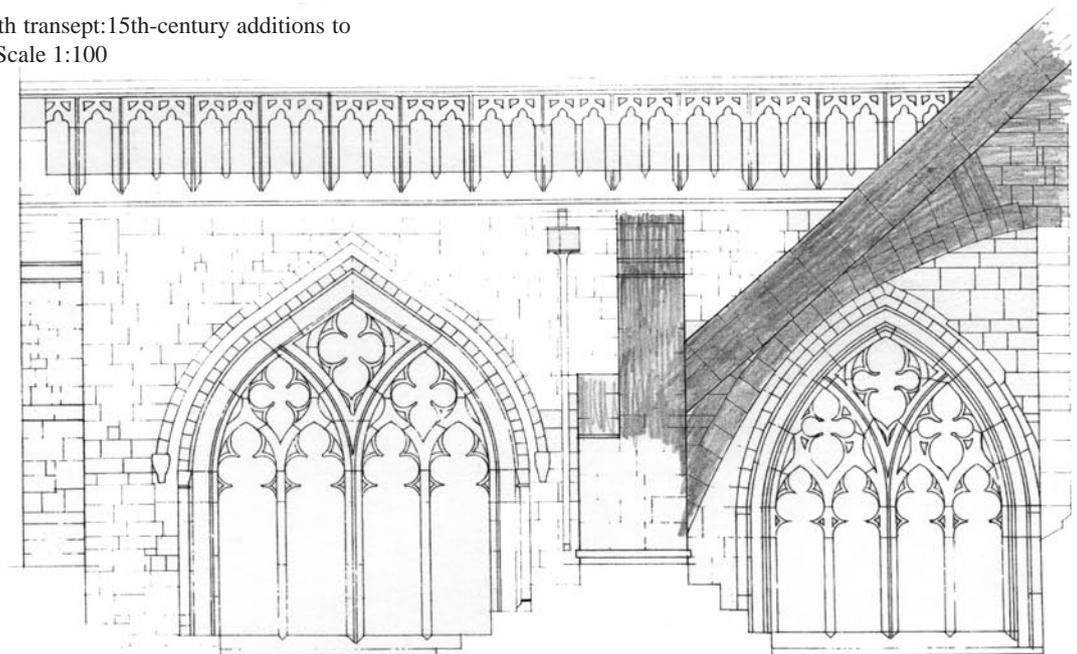
1c East side of the south transept: 15th-century additions to the elevation (shaded). Scale 1:100

The addition of the tower in the 15th century has been thought to be the occasion of the addition of buttresses built into the wall face (Figure 1c). In face the date of these buttresses is still in question: on the whole it seems likely that these buttresses were inserted in the 14th century (Bagshaw 2003, 9-11)

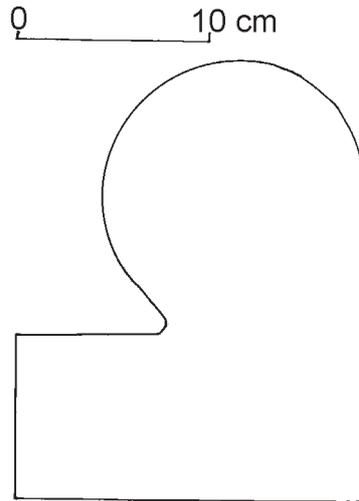
2. 12th-century shaft moulding re-used in hood-mould of east transept window (see Figure 1c, at A)

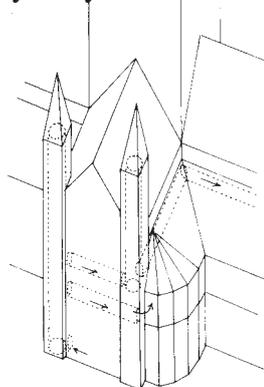
3 Diagrammatic reconstruction of Romanesque wall passages in south transept: after Wilson 1985, p 72

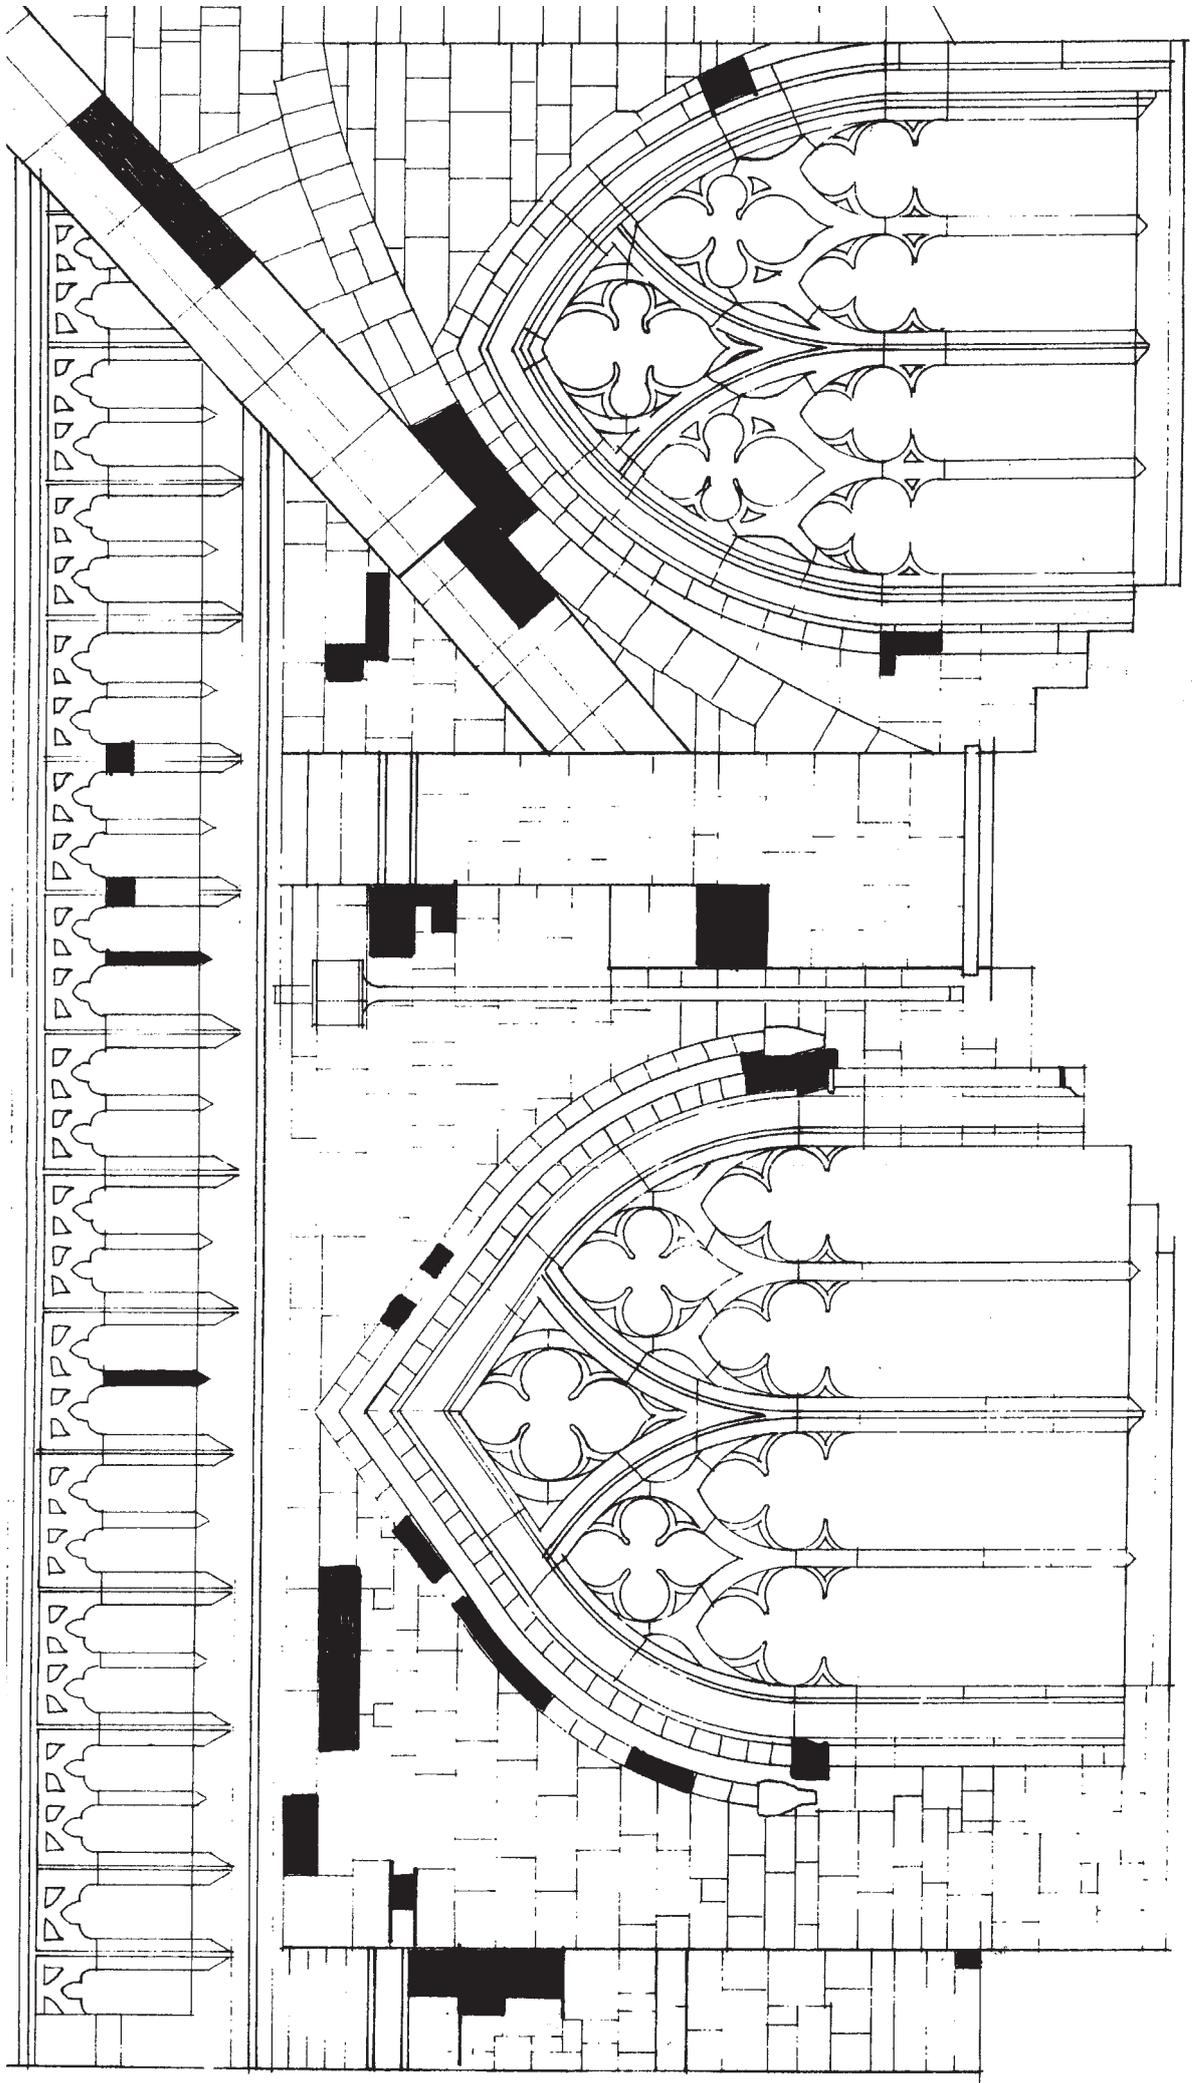
4 Elevation of east side of south transept, showing stone replaced in Lepine stone. Based on drawing by Pascal Mychalysin. Scale 1:50.

The stone marked on Figure 4 was replaced in Lepine stone. It included ten replacements of Romanesque rolls used as hood moulds, two replacements of Romanesque chevrons, and three replacements of capitals.

The replaced capitals were both those on the southern window and one on the northern. The new stones followed the geometry of the old stones. The two on the southern window had an hexagonal cap (like those inside the window). The two capitals however showed substantial differences in measurements. The top chamfer of the capital cap was shallower on the southern example, steeper on the northern. The northern window had an unfinished square cap on its southern capital, as can be seen on the other surviving old capital of the same window (though on this one the stone cutting of the chamfer was finished). the unfinished capital was replaced as found with an unfinished square cap.

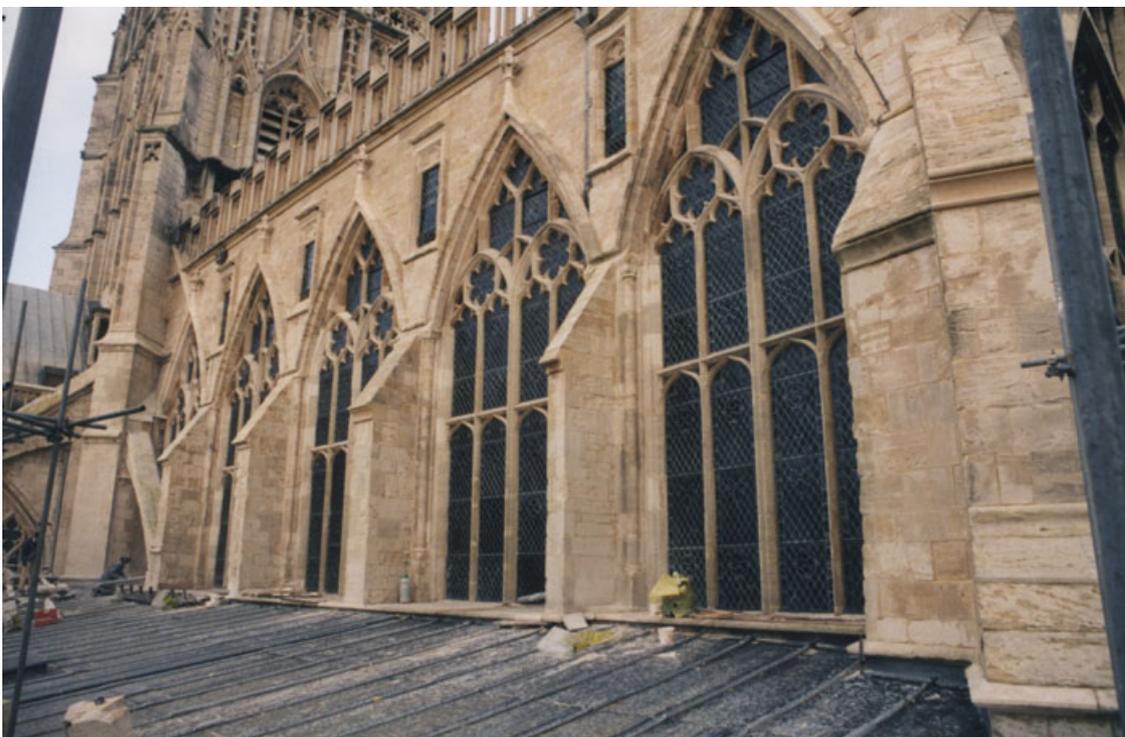
Plate 1. S elevation of choir clerestory after restoration in 1999. Photo: Alan Norton.

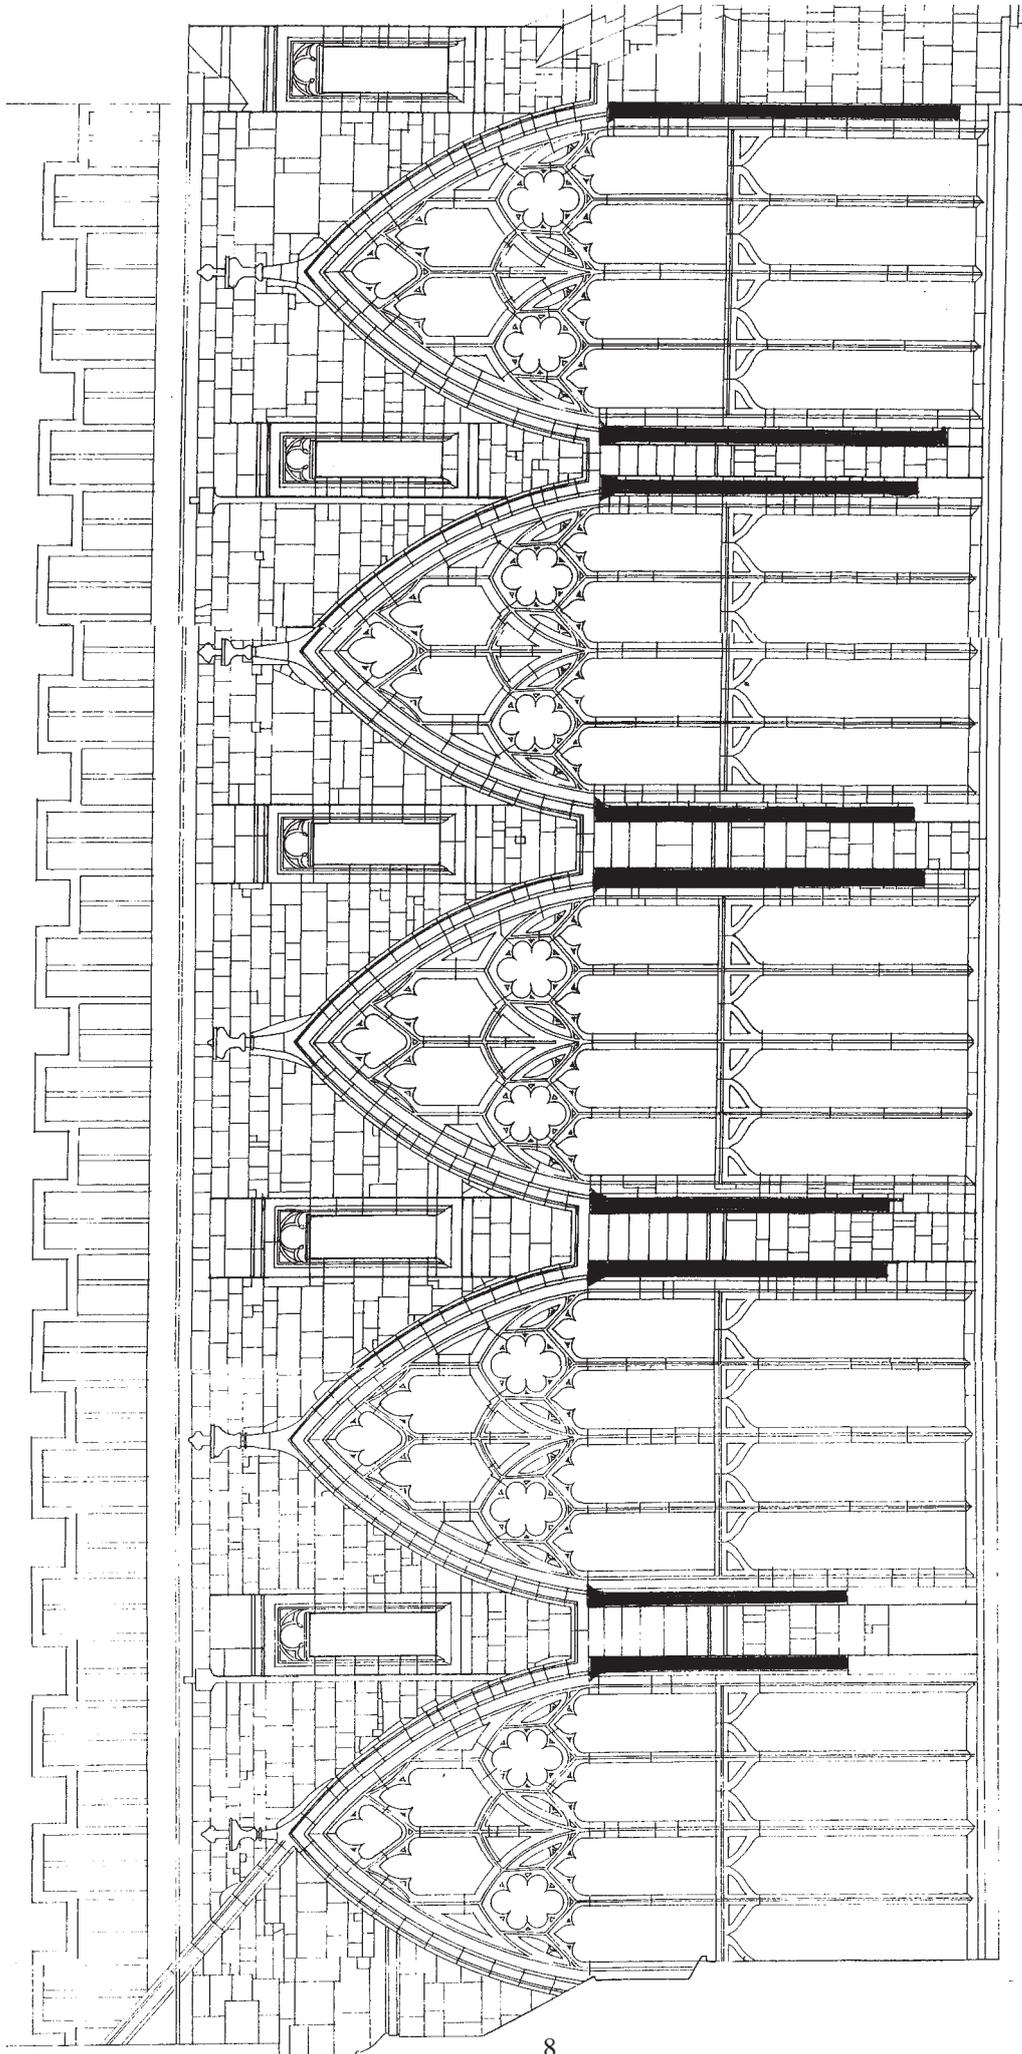
1 South choir elevation: reused Romanesque material (shaded black) scale 1:100

The tower was built 1450-60 (Welander 1991). At the west end of the elevation is an area of differently coursed masonry, with a clear vertical join, presumably where the tower and its buttresses were inserted (Fig 1).

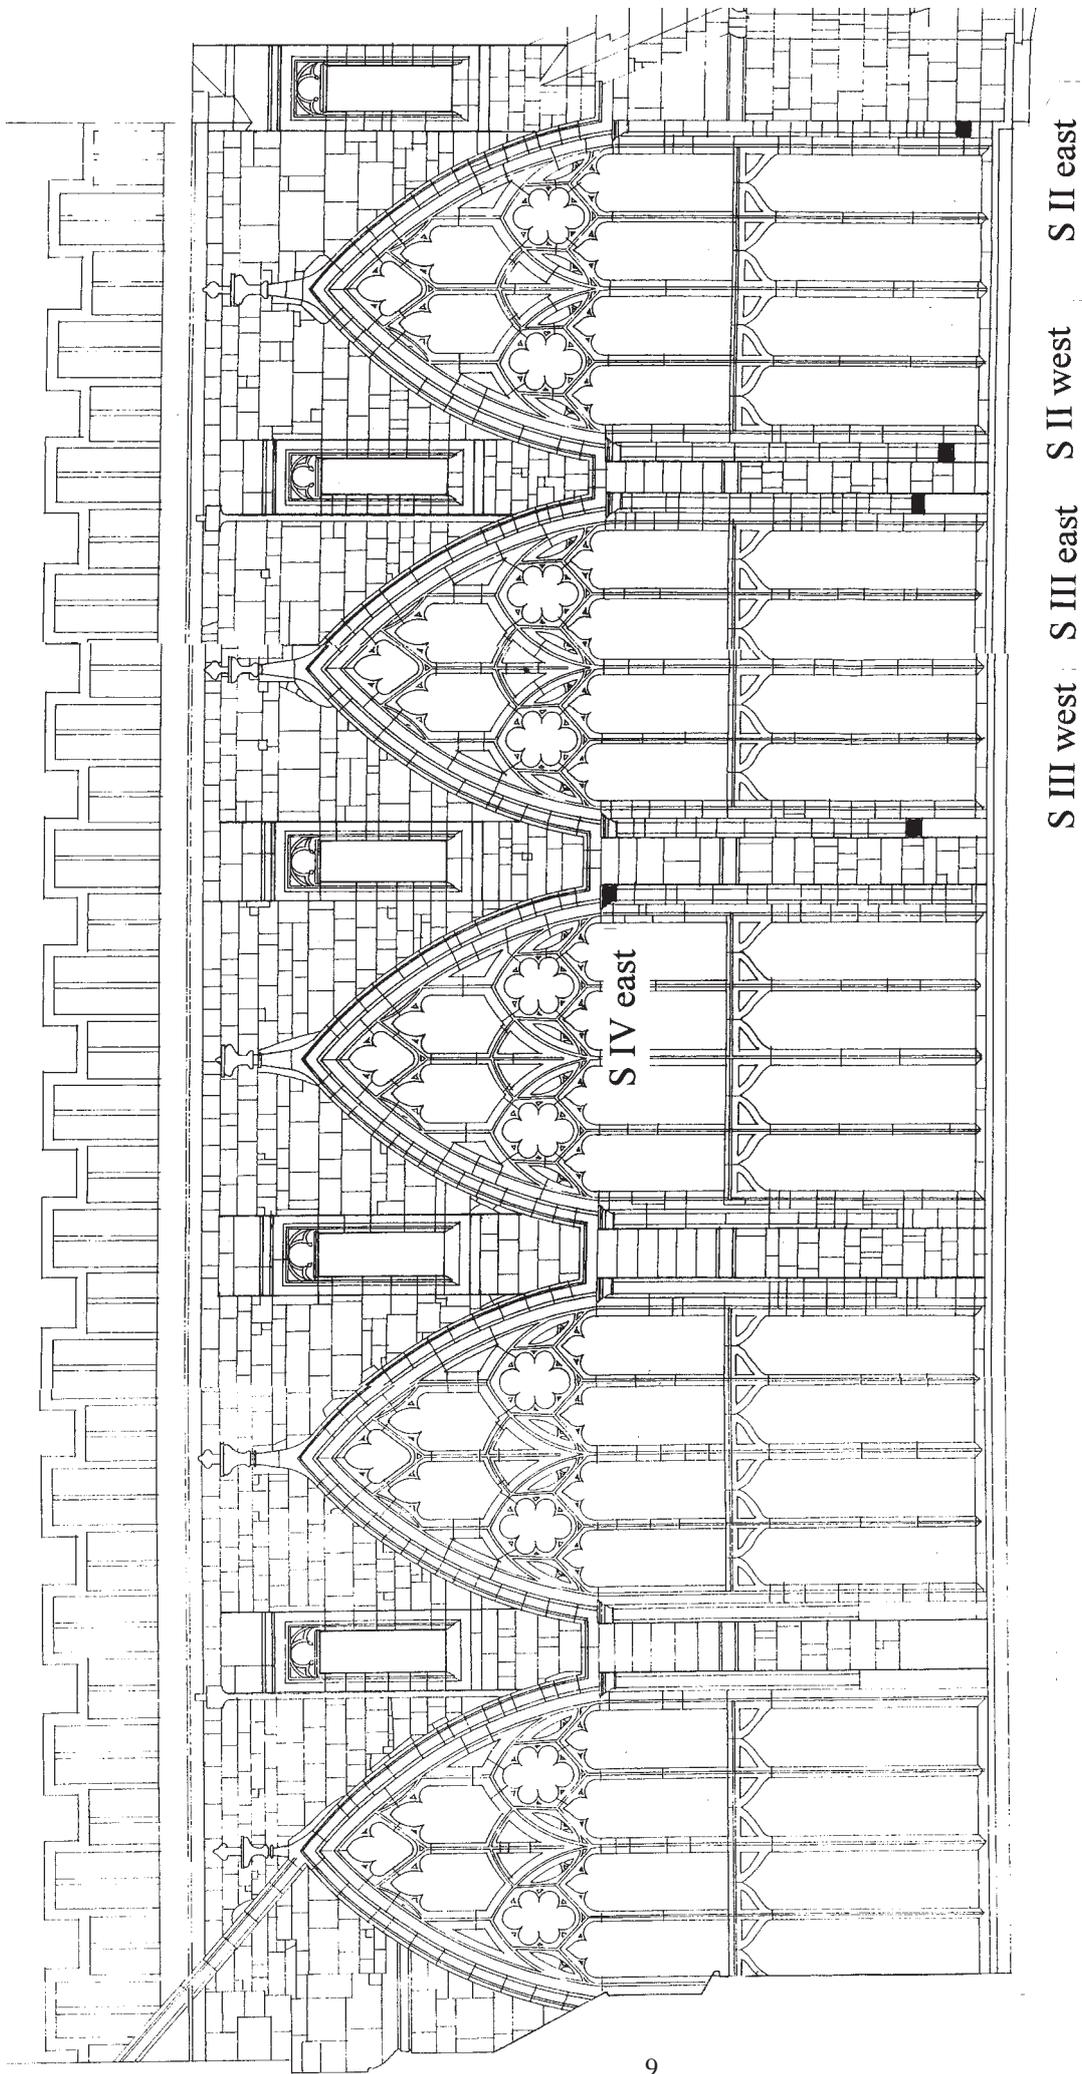
2 South choir elevation: recorded Romanesque mouldings. S IV east - position of Romanesque capital (see figure 3) S III west and east, S II west and east - position of Romanesque bases illustrated in figure 4.

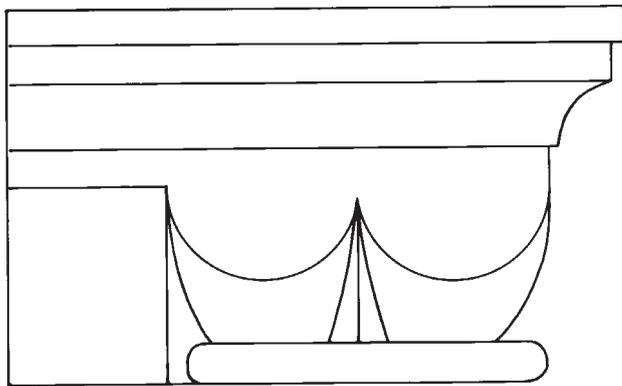
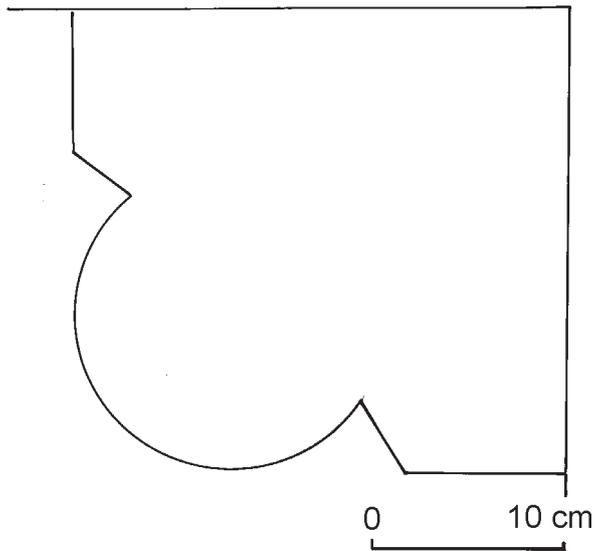
3 South choir elevation: window S IV (3rd window from the west), east side, Romanesque capital and shaft, section of shaft, profile of capital. Drawings by R Bossons

The eastern capital of window S IV (a Victorian replacement) has in turn been replaced. A short report on the capital was done by Richard Bossons, stonemason. His reduced templates are shown here (Fig 3). The shaft diameter is 16 cm which, according to Christopher Wilson, matches the shaft diameter of the blind arcading which once decorated the choir (Wilson 1985, p.71). All the re-used Romanesque shafts in the choir elevation are this size (by contrast, the shafts of the blind arches in the 12th-century south radiating chapels are of diameter 19 cm).

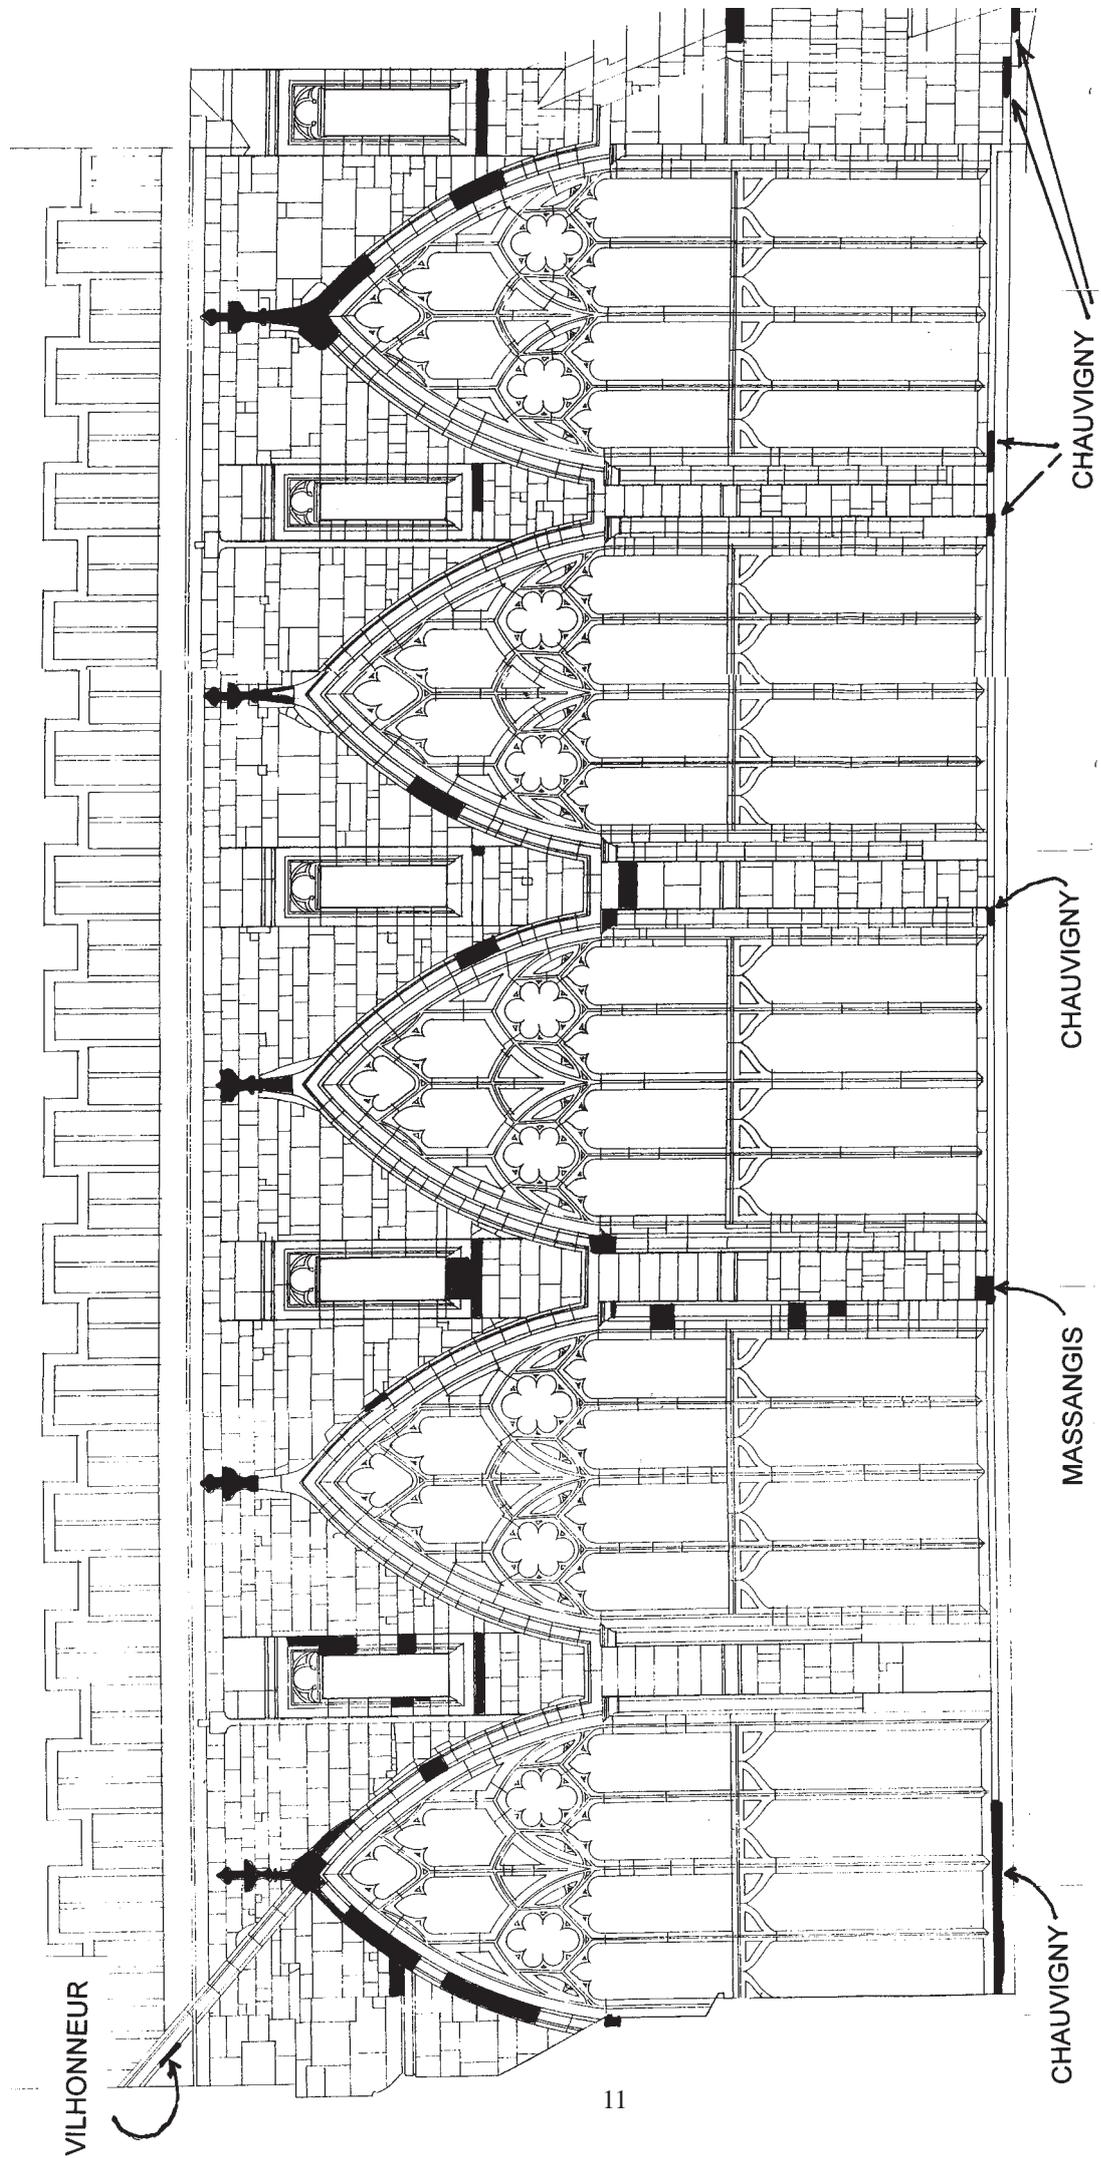
5 South choir elevation: stone replacement, based on a field drawing by Pascal Mychalysin. The replacement stone was Lepine, except where indicated. Scale 1:100

The limited amount of stone replacement was carried out in Lepine stone, which the Cathedral have been using since 1972. There are now some difficulties in obtaining Lepine and a few examples of other French stone have been used, as shown on Figure 5.
