GLOUCESTER CATHEDRAL NORTH TRANSEPT,

PHASE 2 , NORTH GABLE

ARCHAEOLOGICAL REPORT 2007

*Archaeology reference number* GCAR 2007/A

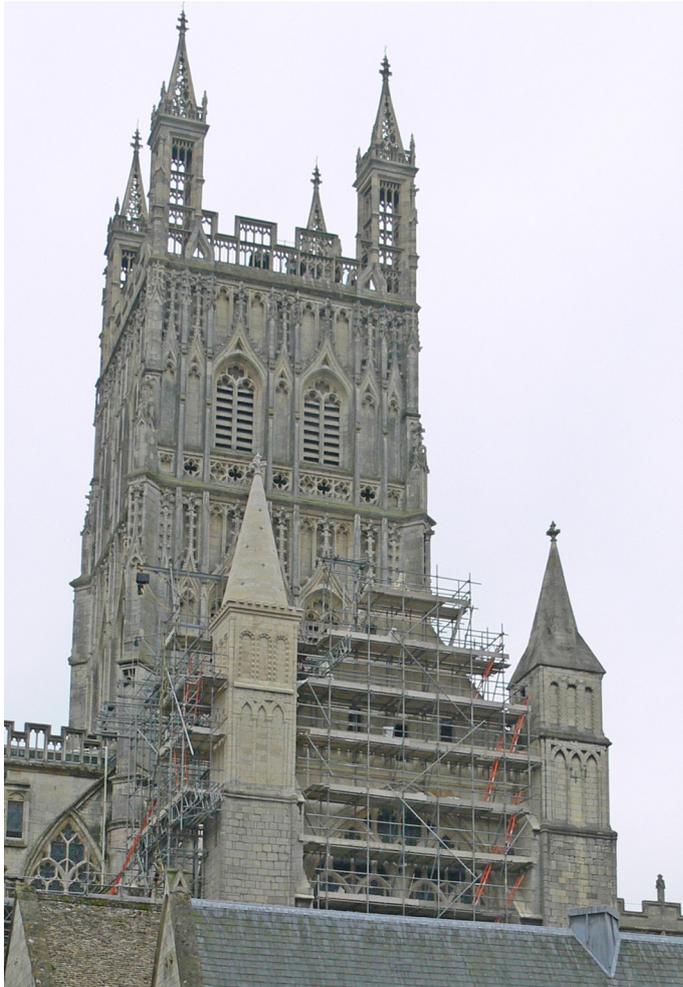
1  
The north transept of Gloucester Cathedral, viewed from the north, after completion of work on the north east turret (the left hand turret) and at the commencement of work on the north gable.

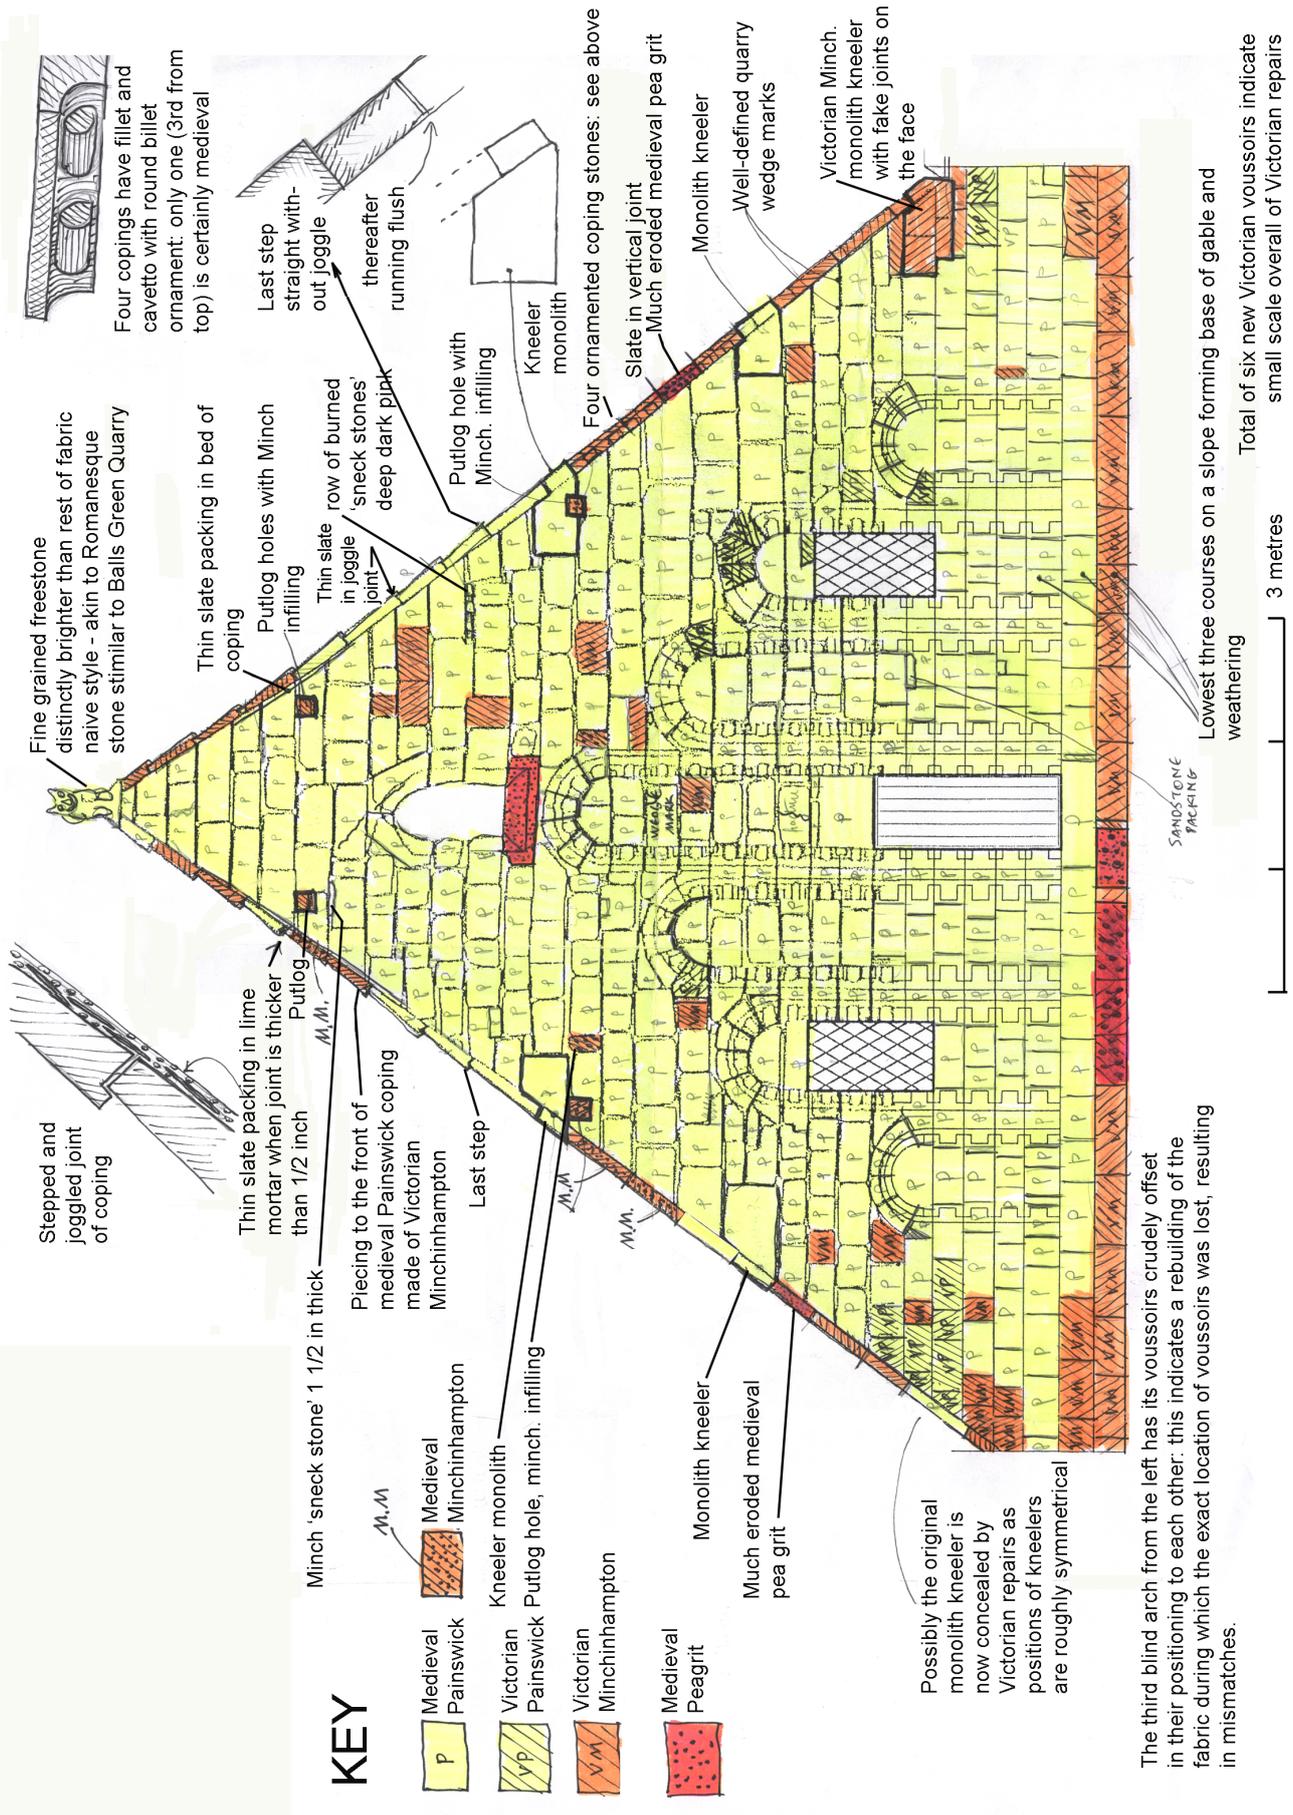
NORTH TRANSEPT  
The North Elevation, Interpretation  
(NE Turret to the Left)

A preliminary survey of petrology and historic detail was carried out by master mason Pascal Mychalysin (Fig 3; Figs 6-7 and Appendix 1 below). Stone types used at Gloucester cathedral are described elsewhere (Bagshaw Heighway and Price 2006). Though Victorian repairs generally tended to be in Bath stone, on the north transept gable, parapet, and north window, the area concerned here, no Bath stone was used, and cathedral architect F S Waller was presumably by this time (the 1870s) using 'Painswick' stone and Minchinhampton weatherstone from Plantation or Catsbrain quarries (GCAR 06/F; Heighway 2007a, 2-3).
